Review of incidents resulting in loss of containers

Report No. : 33039-1-SEA
Date : May 2022
Version : 1.2
Final Report

Ordered by : TopTier JIP

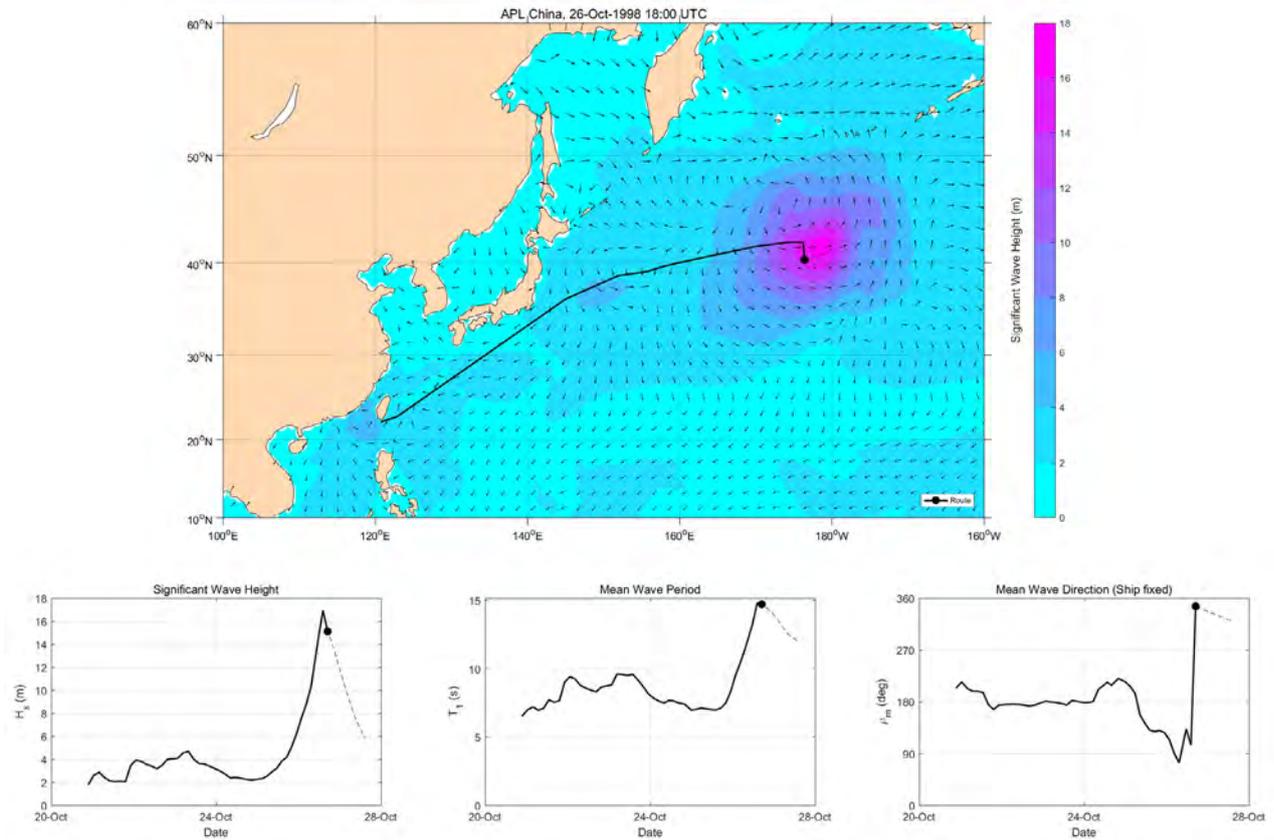
Figure 4-3: Wave hindcast (source ECMWF ERA5)

Assuming that the vessel was indeed sailing in head waves the $T\phi/Te$ is indeed close to 2, so parametric roll in head seas is likely. This is in-line with the conclusion in the publication.

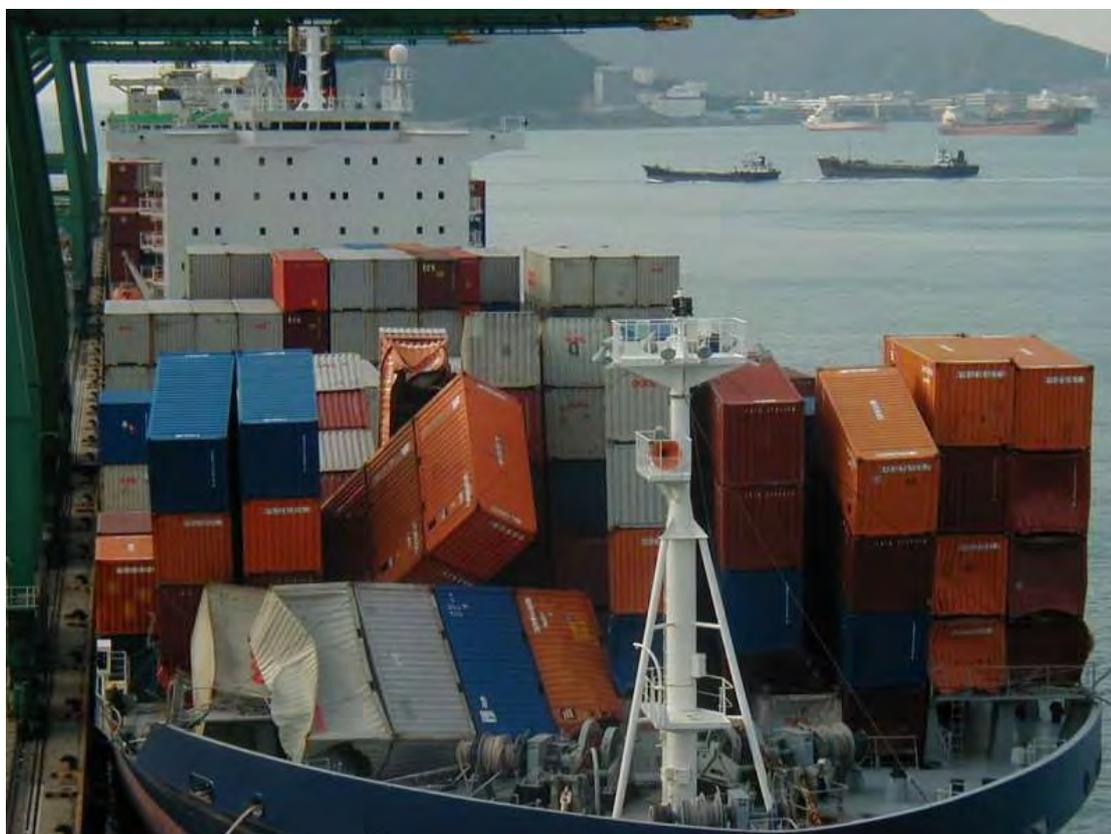
Figure 4-6: Damage overview photo

General info	
IMO	9147112
Name	P&O Nedlloyd Barcelona
Year of build	1997
TEU capacity	3,607
Loa	244 m
B	32 m
Incident info	
date & time	Somewhere between 1997-2002
Speed	Unknown
Position	Unknown
Heading	Head seas (from photos) <i>To Busan, South Korea</i>
hindcast waves	Unknown
Draught	Unknown
transverse stability	Unknown
Rolling period	Unknown
affected/damaged/lost containers	Approx. 51/40/11 (rough count from photos)

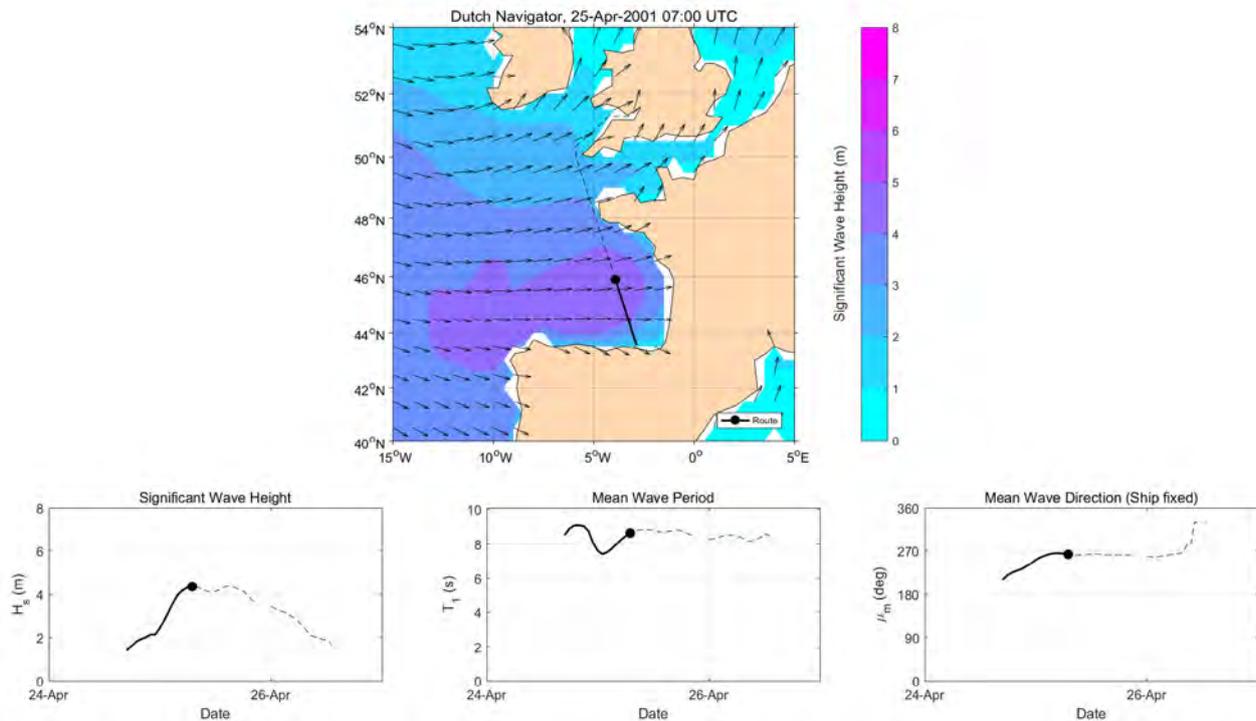
Figure 4-16: *Wave hindcast (source ECMWF ERA5)*

Given the close to beam on wave conditions, wave period close to the estimated roll natural period, resonant roll in beam seas is likely.

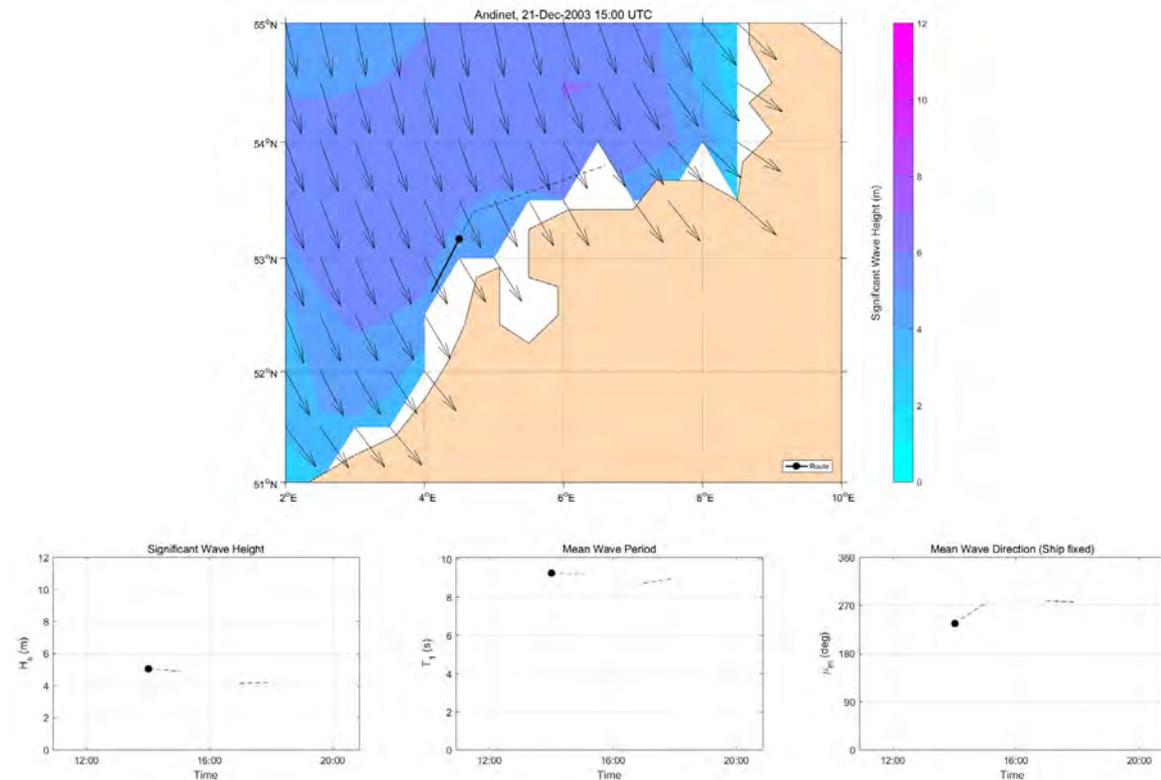
Figure 4-20: Wave hindcast (source ECMWF ERA5)

Based on the above wave conditions, resonant roll in beam seas is likely.

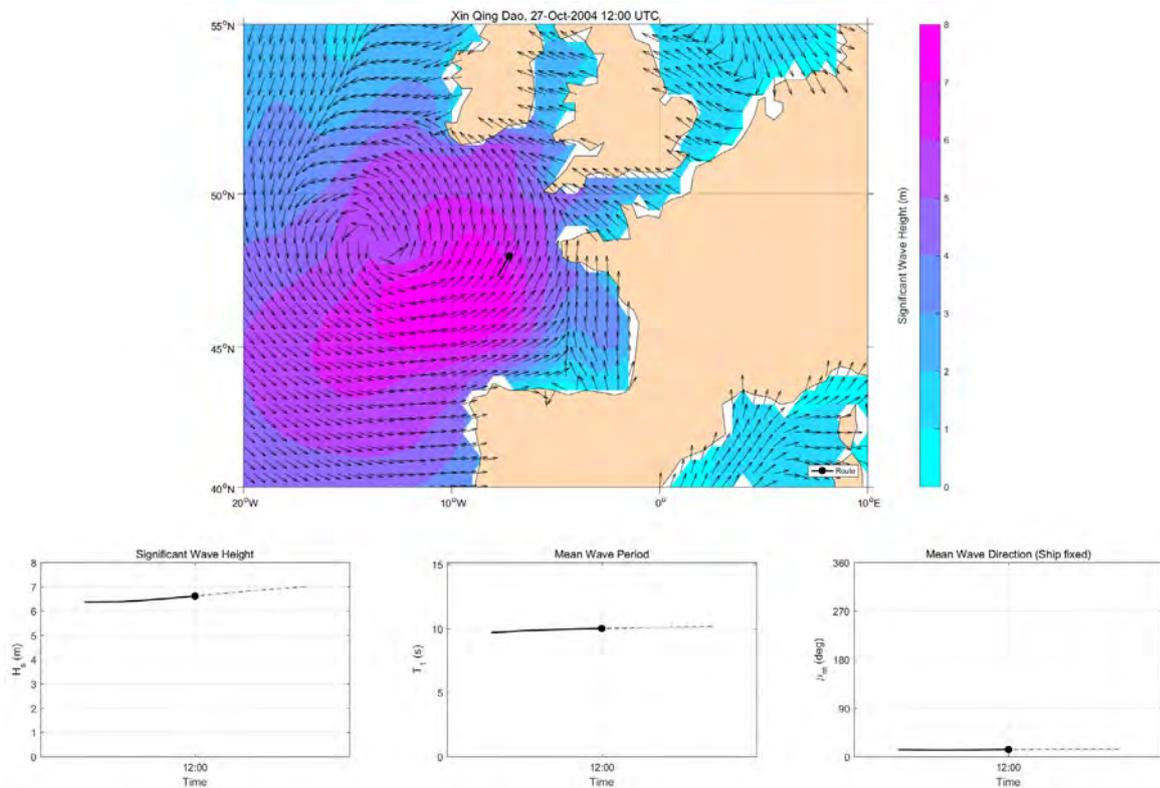
Figure 4-22: Wave hindcast (source ECMWF ERA5)

In these close to following seas conditions it could be parametric roll, although with the assumed GM value of 3 m, the T ϕ /Te ratio is considerably below 2. Therefore resonant roll is slightly more likely.

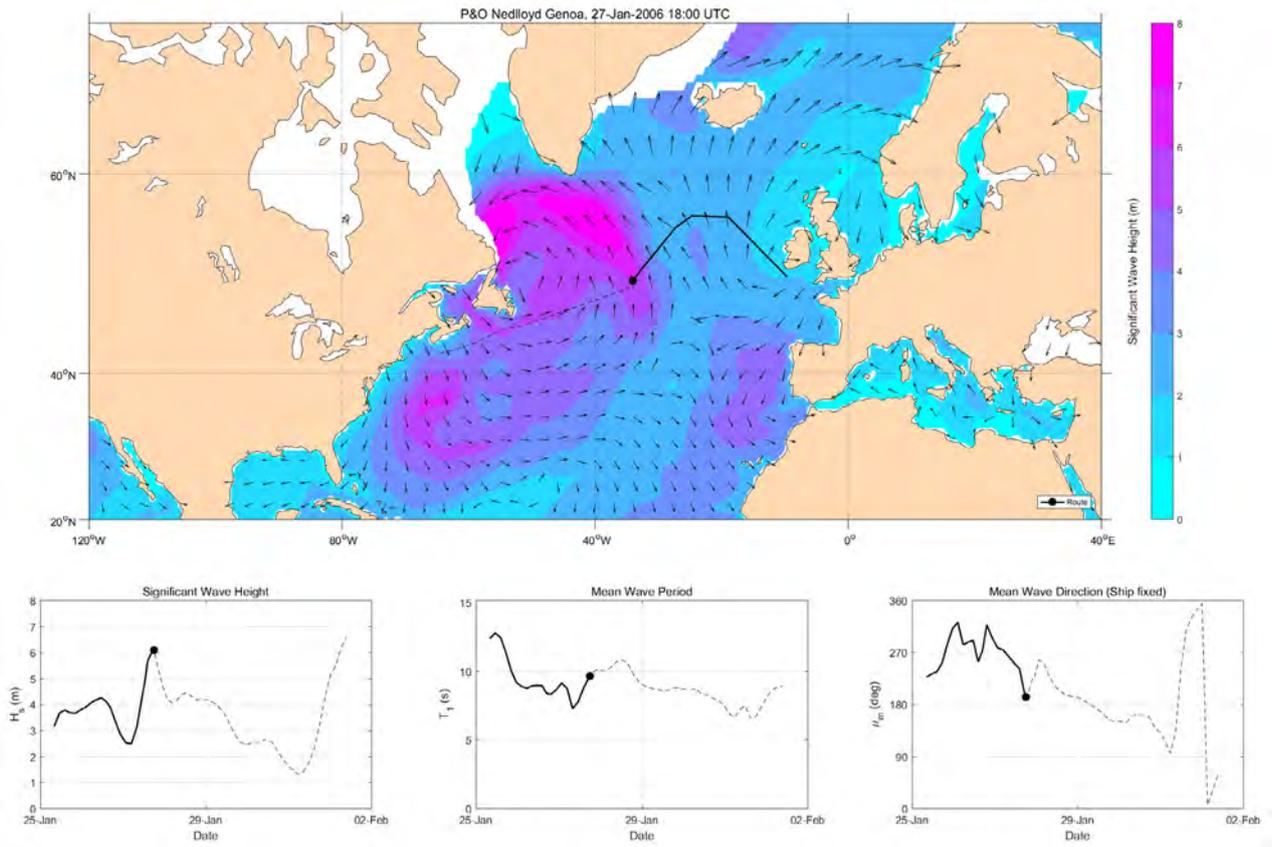
Figure 4-27: Wave hindcast (source ECMWF ERA5)

Given the (close to) head seas condition, λ/L and $T\phi/Te$ ratio, parametric roll in head seas seems most likely.

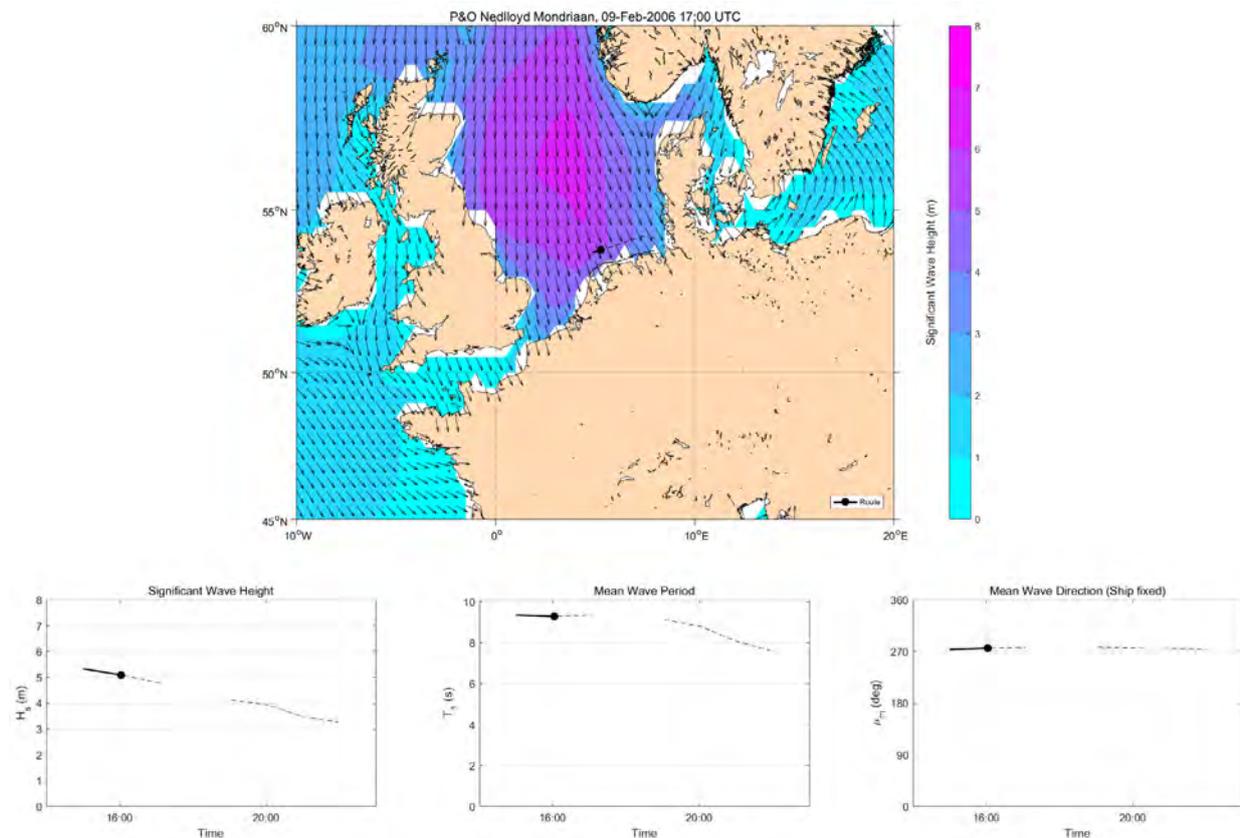
Figure 4-30: Wave hindcast (source ECMWF ERA5)

Based on the above wave conditions, resonant roll in beam seas is likely.

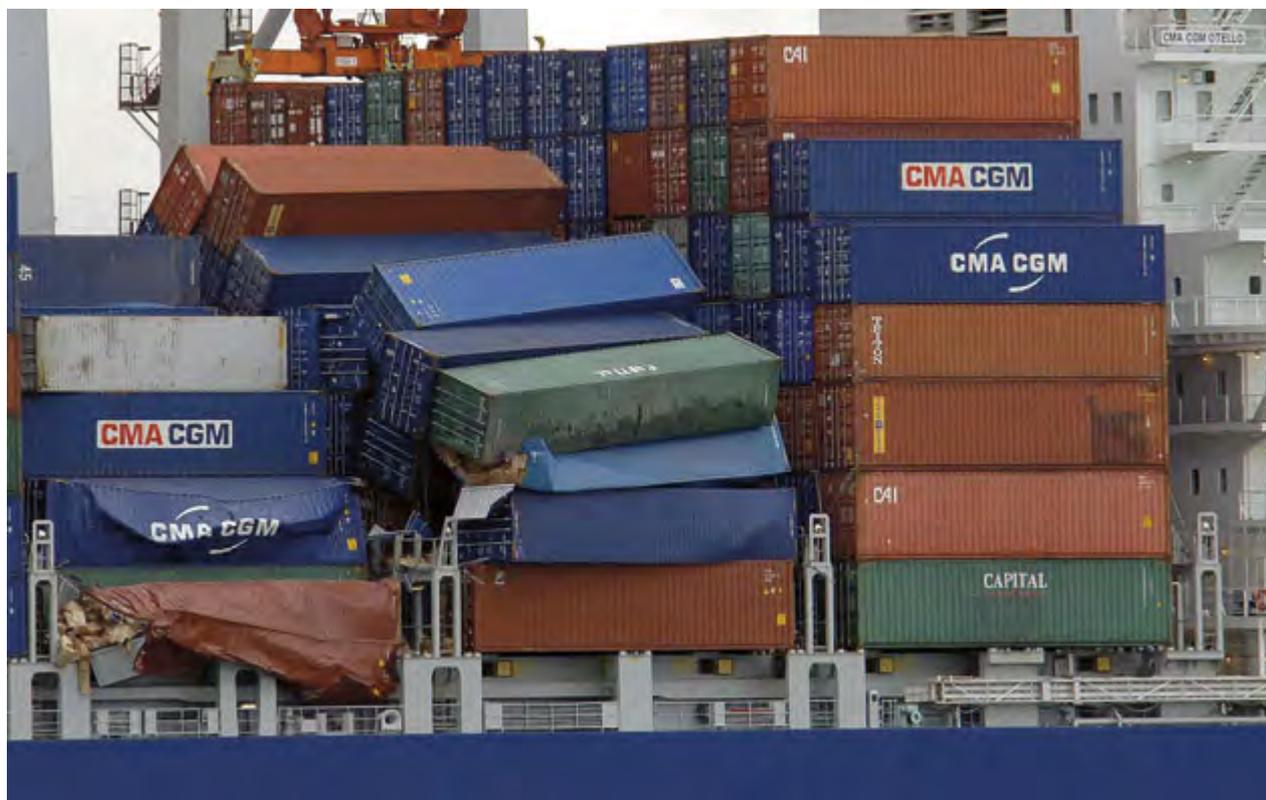
Figure 4-31: Damage overview photo

date & time	17 Feb 2006 06:25 UTC (same storm as P&O Nedlloyd Mondriaan and CMA CGM Verdi)
speed	Approx. 23 kn
position	45° 29' N / 008° 07' W <i>French Coast</i>
heading	027 deg <i>Port Kelang, Malaysia to Le Havre, France</i>
hindcast waves	Hs = 7.8 m
draught	Unknown
transverse stability	2 m (long voyage, estimation as per chapter 2)
roll period	24.4 s (long voyage, estimation as per chapter 2)
affected/damaged/lost containers	70/20/50

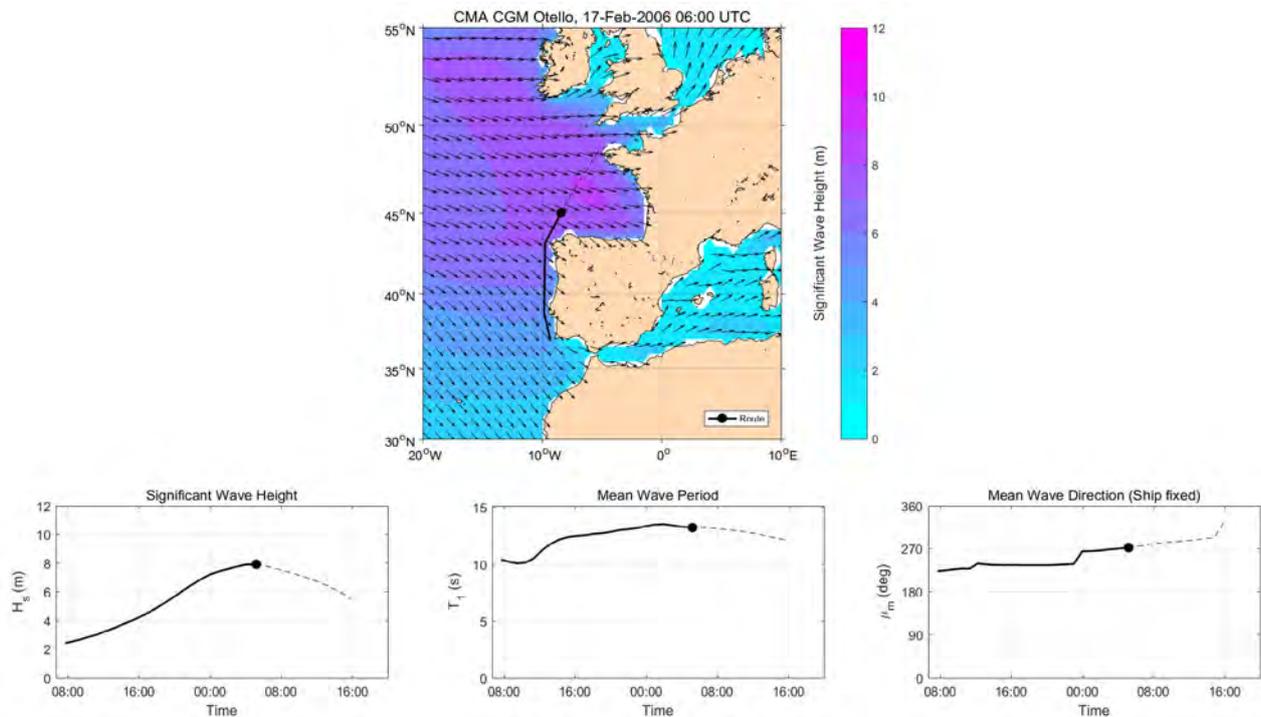
Figure 4-32: Wave hindcast (source ECMWF ERA5)

Based on the above wave conditions, resonant roll in beam seas is likely.

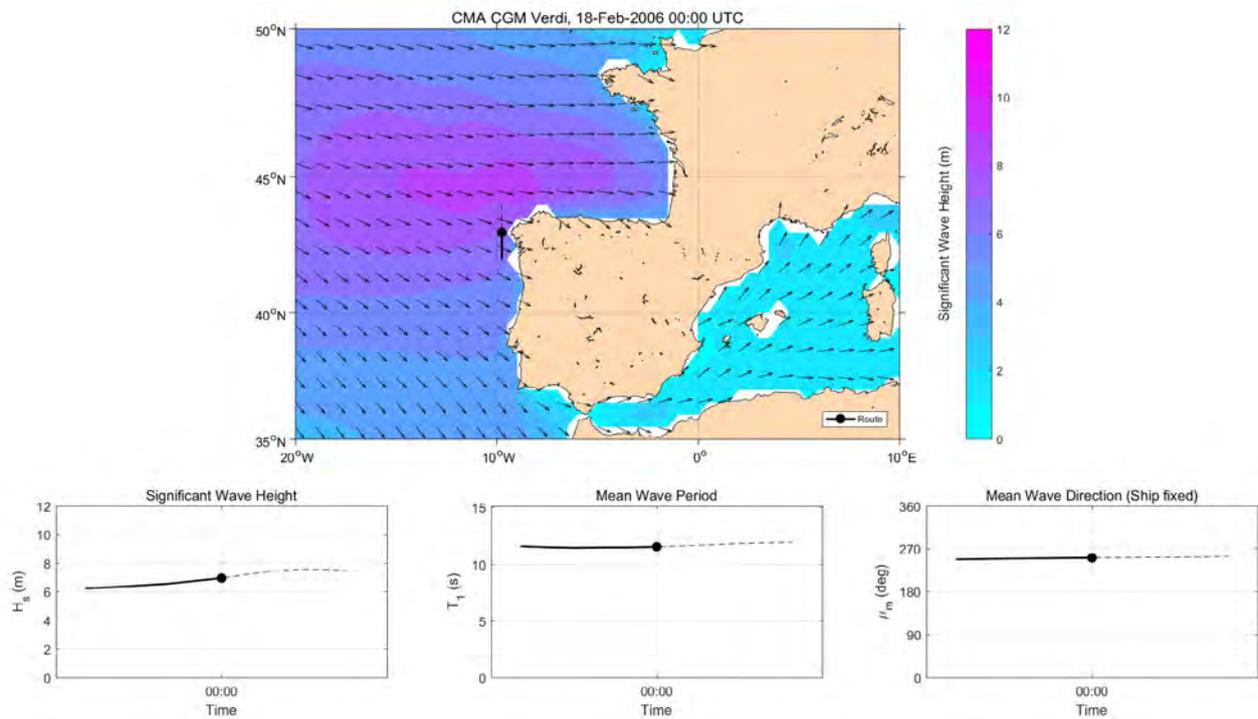
Figure 4-36: *Wave hindcast (source ECMWF ERA5)*

Based on the above wave conditions, resonant roll in (close to) beam seas is likely.

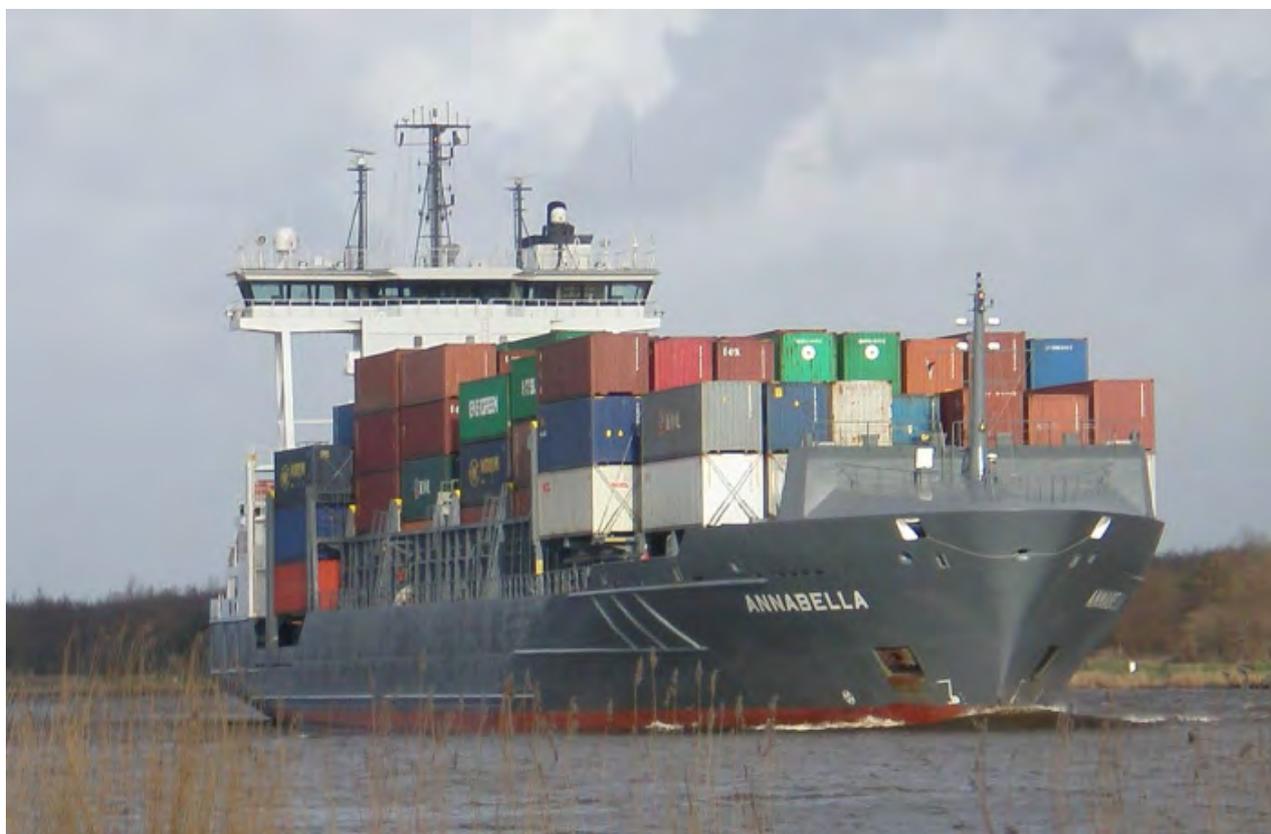
Figure 4-41: Overview photo (no damage overview photo available)

General info	
IMO	8919788
Name	Annabella
Year of build	1991
TEU capacity	868
Loa	134.0
B	22.0
Incident info	
date & time	25 Feb 2007 18:50 UTC, course & speed altered
speed	12 kn, reduced from estimated 18+ kn before
position	Approx. 56° N / 017° E <i>Baltic Sea</i>
heading	From 060 deg to 017 deg to pass west of Gotland
hindcast waves	Hs = 2.4 m
draught	Unknown
transverse stability	1.68 m
roll period	14.6 s (based on estimate roll inertia)
affected/damaged/lost containers	7/7/0

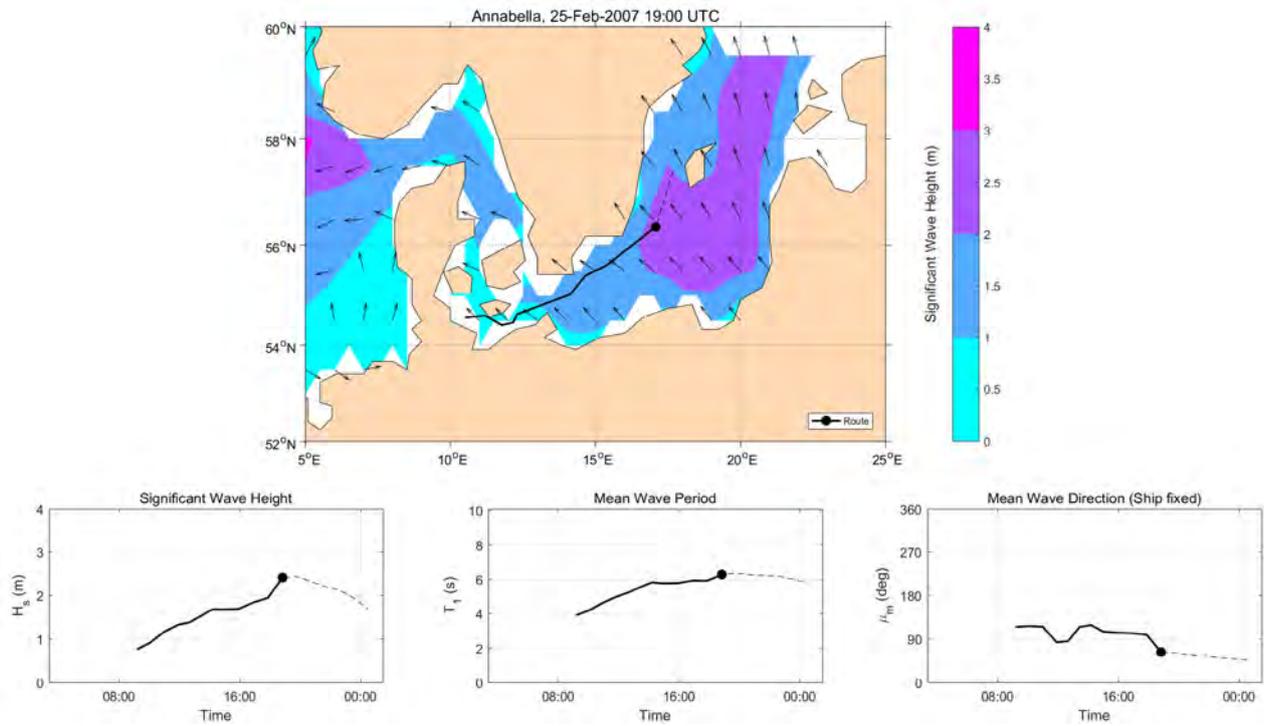
Figure 4-42: Wave hindcast (source ECMWF ERA5)

Based on the above wave conditions, resonant roll is less likely (although the vessel is sailing in close to beam seas). As one stack collapsed in the cargo hold, vertical motions due to heave in beam seas or pitch in bow quartering seas are the most likely contributors.

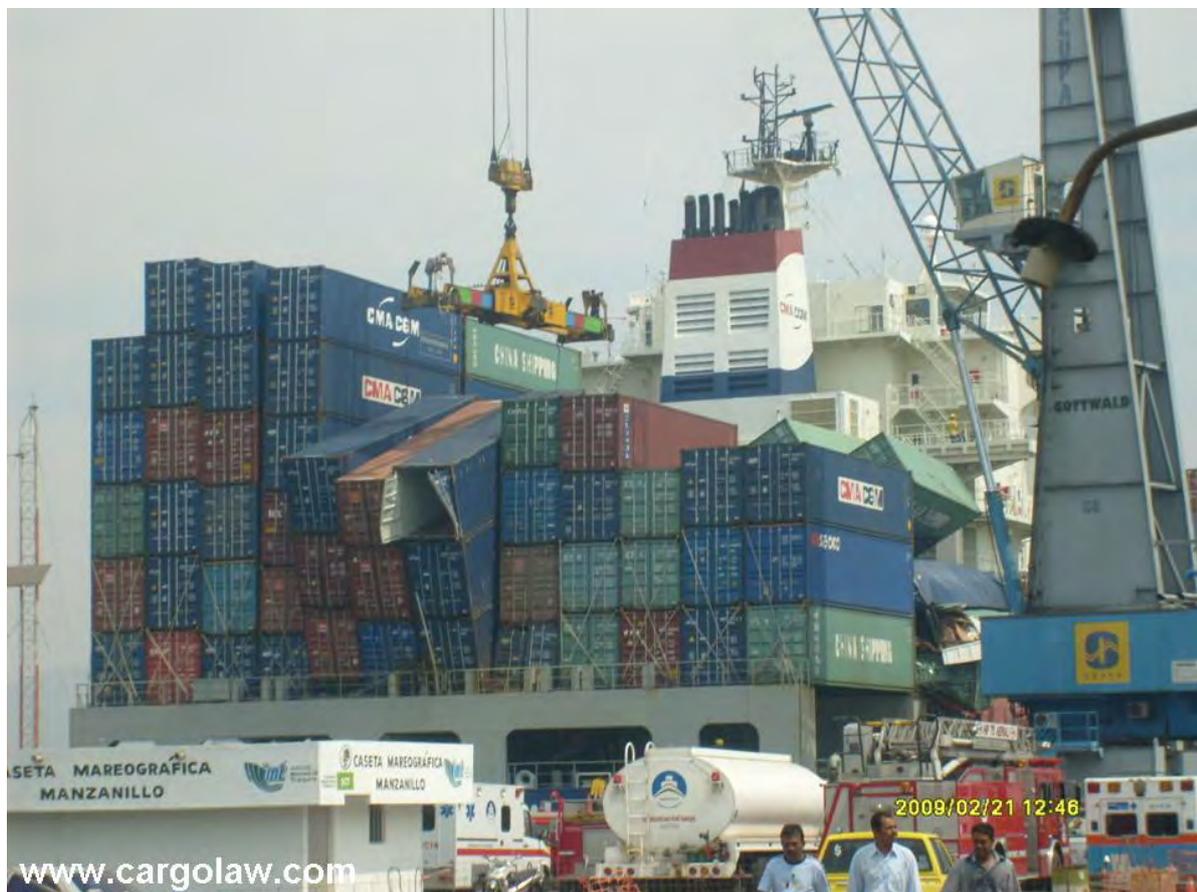
Figure 4-48: Damage overview photo

General info	
IMO	9314959
Name	CMA CGM Dahlia
Year of build	2006
TEU capacity	2,824
Loa	223.0
B	30.0
Incident info	
date & time	10 Feb 2008 (arrival in port on 21 Feb 2008)
speed	Unknown
position	Pacific, Eastbound
heading	To Manzanillo, Mexico
hindcast waves	Unknown
draught	Unknown
transverse stability	Unknown
roll period	Unknown
affected/damaged/lost containers	80/20/20

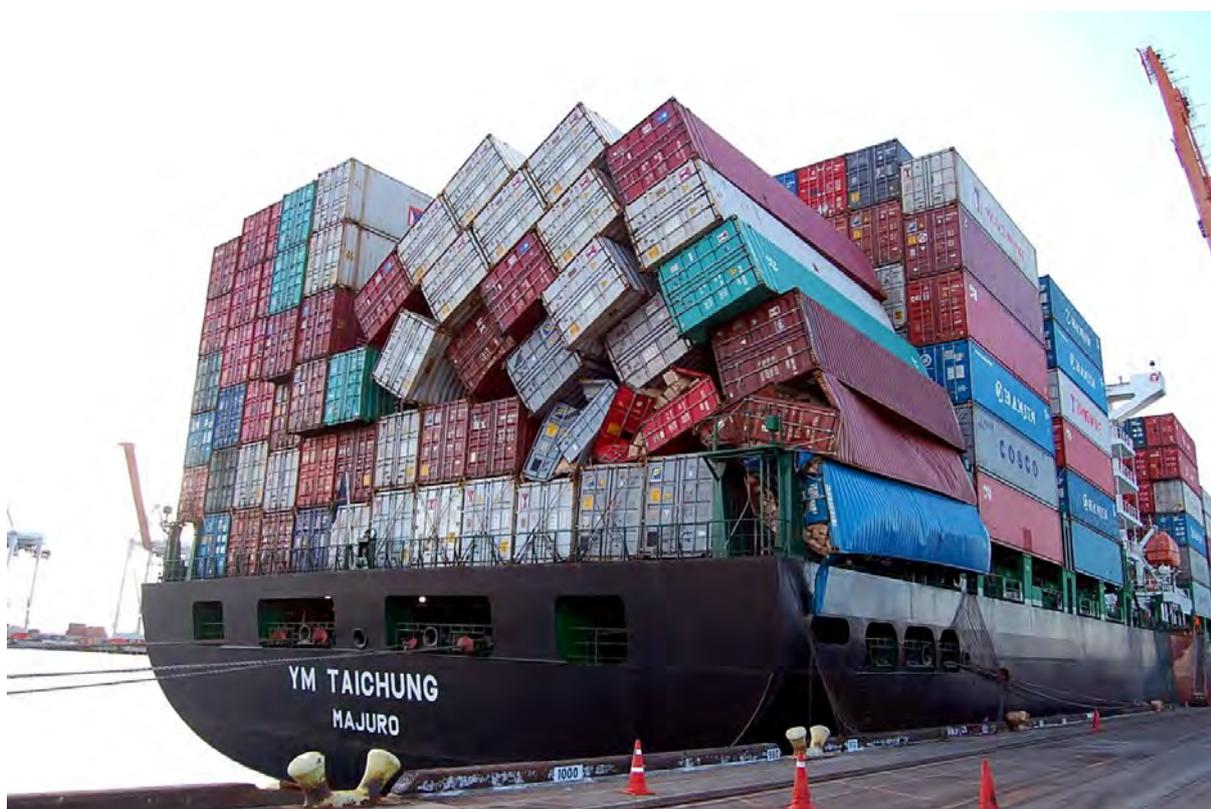
Figure 4-56: Damage overview photo

General info	
IMO	9280811
Name	YM Taichung
Year of build	2004
TEU capacity	4,132
Loa	261.0 m
B	32.0 m
Incident info	
date & time	5 Apr 2009
speed	15 kn (estimation as per chapter 2)
position	Approx. 35° N / 144° W 1,000 NM west of San Francisco
heading	Assumed at 090 deg To Long Beach, USA
hindcast waves	Hs = 5.2 m
draught	Unknown
transverse stability	2 m (long voyage, estimation as per chapter 2)
roll period	19.5 s (long voyage, estimation as per chapter 2)
affected/damaged/lost containers	40/26/14

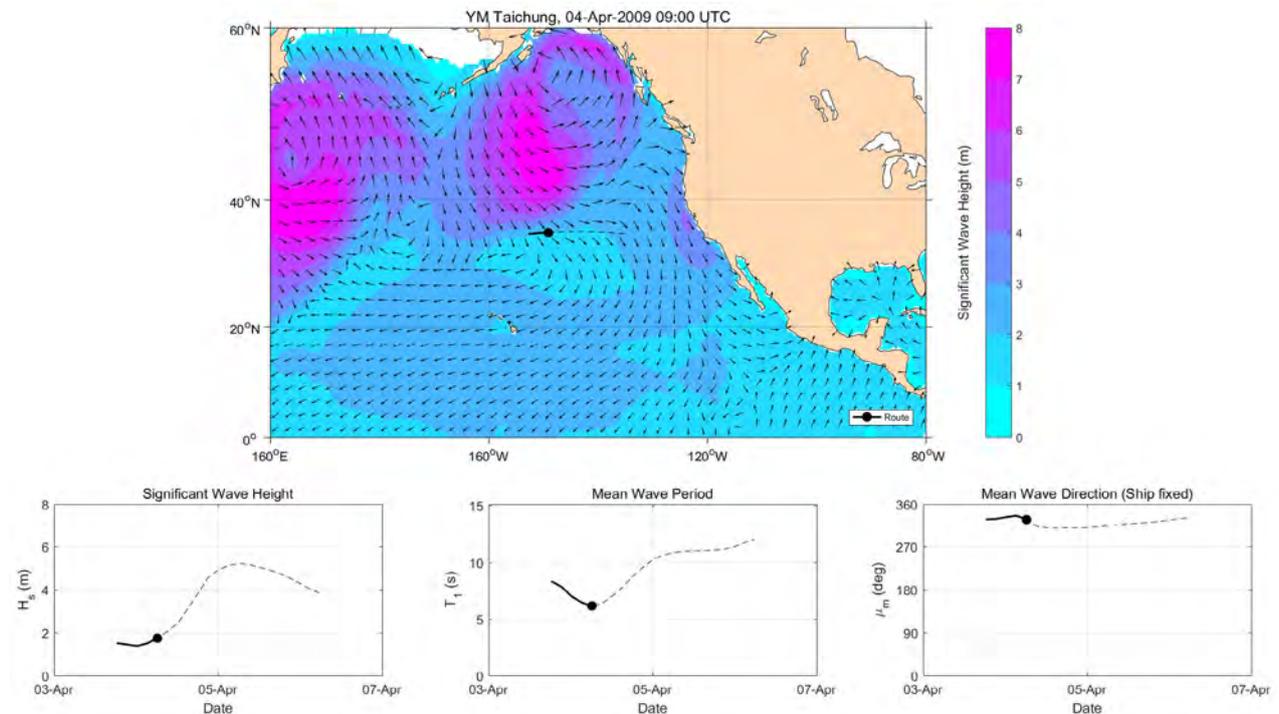
Figure 4-57: Wave hindcast (source ECMWF ERA5)

From the wave conditions and estimated rolling period, resonant roll in stern quartering seas seems most likely.

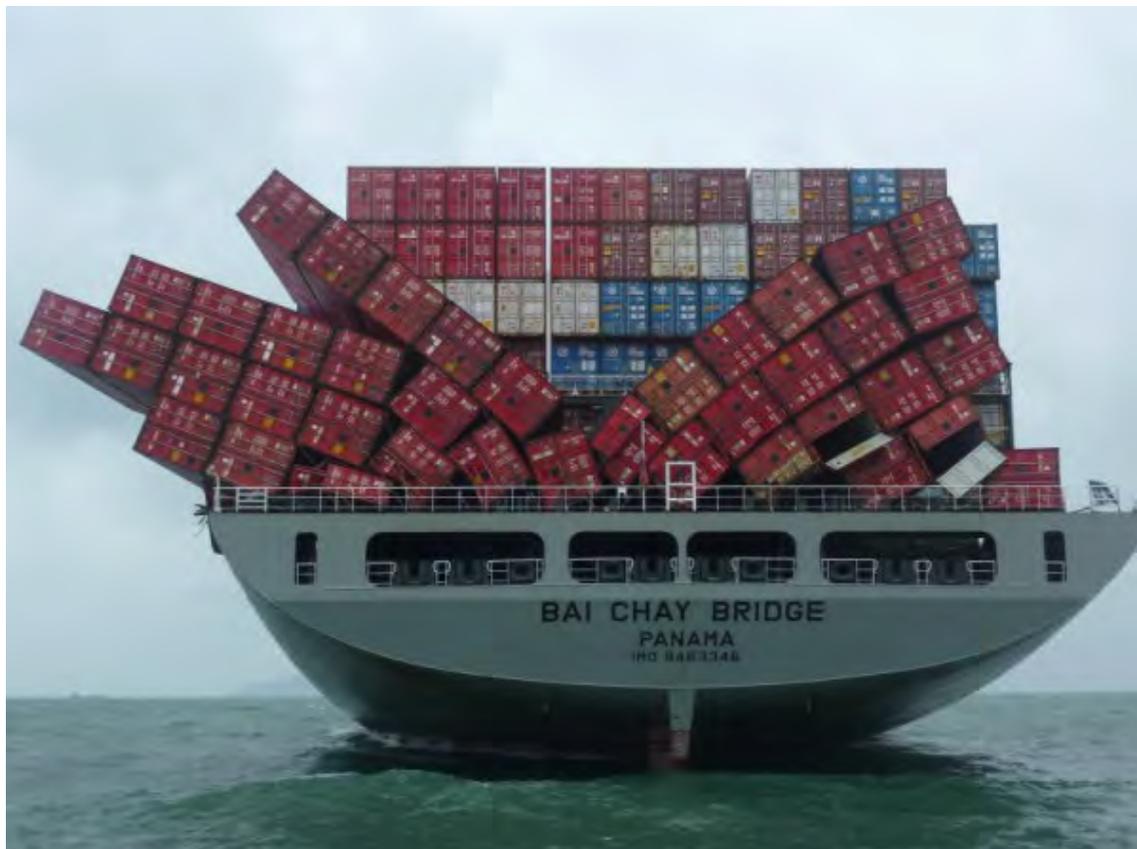
Figure 4-60: Damage overview photo

General info	
IMO	9463346
Name	Bai Chay Bridge
Year of build	2011
TEU capacity	4,430
Loa	266.0
B	36.0
Incident info	
date & time	Before 23 Jun 2012 (arrival date Hong Kong)
speed	Unknown
position	East of Japan (exact location unknown)
heading	Pacific, westbound
hindcast waves	Unknown (Typhoon Guchol)
draught	Unknown
transverse stability	Unknown
roll period	Unknown
affected/damaged/lost containers	168/60/30 (rough count from photos)

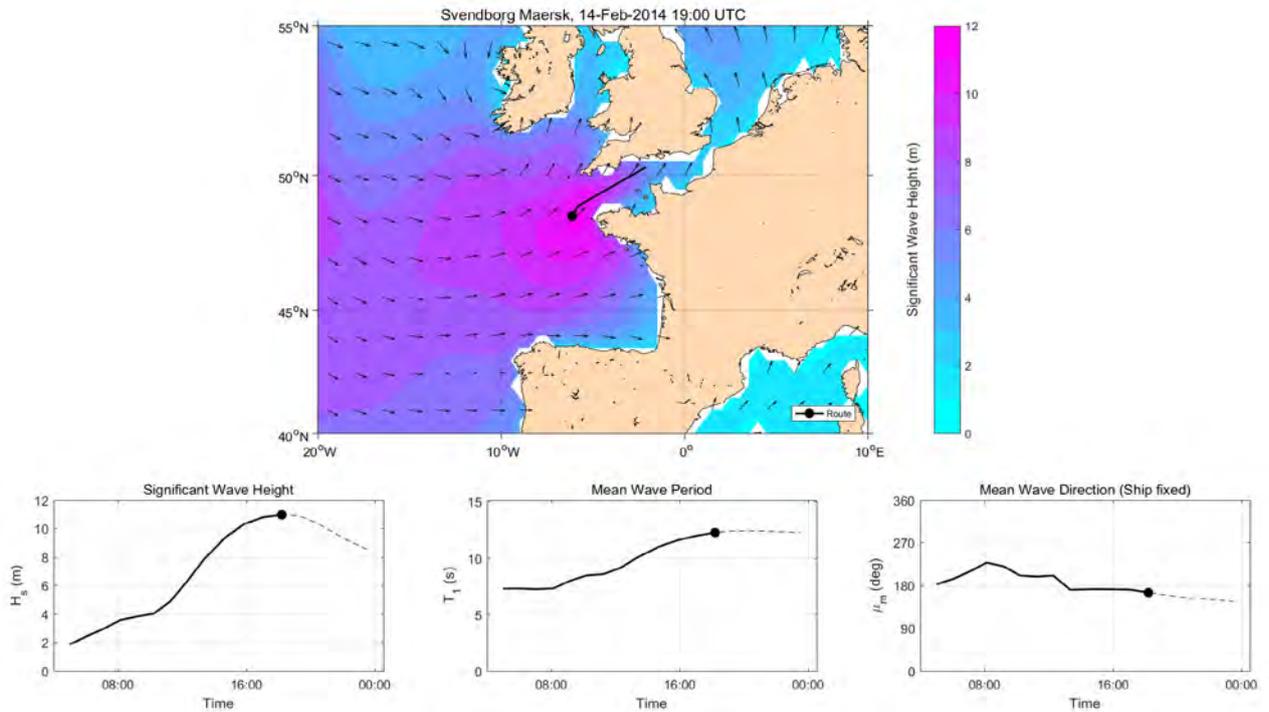
Figure 4-64: Wave hindcast (source ECMWF ERA5)

Based on the above wave conditions, the vessel was sailing in close to head seas conditions. With an estimated GM of around 4 m the T ϕ /Te is fairly close to 2, so parametric roll in head seas is likely. This was also the conclusion in the DMAIB report.

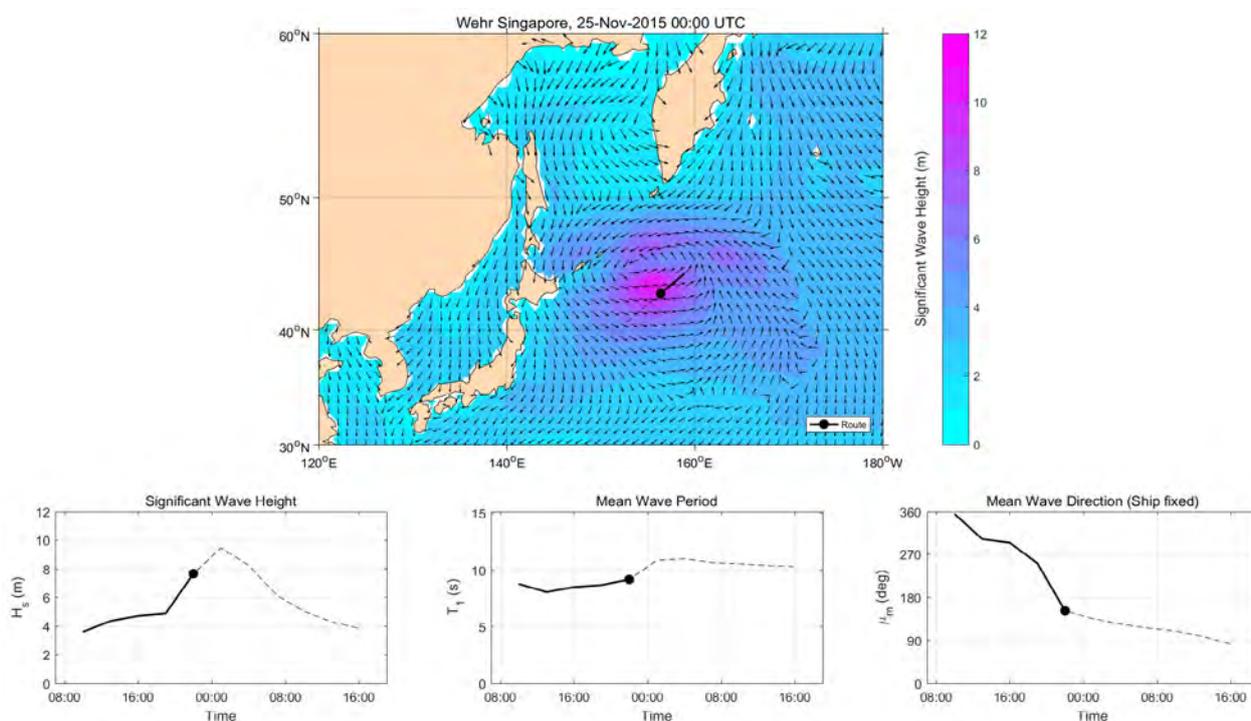
Figure 4-68: Wave hindcast (source ECMWF ERA5)

In these bow quartering seas conditions, resonant roll and parametric roll seems unlikely. Combined first order ship motions (heave, pitch, and roll) and/or slamming induced vibrations are the most likely contributors. However due to the rapidly changing weather conditions, the result is quite sensitive to position and time of the incident.

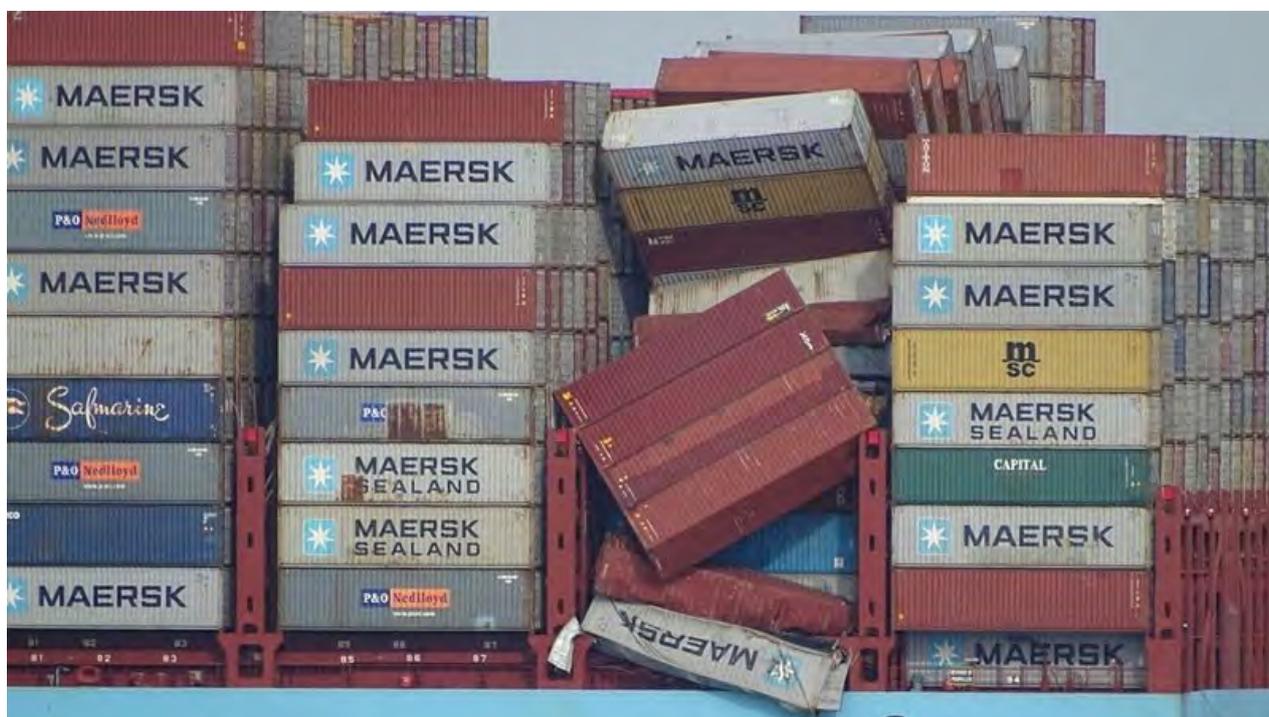
Figure 4-69: Damage overview photo

General info	
IMO	9632064
Name	Maersk Merete
Year of build	2014
TEU capacity	18,270
Loa	399.0
B	59.0
Incident info	
date & time	Approx. 6 Feb 2017 16:00 UTC
speed	15 kn (estimation as per chapter 2)
position	38° N / 007° E <i>Mediterranean, North of Skikda, Algeria</i>
heading	Approx. 270 deg <i>Suez, Egypt (Tanjung Pelepas) to Algeciras, Spain</i>
hindcast waves	Hs = 7.0 m
draught	Unknown
transverse stability	1.9 m
roll period	36.9 s (based on estimated roll inertia)
affected/damaged/lost containers	128/85/43

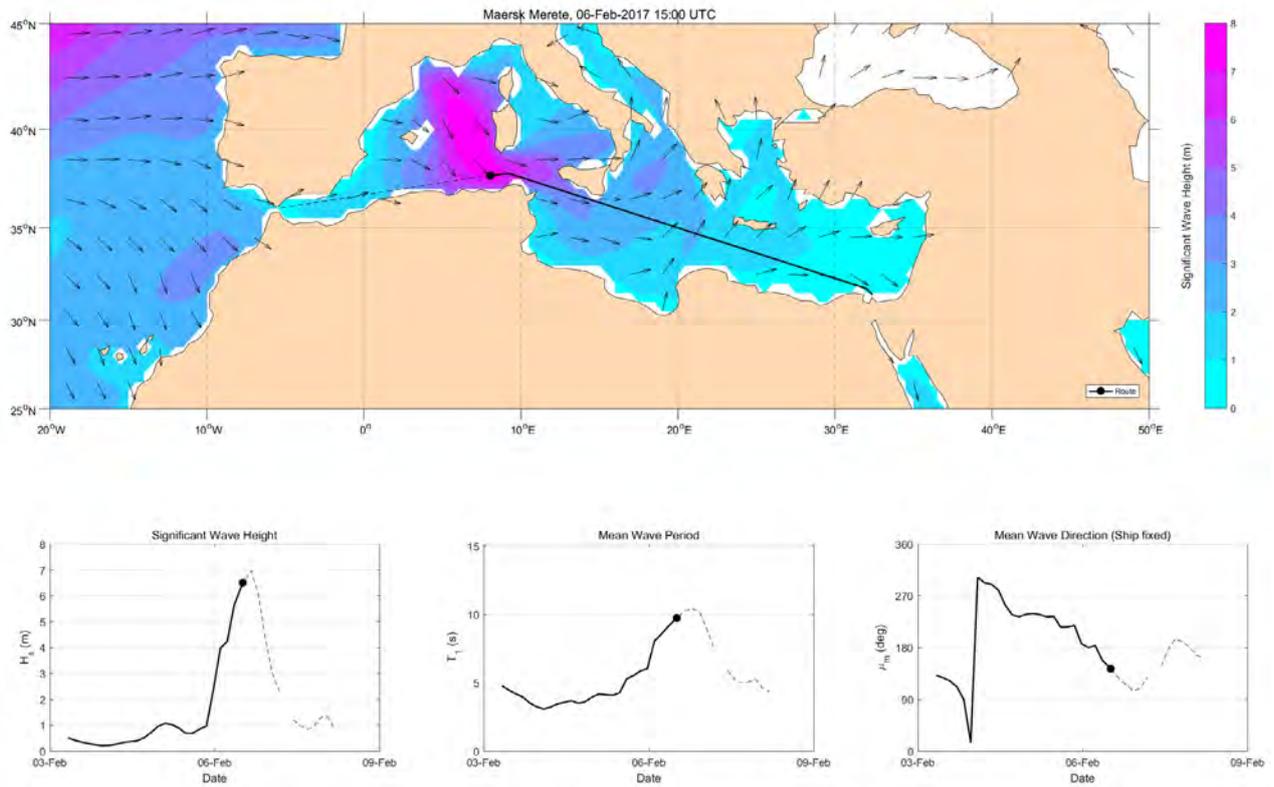
Figure 4-70: Wave hindcast (source ECMWF ERA5)

In these bow quartering seas conditions, resonant roll and parametric roll seems unlikely. Combined first order ship motions (heave, pitch, and roll) and/or slamming induced vibrations are the most likely contributors.

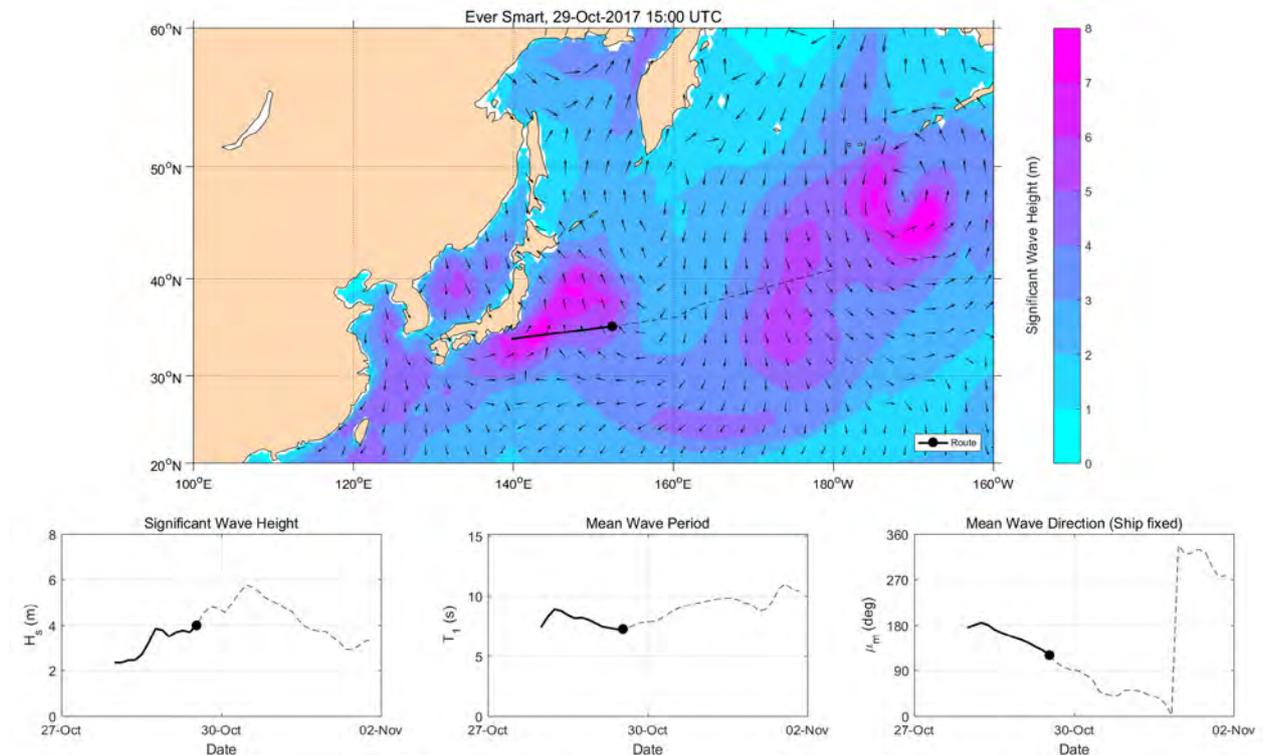
Figure 4-74: Wave hindcast (source ECMWF ERA5)

As wave directions conditions changed rapidly in this storm a more beam or stern quartering seas condition would also have been possible. But present heading (beam to bow quartering seas) seems to be more or less in line with the reported ship behaviour.
