Review of incidents resulting in loss of containers

Report No. : 33039-1-SEA
Date : May 2022
Version : 1.2
Final Report

Ordered by : TopTier JIP

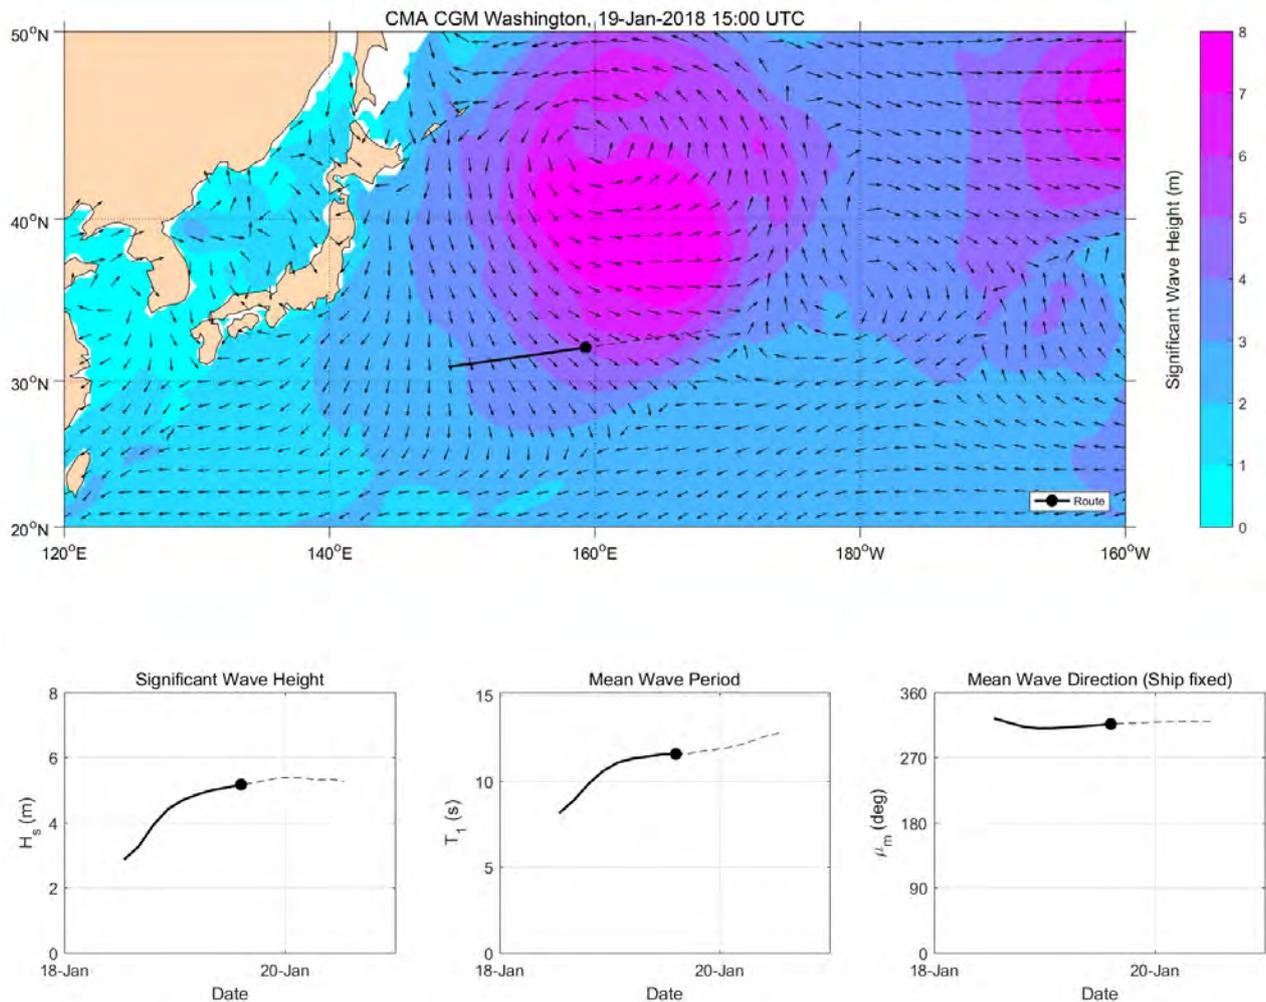
Figure 4-78: Wave hindcast (source ECMWF ERA5)

Given the heading and $T\phi/T_e$ ratio, parametric roll in (close to) following seas is most likely, although resonant roll could be possible as well (requires a higher GM than the taken 1.28 m and a lower k_{xx}).

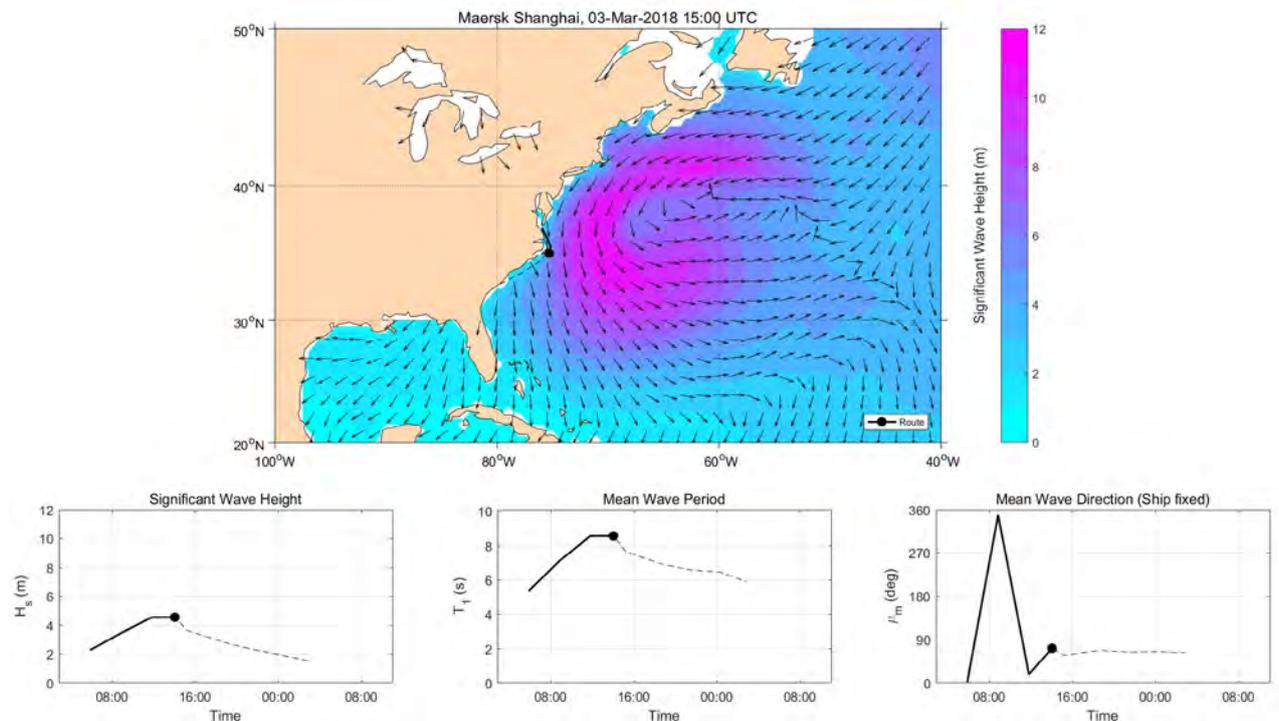
Figure 4-82: Wave hindcast (source ECMWF ERA5)

Based on the above conditions and an estimated speed of 15 kn, the wave encounter period is approximately 17 s. With the provided GM the rolling period would be around 48 s (varying between 36 to 58 s depending on kxx). Given the heading and T_ϕ/T_e ratio, both resonant roll as well as parametric roll seem unlikely.

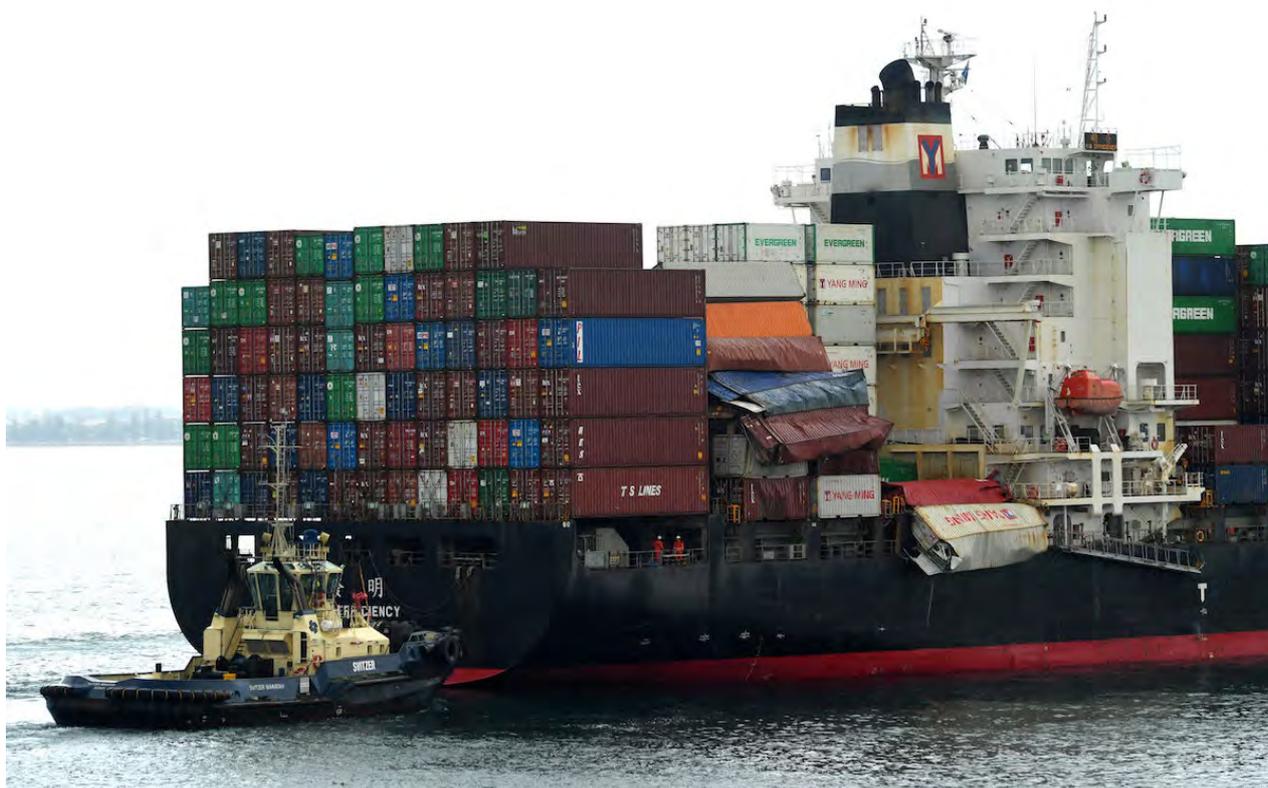
Figure 4-83: Damage overview photo

date & time	31 May 2018 14:35 UTC
speed	3-4 kn
position	33.0° S / 152.1° E <i>Australian Coast</i>
heading	210 deg prior to incident; 000 deg after
hindcast waves	Hs = 4.8 m
draught	Ta/Tf = 12.5/10.5 m
transverse stability	1.09 m (arrival)
roll period	20.1 s
affected/damaged/lost containers	143/62/81

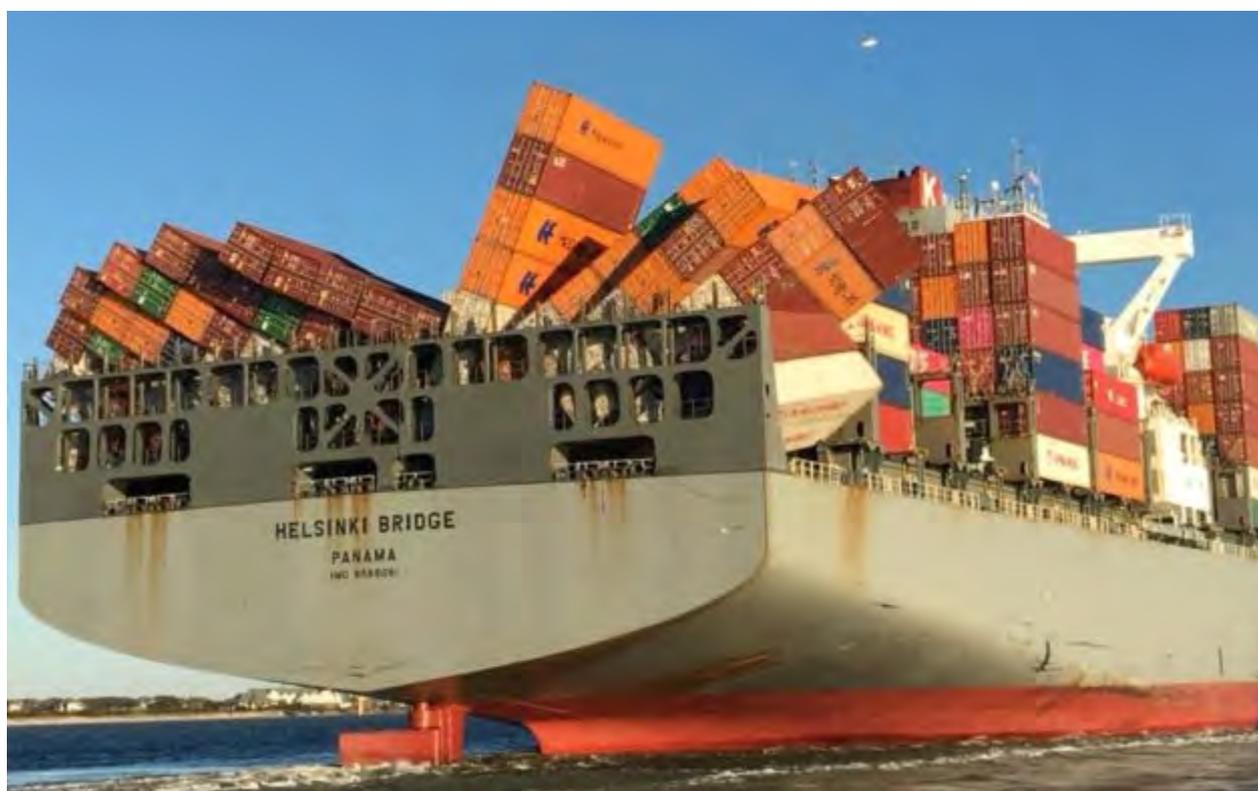
Figure 4-91: Damage overview photo

General info	
IMO	9588081
Name	Helsinki Bridge
Year of build	2012
TEU capacity	8,930
Loa	334.0
B	45.0
Incident info	
date & time	27 Feb 2019, time unknown
speed	18 kn (estimation as per chapter 2)
position	42° N / 070° W <i>US East Coast</i>
Heading	Between 180 to 240 deg <i>Boston, USA to Wilmington, USA</i>
hindcast waves	Hs = 2.5 m
draught	Unknown
transverse stability	3 m (coastal voyage, estimation as per chapter 2)
roll period	22.4 s (coastal voyage, estimation as per chapter 2)
affected/damaged/lost containers	100/20/10

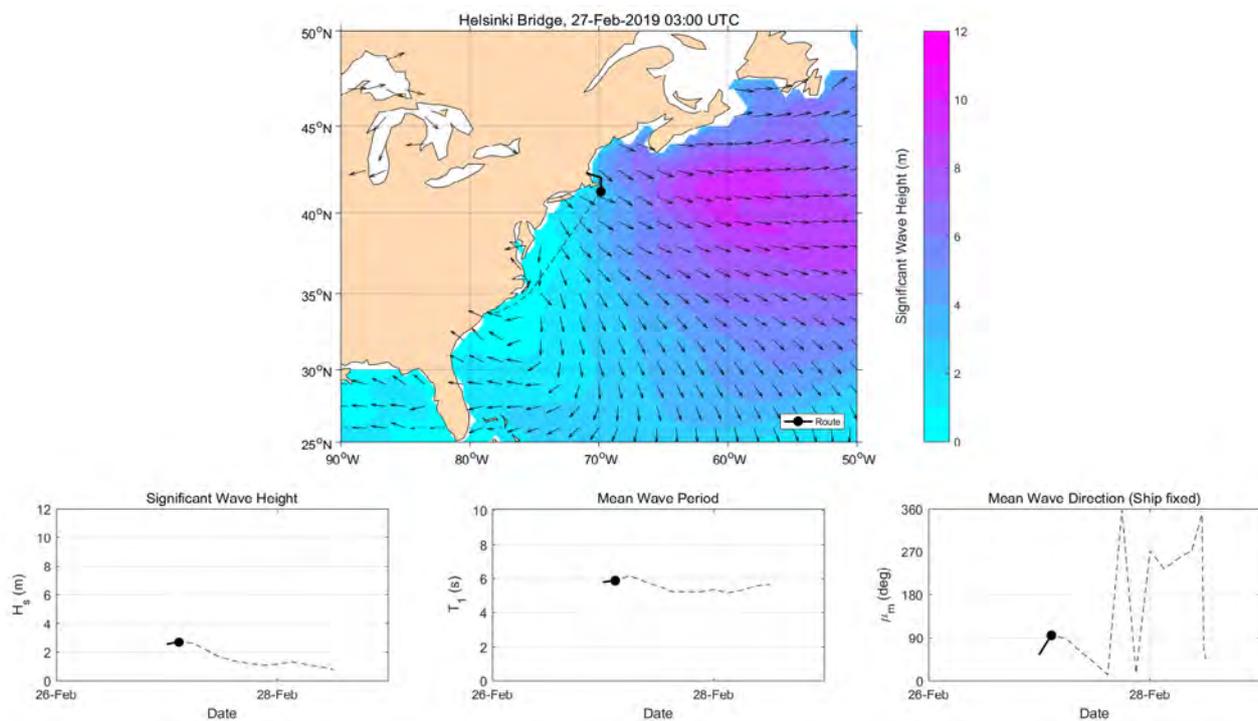
Figure 4-92: Wave hindcast (source ECMWF ERA5)

Based on these stern quartering seas conditions and given the estimated rolling period of 22 s (based on a GM of 3 m), resonant roll in stern quartering seas seems most likely.

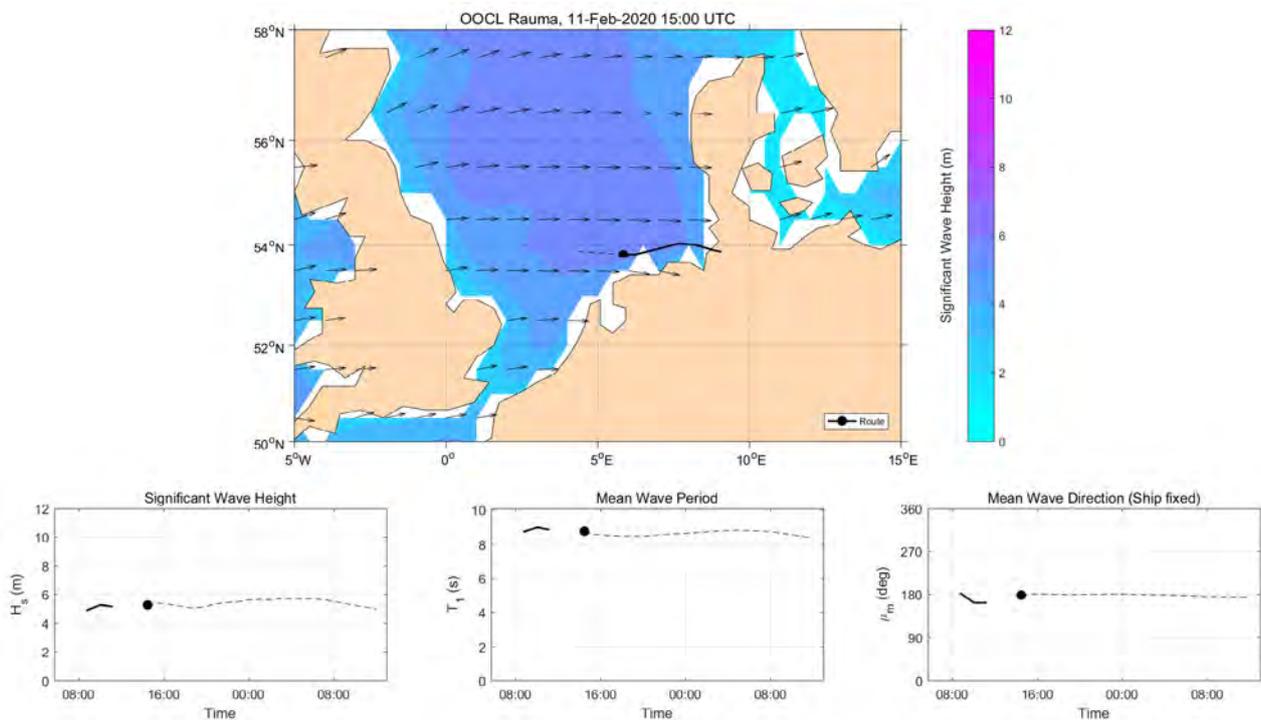
Figure 4-97: Wave hindcast (source ECMWF ERA5)

In these head seas conditions, large pitch/heave motions possibly in combination with shipping green water seem the most likely contributors.

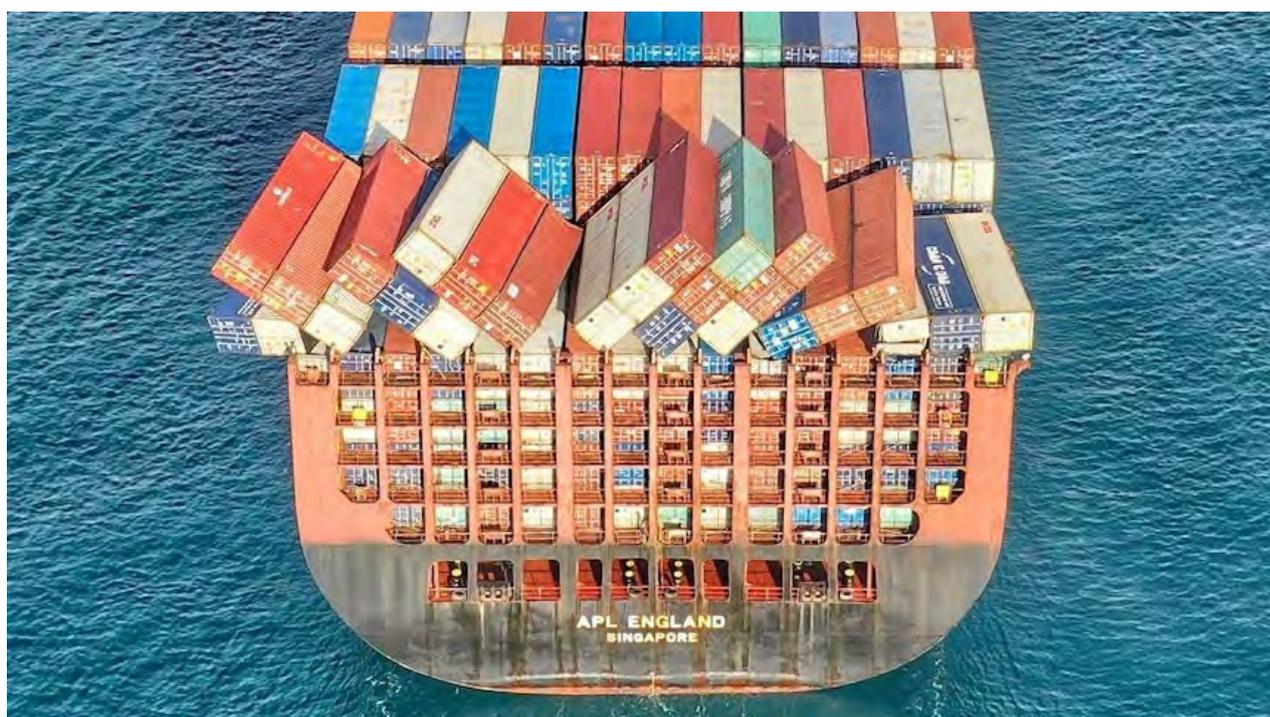
Figure 4-100: Damage overview photo

Incident info	
date & time	23 May 2020 16:15 UTC
speed	7 kn
position	34.37° S / 151.91° E <i>Australian Coast</i>
heading	185 deg
hindcast waves	Hs = 5.3 m
draught	Ta/Tf = 13.32/11.44 m
transverse stability	3 m (coastal voyage, estimation as per chapter 2)
roll period	19.9 s (coastal voyage, estimation as per chapter 2)
affected/damaged/lost containers	113/63/50

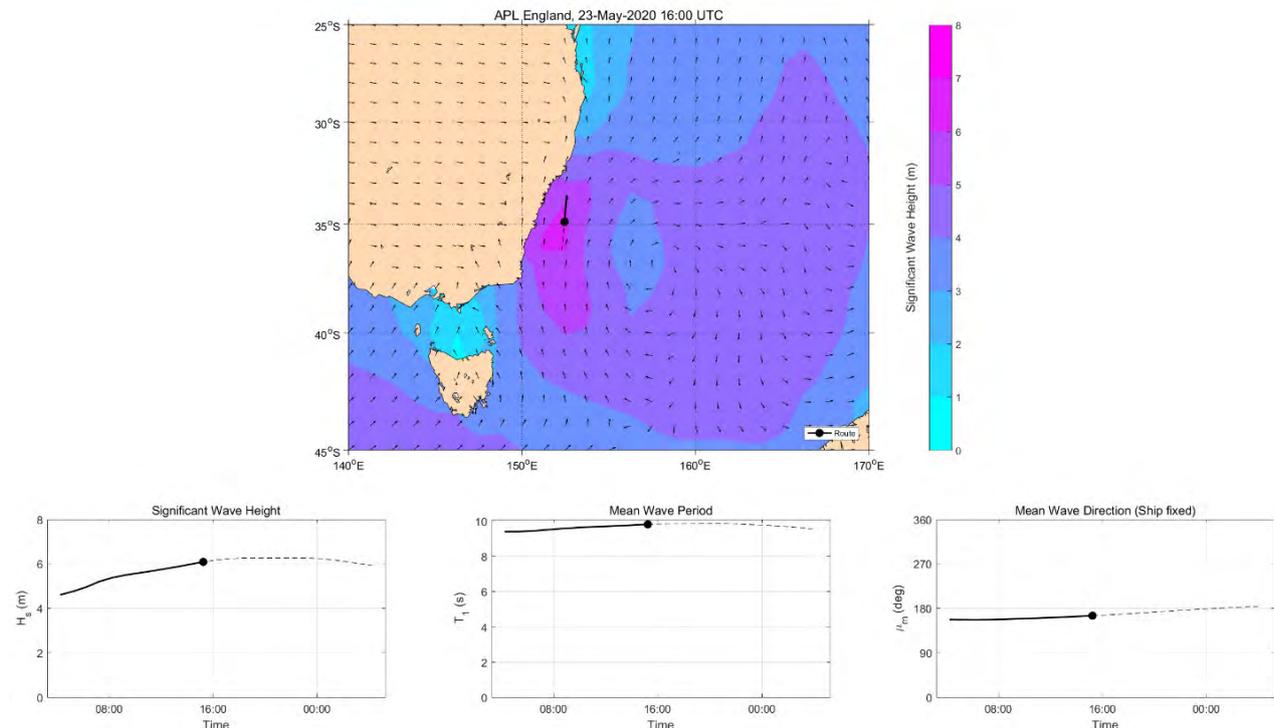
Figure 4-101: Wave hindcast (source ECMWF ERA5)

Based on the above conditions and a speed of 7 kn, the wave encounter period is approximately 8 s. As the transverse stability (GM) is not provided in the incident report, it is difficult to estimate the rolling period. A very rough guess would around 20 s (assuming a GM of 3 m and typical roll inertia) but it could vary between less than 10 s and above 38 s. Given the heading (head seas), low speed and T_{ϕ}/T_e ratio, parametric roll in head seas is likely.

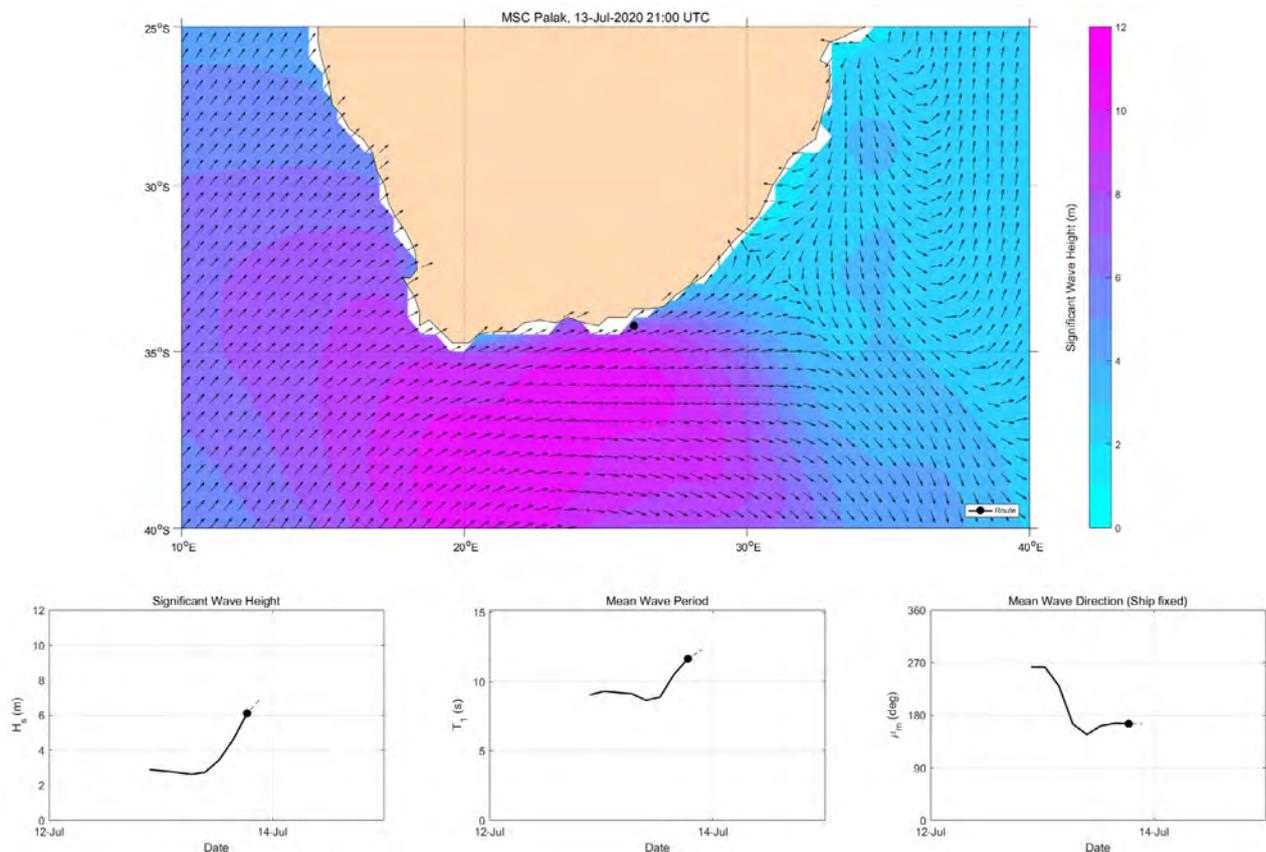
Figure 4-105: Wave hindcast (source ECMWF ERA5)

From the above information and estimated rolling period of 24 s (based on a GM of 3 m), parametric roll in head seas seems likely.

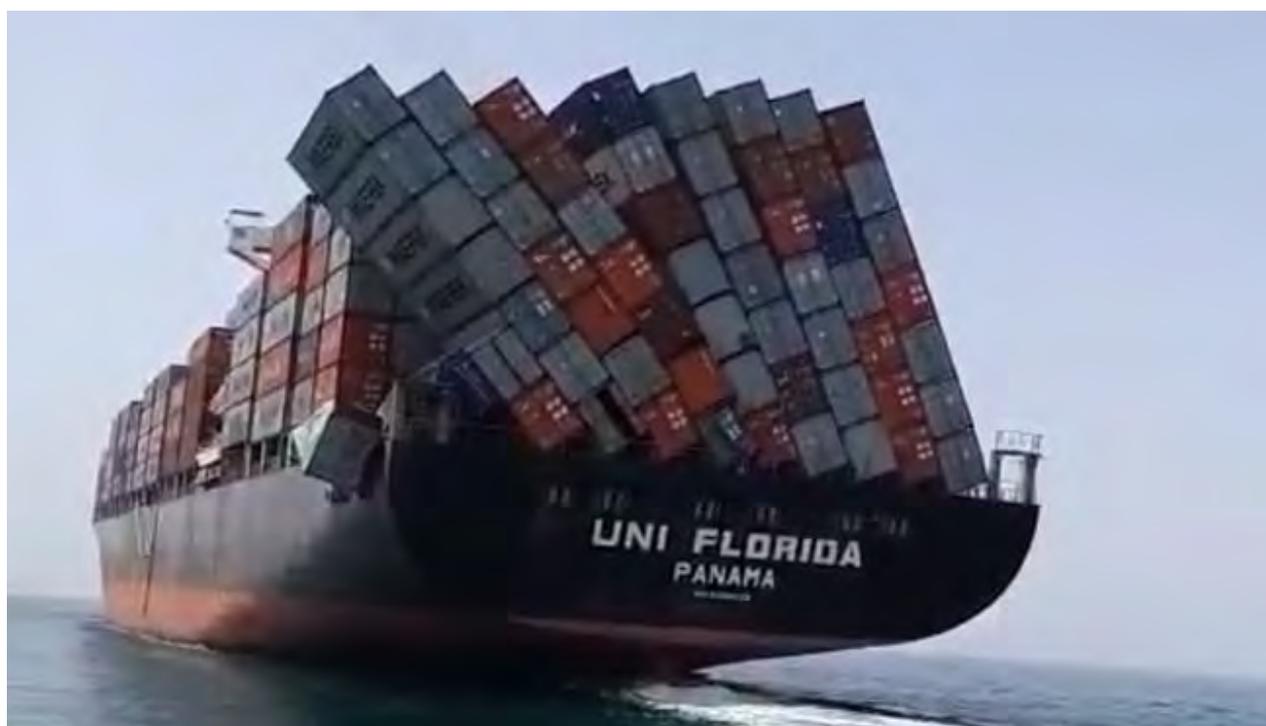
Figure 4-106: Damage overview photo

General info	
IMO	9308039
Name	GFS Perfect UNI Florida (2015) ITAL Florida (2007)
Year of build	2007
TEU capacity	3,450
Loa	239.0
B	32.0
Incident info	
date & time	Before 27 Jul 2020 (arrival port Jabel Ali, Dubai)
speed	Unknown
position	Arabian Sea
heading	Saudi Arabia (unknown departure port) to Dubai
hindcast waves	Unknown
draught	Unknown
transverse stability	Unknown
roll period	Unknown
affected/damaged/lost containers	65/20/10 (rough count from photo)

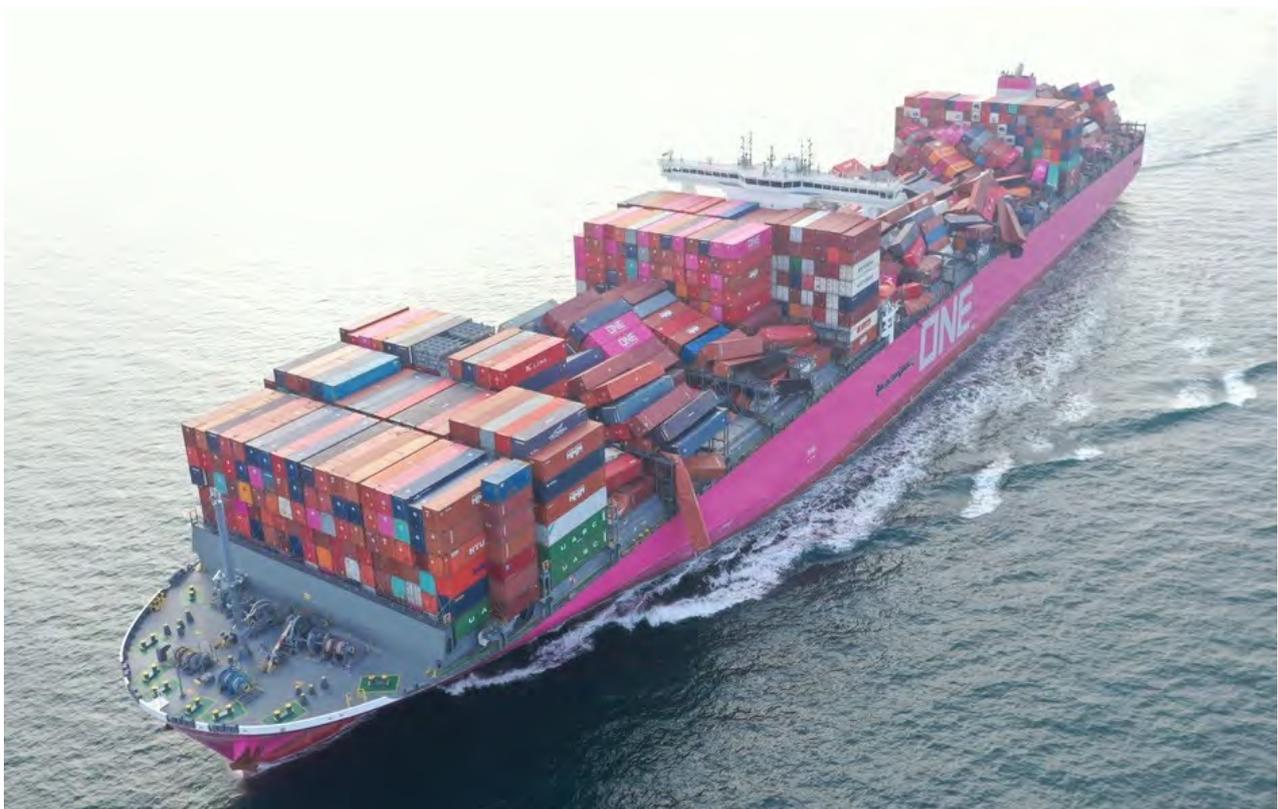
Figure 4-116: Damage overview photo

General info	
IMO	9806079
Name	ONE Apus
Year of build	2019
TEU capacity	14,000
Loa	364.0 m
B	51.0 m
Incident info	
date & time	30 Nov 2020 13:15 UTC
speed	13.1 kn
position	33.25° N / 172.6° W <i>Pacific</i>
heading	Approx. 100 deg <i>Eastbound</i>
hindcast waves	Hs = 4.6 m
draught	Unknown
transverse stability	1.5 m (Pacific eastbound, estimation as per chapter 2)
roll period	35.9 s (Pacific eastbound, estimation as per chapter 2)
affected/damaged/lost containers	2756/940/1816

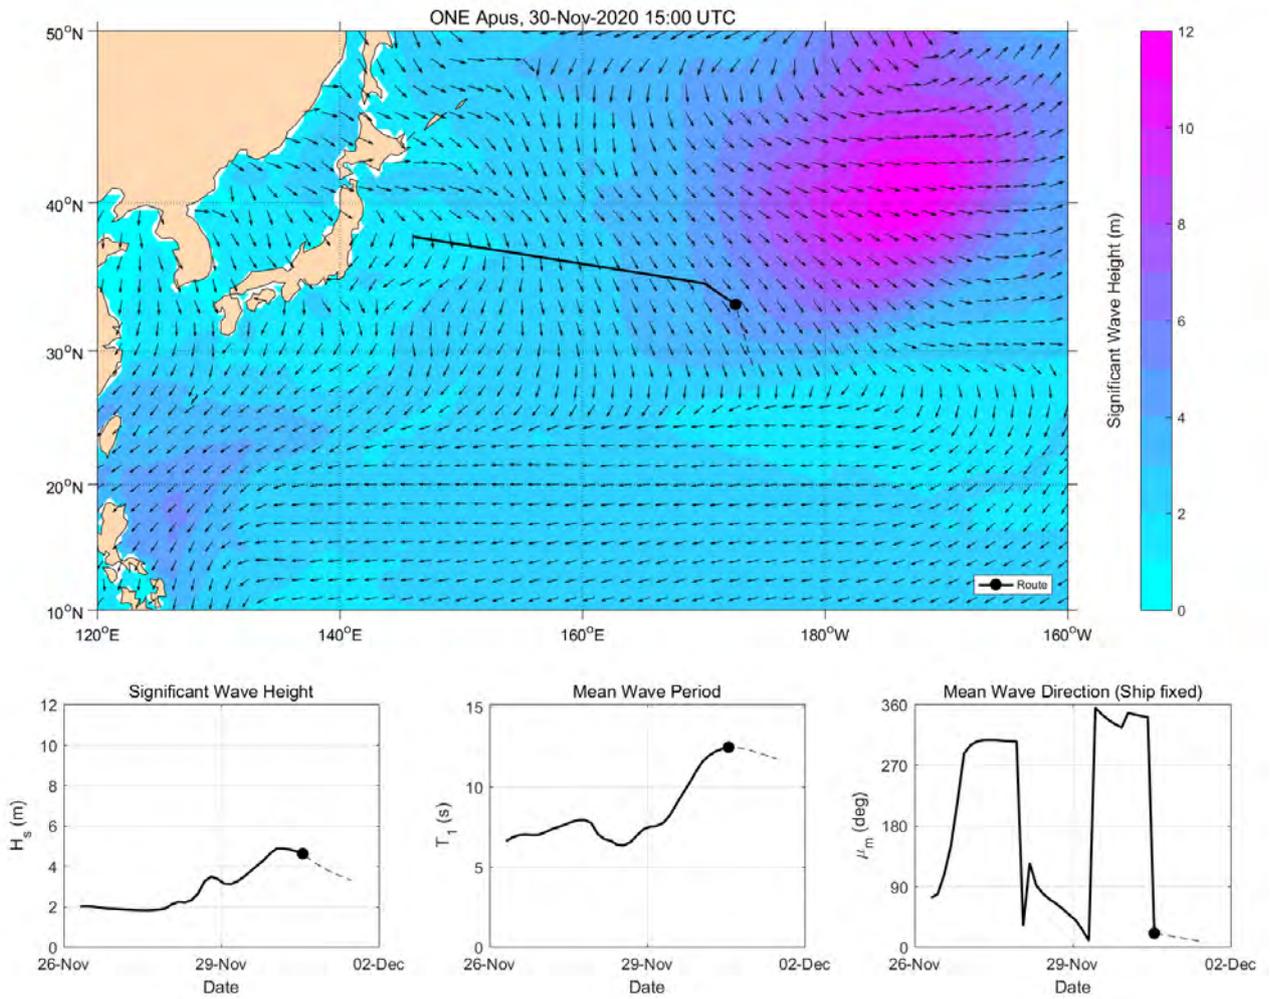
Figure 4-118: Wave hindcast (source ECMWF ERA5)

As the loading condition is unknown it is difficult to estimate the rolling period. A very rough guess would around 36 s (assuming a GM of 1.5 m and typical roll inertia) but it could vary between roughly 24 s and above 50 s. Based on the wave direction and T_ϕ/T_e ratio, parametric roll in following seas seems most likely.

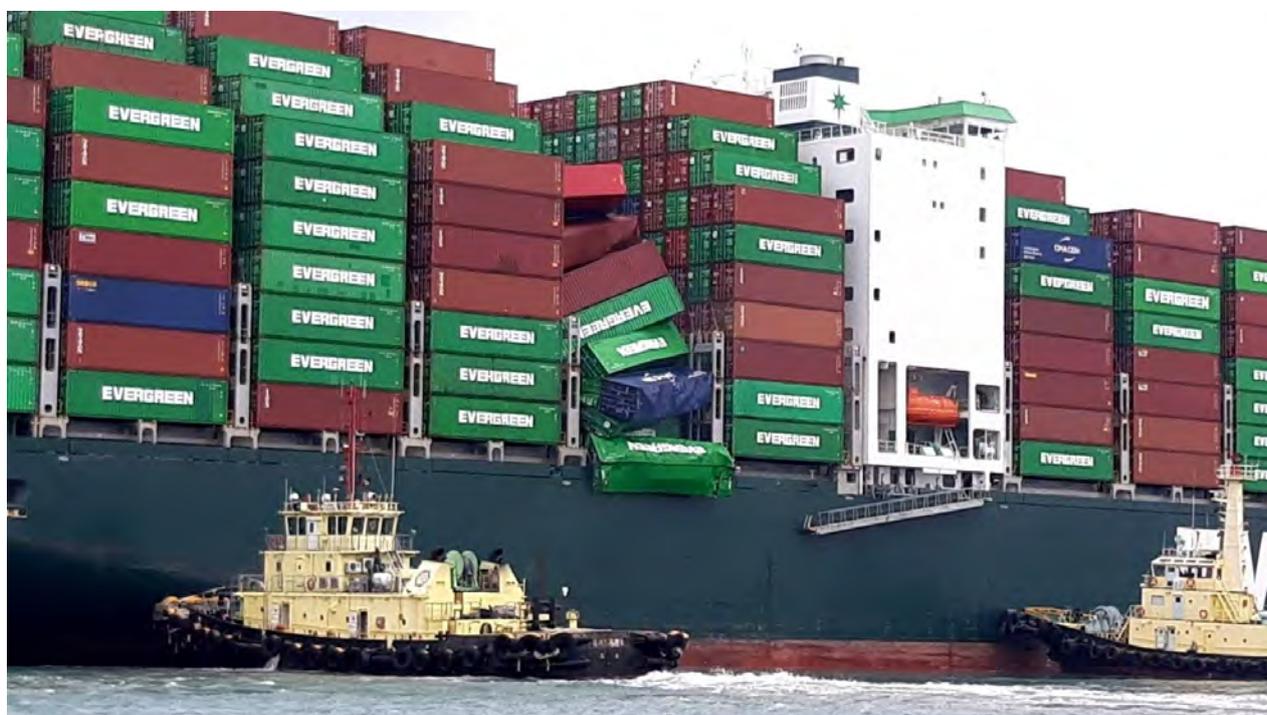
Figure 4-121: Damage overview photo

date & time	30 Dec 2020 02:30 UTC
speed	23.4 kn
position	31° 21.6' N / 129° 32.3' E <i>Japanese Coast</i>
heading	144 deg <i>Busan, Korea to Los Angeles, USA</i>
hindcast waves	Hs = 5.5 m
draught	Ta/Tf = 12.6/12.6 m
transverse stability	1.4 m
roll period	33.2 s (based on estimated roll inertia)
affected/damaged/lost containers	66/30/36

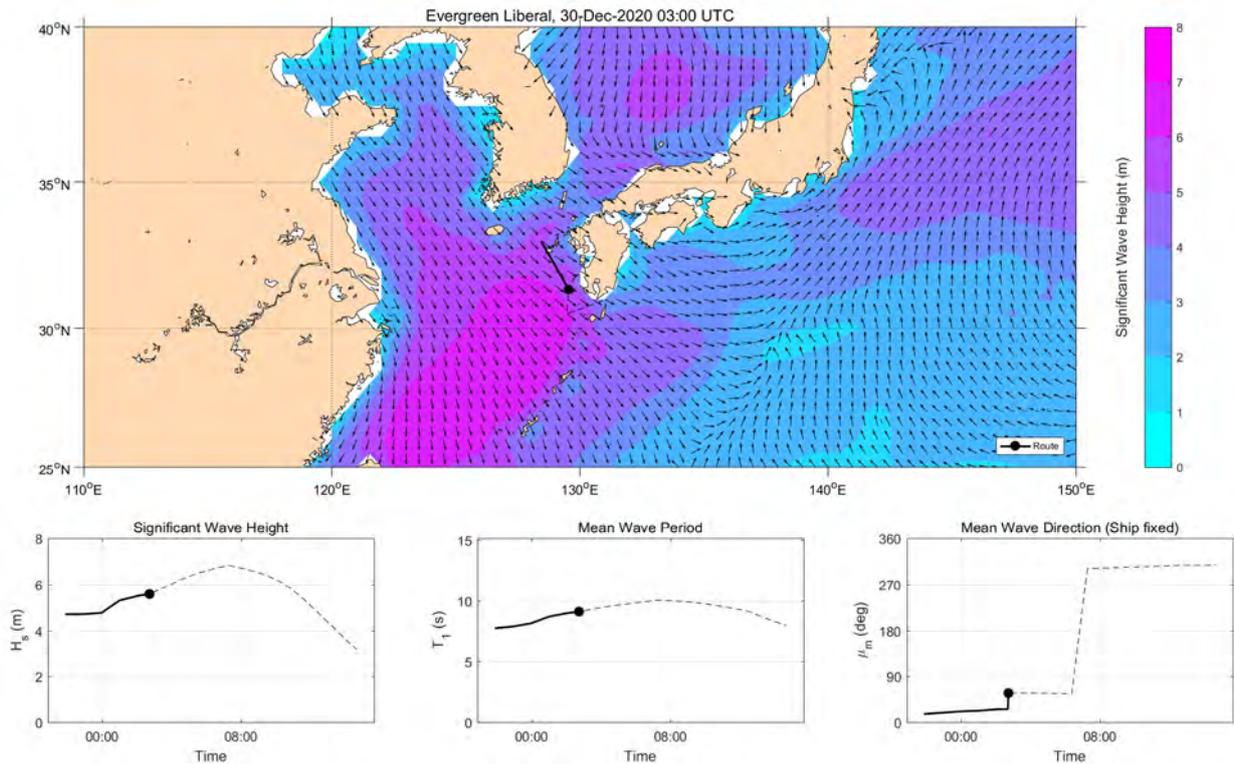
Figure 4-123: Wave hindcast (source ECMWF ERA5)

At a speed of 23.4 kn this results in a wave encounter period of approximately 31 s. The rolling period is estimated at 33 s (assuming a typical kxx). Therefore resonant roll seems likely.

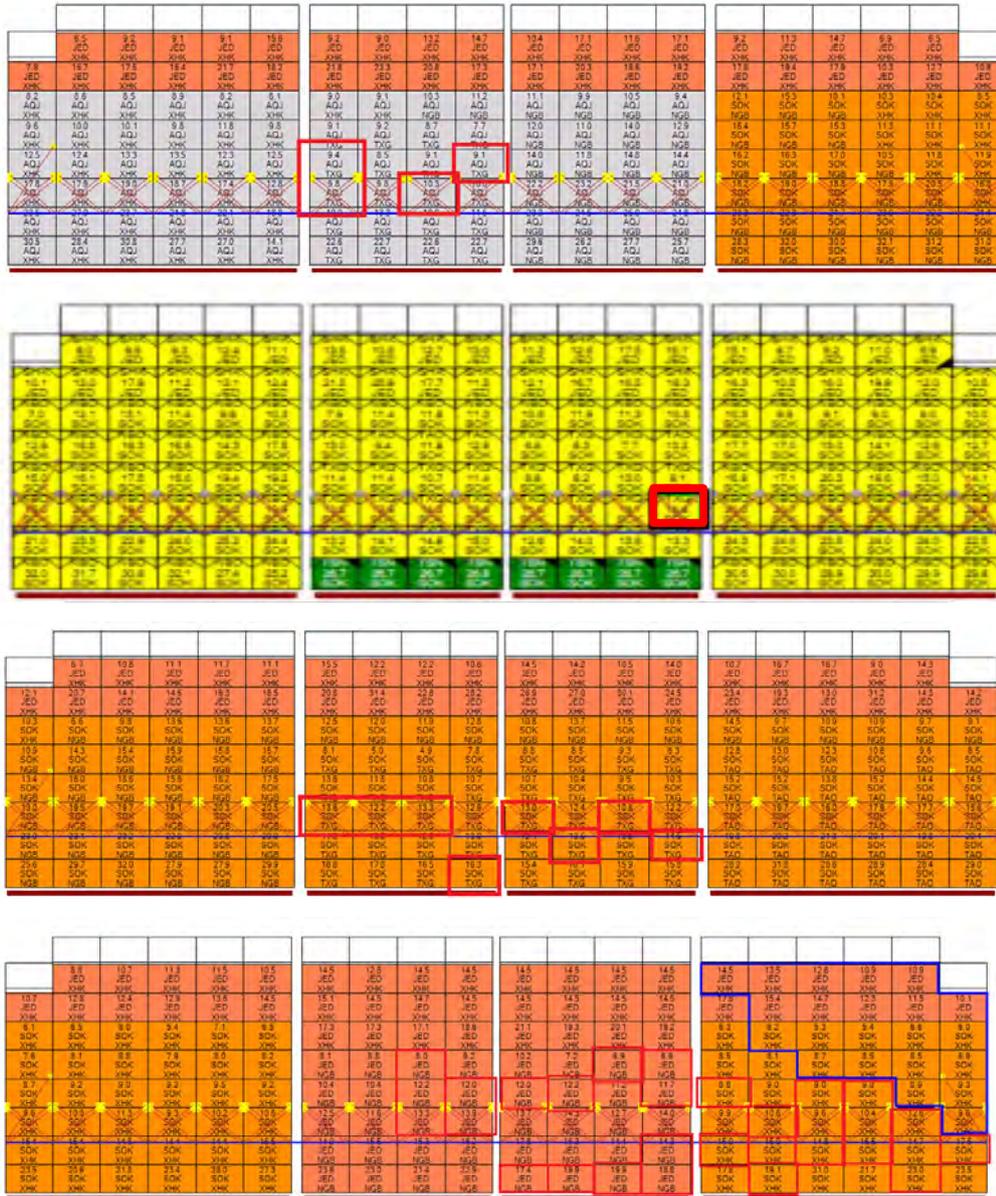
Figure 4-156: Location of damage (bay 34, 37, 50 and 82 respectively)
