SEWOL FERRY CAPSIZING AND FLOODING

H van den Boom, V Ferrari and R van Basten Batenburg, Maritime Research Institute Netherlands (MARIN),
S T Seo, Sewol Investigation Commission (SIC), South Korea

SUMMARY

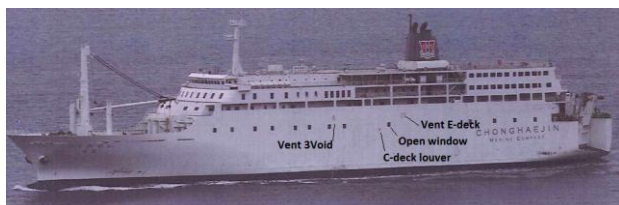
Figure 1: Picture of the port side of Sewol ferry

On the 16th of April 2014, on her way from Incheon to Jeju-island under calm weather conditions, the Korean ferry SEWOL (Figure 1) turned, capsized, flooded and sank one nautical mile off the coast of Donggeochado, Jindo County, South Korea. In total 304 people including 250 secondary school students, other passengers and several crew members, did not survive this national disaster. In December 2017, the Sewol Investigation Commission (SIC) of Korea contracted MARIN to investigate the turning, heeling, flooding and sinking of the vessel by means of computer simulations, model tests and nautical simulators.

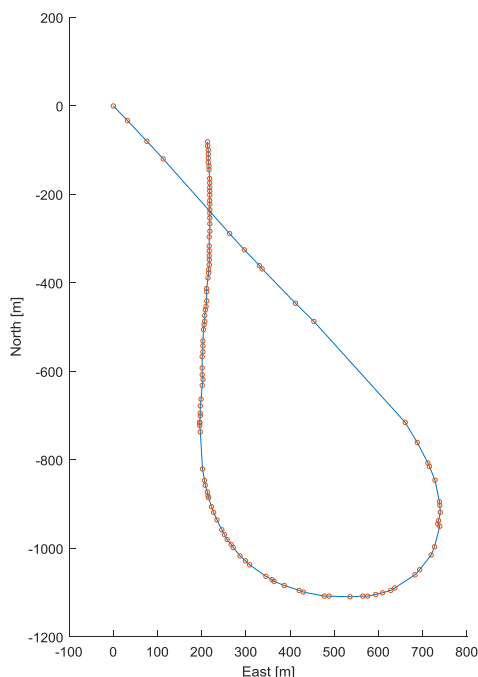
Figure 2: Vessel position received from AIS

The vessel position was transmitted by the AIS and received at irregular intervals (Figure 2). This track clearly shows the sudden turn of the vessel and, after capsizing, her drifting in northerly direction due to the current. The magnitude and direction of the current was derived from this drift path.

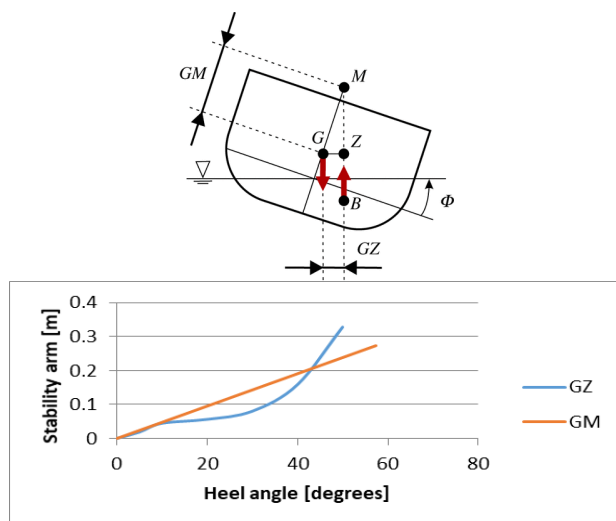
Figure 3: Effective arm of stability GZ compared with initial stability GM

During the inclination tests of the model, it was noted that when the heeling angle exceeded 10 degrees, the restoring stability moment did not increase proportionally. In Figure 3 the effective stability arm GZ as function of heeling angle is presented. Up to 40 degrees of heel this effective arm is significantly lower than the initial stability value GM indicates. This is due to the shift of metacenter M caused by the 3-D geometry

of the submerged hull. The hull of Sewol is characterised by a slender bow section and a wide aft body featuring large recess areas for the external ramps. This recess is flooded at 10 degrees heel.

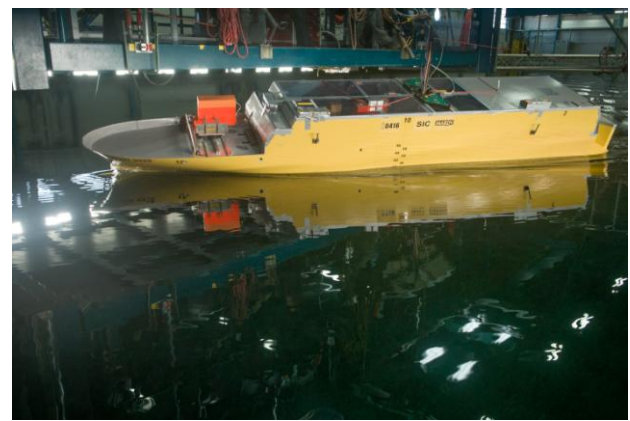
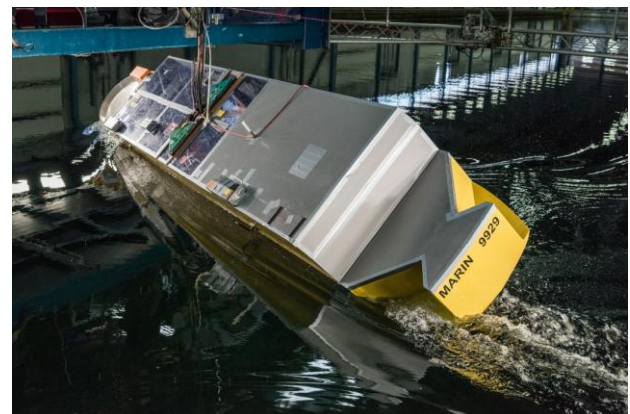
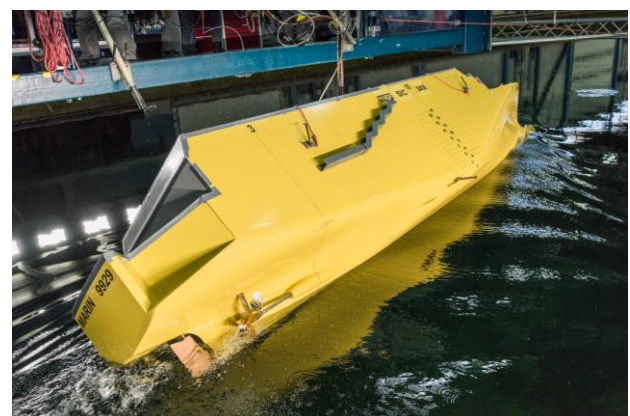
The turning and heeling tests were conducted in MARIN's Seakeeping and Manoeuvring Basin (170 x 40 x 5 m). The model was self-propelled and steered by autopilot. The only connection to the basin sub-carriage was the flexible power and signal cabling. The sub-carriage is able to move in transverse direction whereas the main carriage moves in longitudinal direction of the basin. By using the vessel position from the optical tracking system, the sub-carriage automatically followed the model in arbitrary horizontal directions (Figure 4).

Figure 4: Sewol Model during Turning and Heeling tests

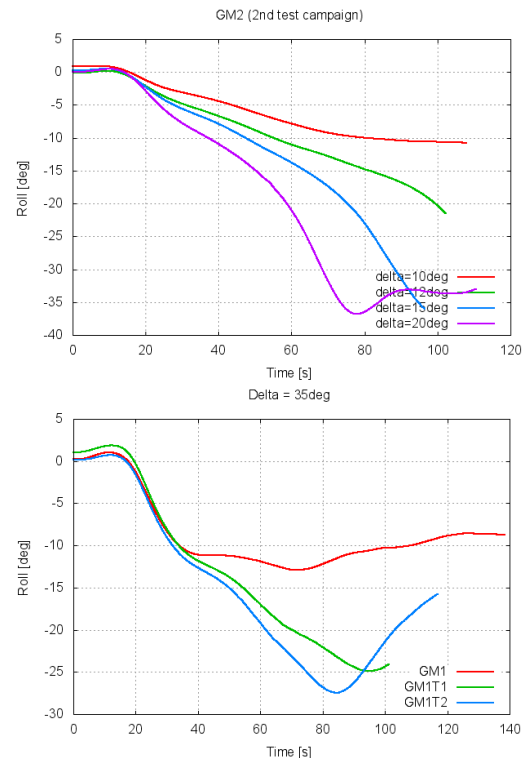
Both the fast time manoeuvring simulations and model tests showed that the Sewol turning and heeling are strongly coupled. The turning of the vessel initiated by a rudder angle, inevitably leads to vessel heeling. As expected the maximum heel angle increased with decreasing transverse stability and increasing rudder angle. Approach speed had a similar effect on the ship motions; the yaw, yaw velocity, heel amplitude and rate of heel all increased. Heeling in a turn is thus governed by ship speed, rudder angle and the transverse stability (Figure 5).

The model tests also demonstrated that trimming by the bow by 0.5 m, while maintaining the same vertical centre of gravity, results in a significant decrease of transverse stability. As illustrated by Figure 5 such trim by the bow results for a GM equal to 0.60 m in a heel of 25 degrees thus exceeding the 18 degrees threshold for cargo sliding. For an initial GM of 0.45 m the bow trim reduced the stability value to 0.23 m.

Figure 5: Influence of rudder and trim on heeling angle

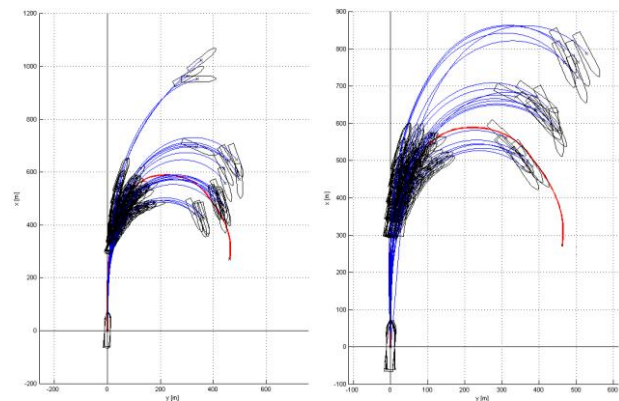
As illustrated by Figure 6, several combinations of low transverse stability (GM between 0.1 and 0.3) and rudder angles (10 to 25 degrees) can result in a track which resembles the recorded AIS track of the vessel.

Figure 6: Model test results for GM2C (Left) and GM4B (Right) compared with AIS-track (red)

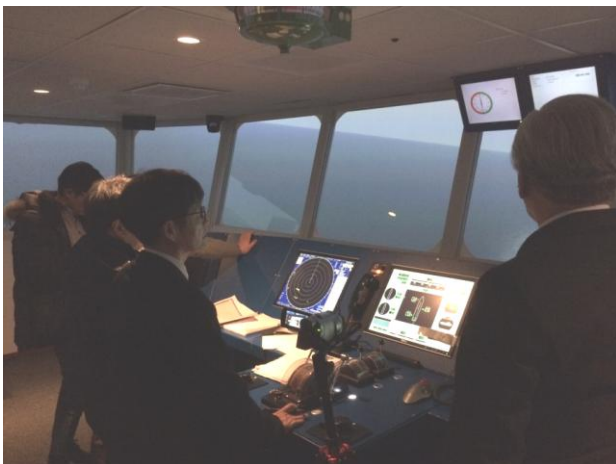
To investigate the effect of human intervention in the turning and heeling of Sewol, a part of the investigation was conducted on MARIN's nautical simulator. In this full mission simulator, with 360 degrees surrounding view, the manoeuvring model was used at real time and received input from the helm and power settings controlled by the helmsman and captain in a full mock-up of the wheelhouse. Although the ship motions are only included in the outside view whereas the wheelhouse maintains a horizontal orientation, up to some 10 degrees of heel the simulator provides a realistic experience for the ship officers. The runs were conducted by experienced master mariners including members of SIC, assisted by a helmsman (Figure 7).

On the simulator various rudder commands were tested at the different levels of transverse stability. The resulting tracks were compared with the AIS positions received from Sewol. The simulator runs proved that even in the condition with extreme low initial stability ($GM = 0.01$ m), the vessel at 17 knots of speed was still controllable.

Figure 7: Run on the nautical simulator

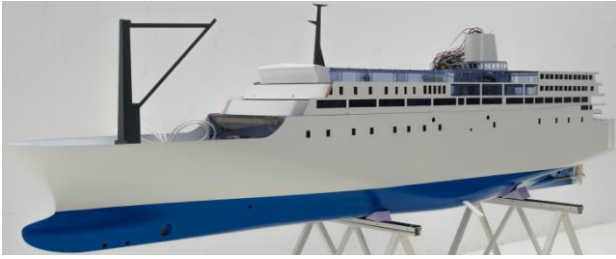
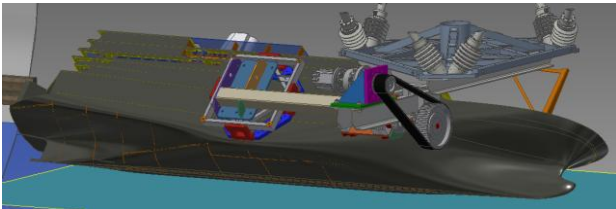
Since sufficient time stamped images of the actual vessel during flooding and sinking were made from assisting boats and helicopters, the positions and orientations of the vessel during the flooding process were known. This information enabled the execution of captive model tests where the motions of the vessel were forced by means of a 6 degrees of freedom actuator arm called 'hexapod' as shown in Figure 9.

In nature there should be a balance between the water ingress and the position and orientation of the vessel. By measuring the forces imposed by the hexapod on the model to obtain the known track, a check on the volume and speed of water ingress could be made. In this way various flooding openings and progress could be tested. Once the flooding openings were sufficiently accurately established, the same model was used for flooding and sinking tests in free drifting condition.

Figure 9: Model and test set up for the captive flooding

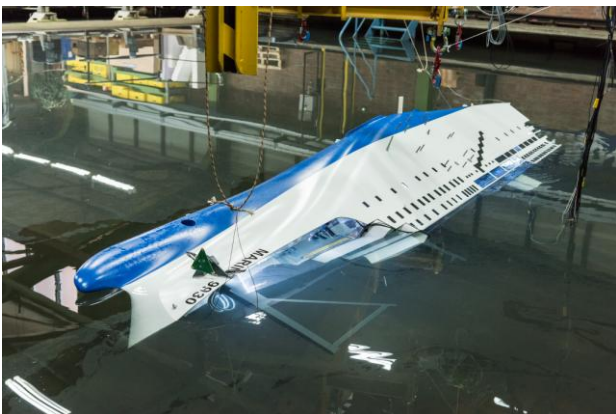
To avoid scale effects due to the compression of air inside the model, the tests were conducted in the Depressurised Wave Basin where the air pressure was lowered to 1/30 atmosphere. Free drifting flooding and sinking tests were also conducted in the harbour of the basin as well as in the Shallow Water Basin under atmospheric conditions (Figure 10). In this way the effect of the depressurised environment could be investigated.

Figure 10: Flooding tests in free drifting condition

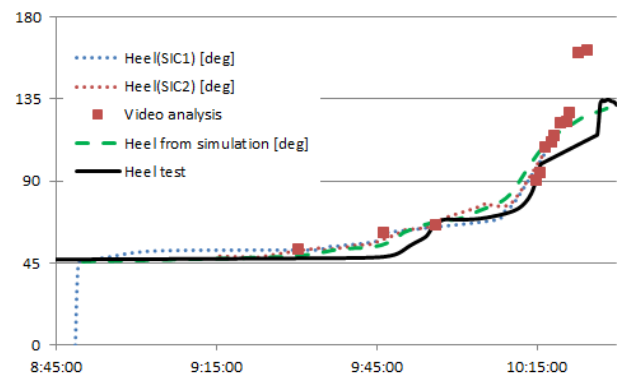
The model tests were accompanied by numerical flooding simulations. For this purpose a 3-D geometry model of Sewol was developed and implemented in a numerical flooding simulation model. This computer code was validated against the results of the model tests and then applied to check additional flooding scenarios (Figure 11).

The flooding investigation focussed on two scenarios: in the ‘C-deck’-scenario, at 45 degrees of heel, water ingresses through the louver vent opening at the C-deck (indicated in Figure 1) and starts to flood this deck. At 48 degrees of heel, the open window at the C-deck increases the inflow of water. Subsequently also the other decks are flooded and the vessel further capsizes and sinks.

Figure 11: Time traces of heel from simulation compared with model tests and with the stills from video of actual flooding.
