Extreme behaviour in shallow water explains why large containerships can lose containers above the Dutch Wadden Islands

The Dutch Safety Board asked MARIN and research institute Deltares to investigate how storm conditions such as those encountered above the Dutch Wadden Islands can lead to Ultra Large Container Ships (ULCS) losing containers.

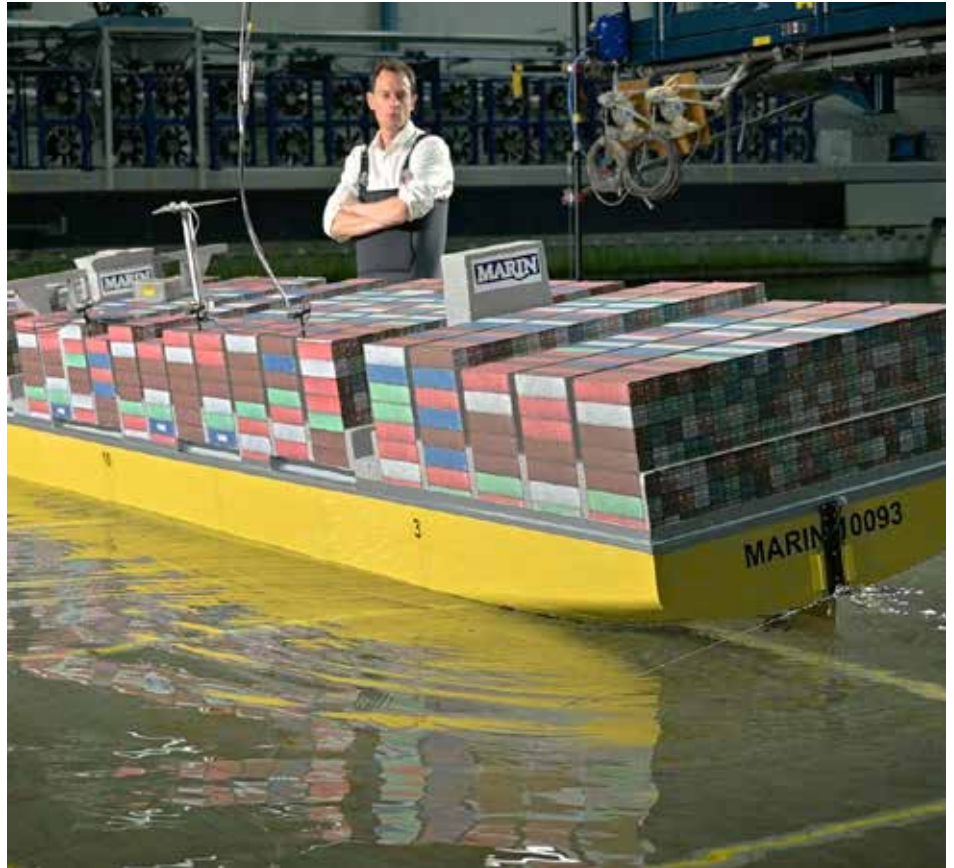
Scale model sailing at 10 kn through 6.5 m high beam waves, water depth 21.3 m

These environmental conditions were recreated at a scale of 1 to 63 in MARIN's Offshore Basin. A special feature of our basin is the movable floor, which made it possible to adjust the water depths to match those encountered on the shipping routes along the Wadden Islands.

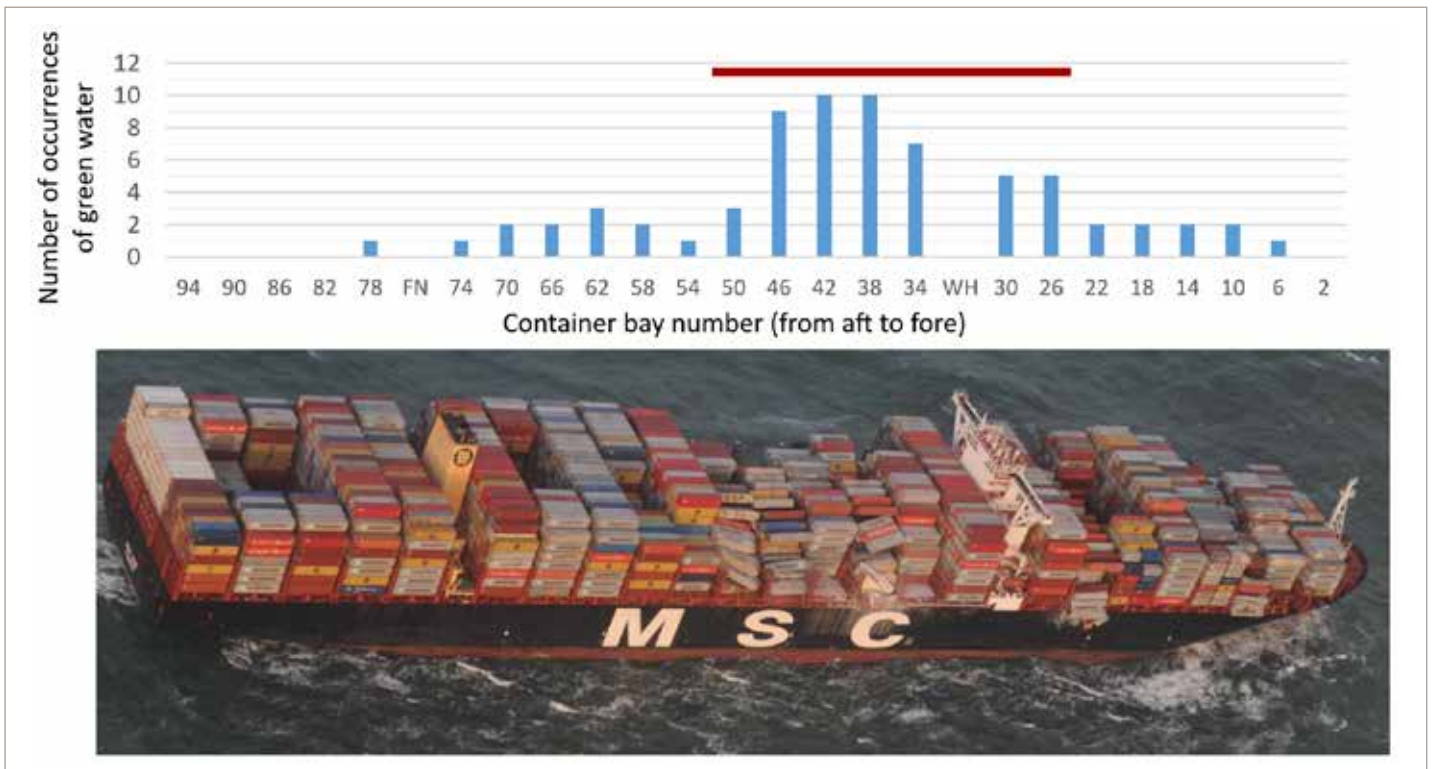
Green water was observed during the tests to occur mostly in the area aft and fore of the wheelhouse, where the MSC Zoe underwent most damage

3. In the very shallow water above the Wadden Islands, breaking waves can hit the side of the ship, resulting in a large upward jet of water reaching the containers, which are 20 to 40 m above the surface of the sea. These enormous volumes of water, also called 'green water', hit the bottom and the side of the containers at high velocity, which can lead to substantial damage. Complete stacks of containers can also be pushed over like dominoes. A comparison of the locations on the ship model where green water impacts were observed with those of the damaged bays of containers on the MSC Zoe found that green water impacts may have played a role in the loss of the containers.

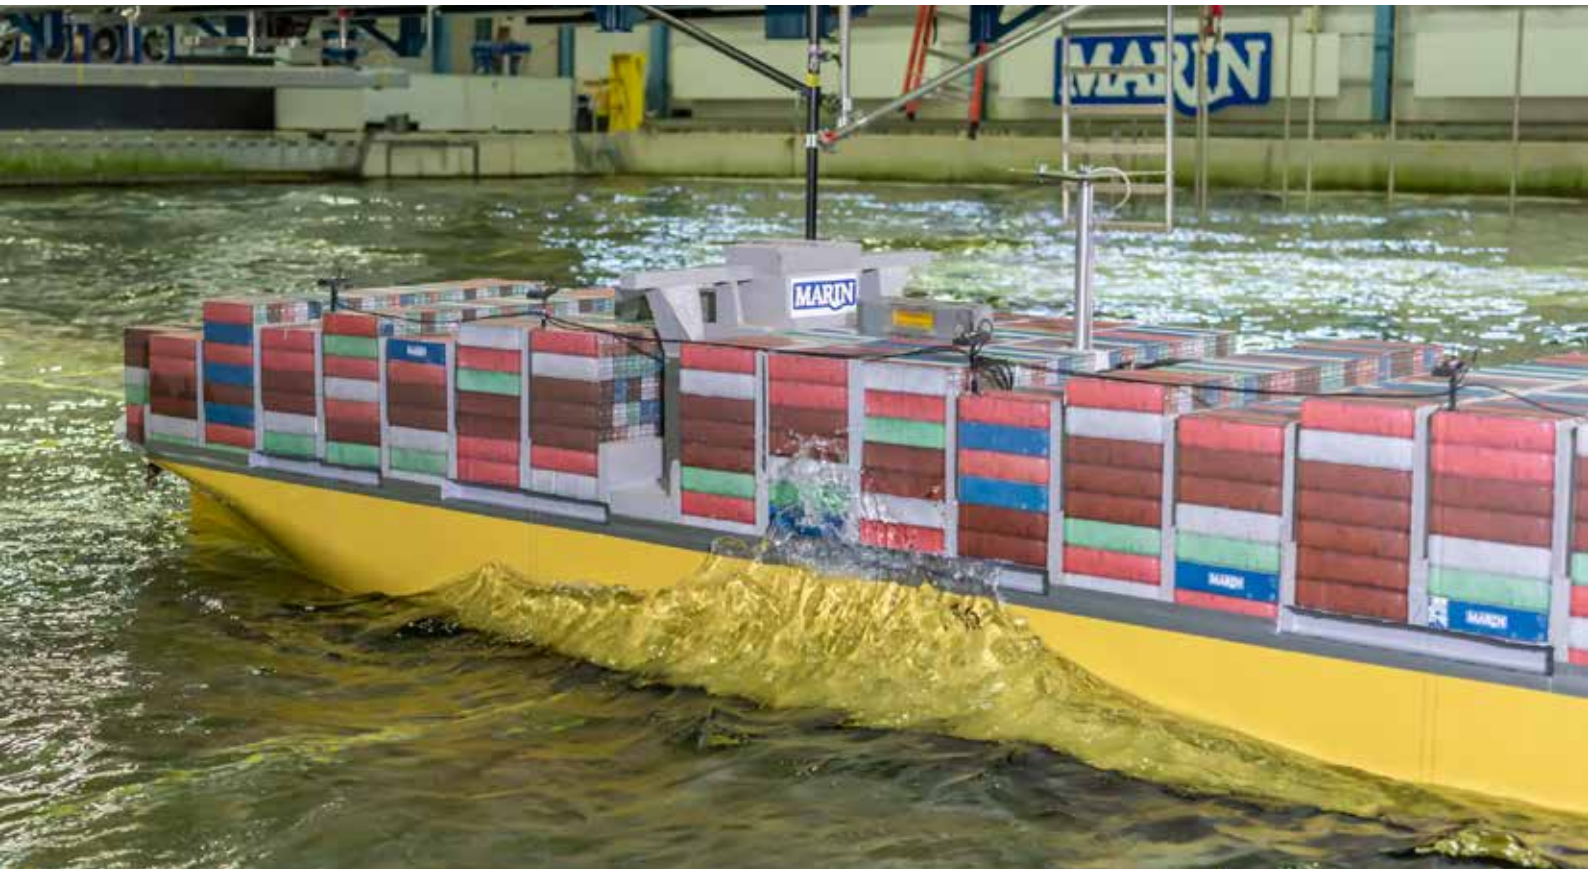
Scale model in 6.5 m high beam waves, water depth 21.3 m

In comparison with deep waters, the shallow water waves encountered in the area are significantly steeper and exhibit much higher crests. These dangerous waves are well-known to the crews sailing frequently in the area.

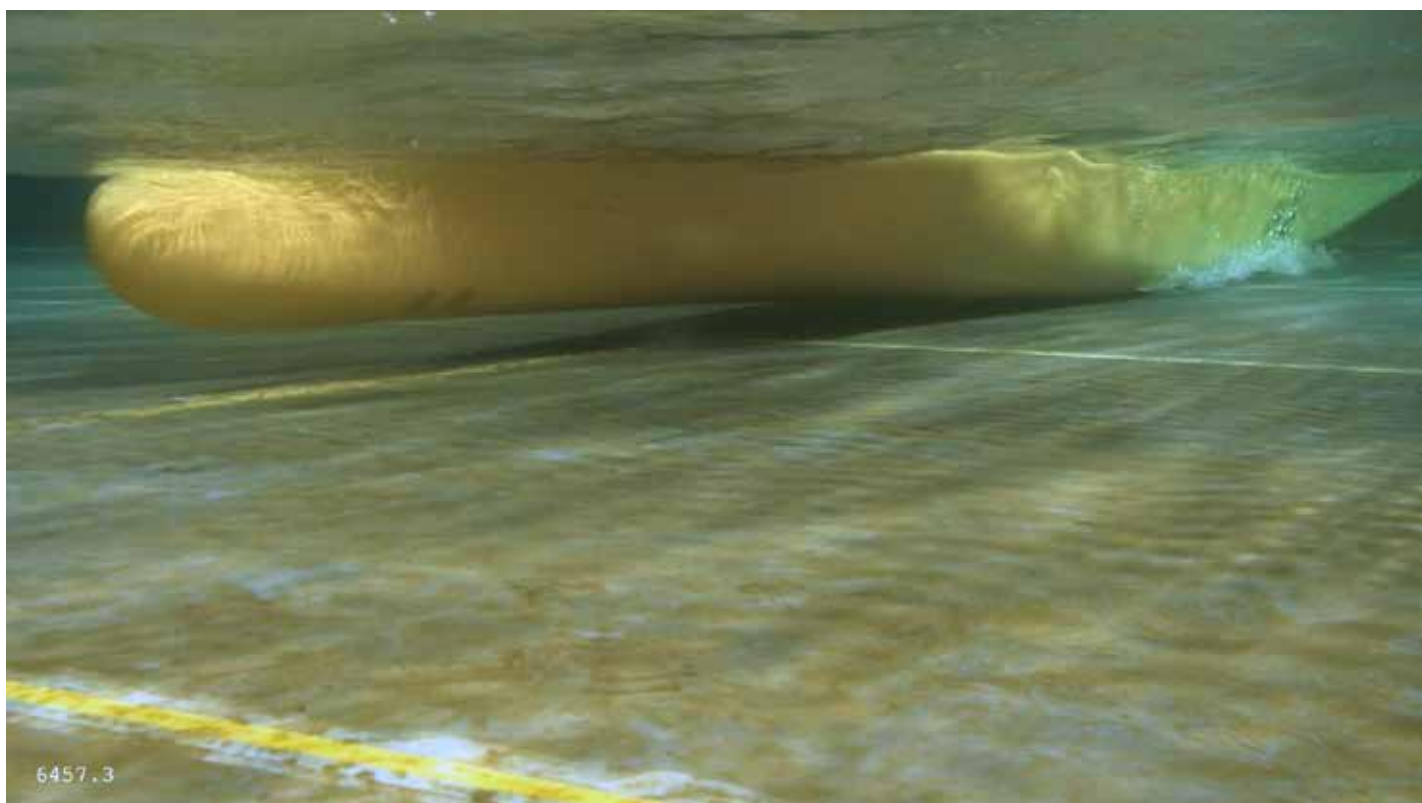
Under combined heave and roll motions the keel of ULCSs can hit the seabed

2. In these beam waves, ships do not only roll from side to side, but also heave up and down many vertical metres. With a draught of around 12 m in a water depth of only 21 m, there is very limited under keel clearance between the ship and the seabed – actually less than 10 m. As a result of the combined rolling and heaving, wide and deep ULCSs can touch the seabed. When this happens, shocks and vibrations can occur in the ship, containers and lashings.
