Review of incidents resulting in loss of containers

Report No. : 33039-1-SEA
Date : May 2022
Version : 1.2
Final Report

Ordered by : TopTier JIP

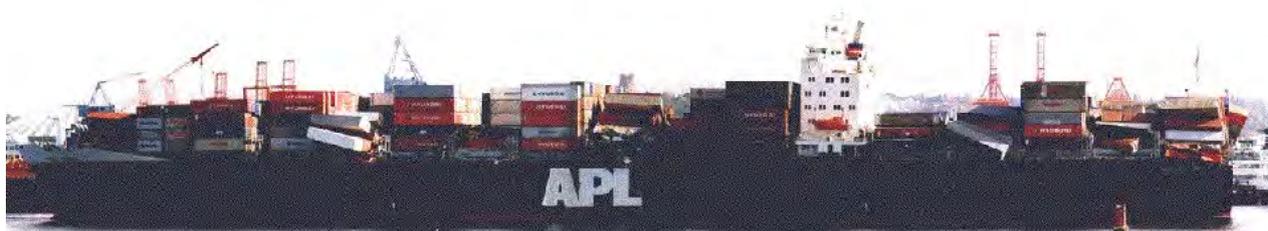
Figure 4-1: Damage overview photo

Large scale collapse. 7 out of 16 bays (partially) collapsed.

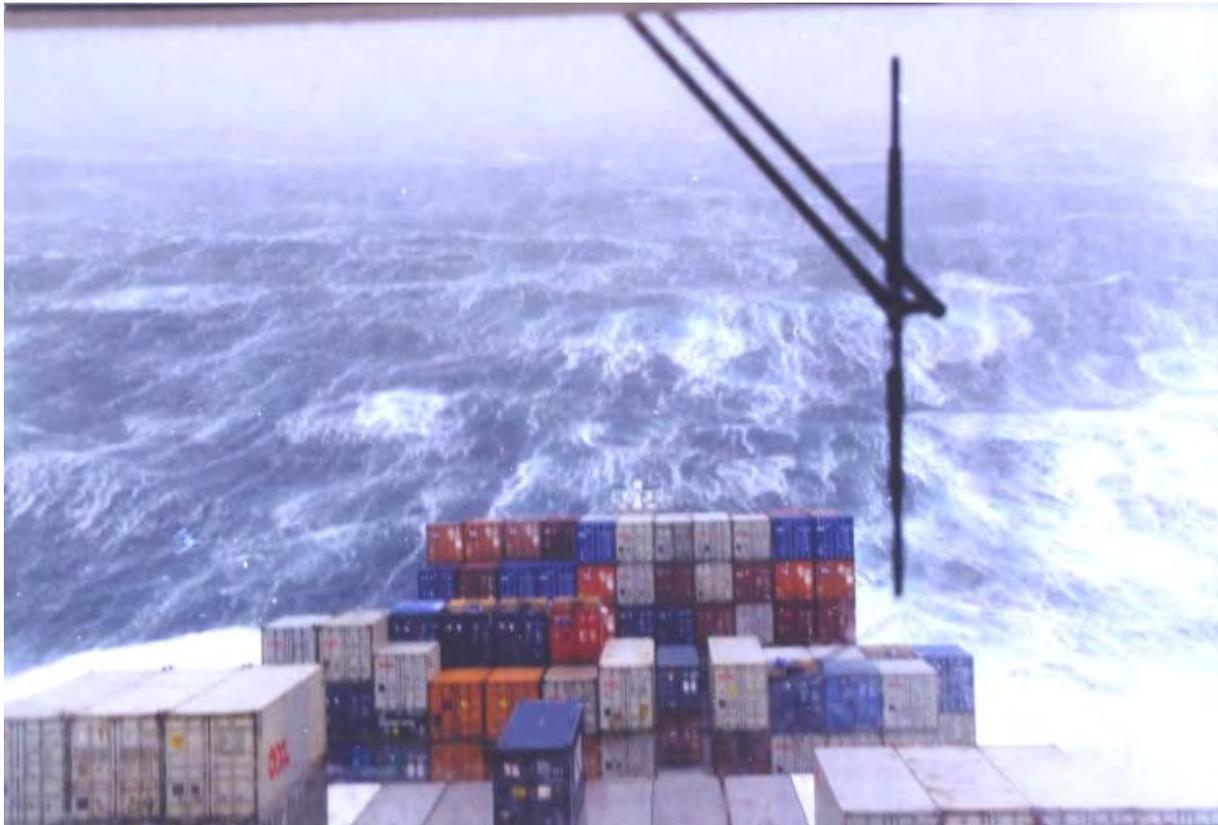
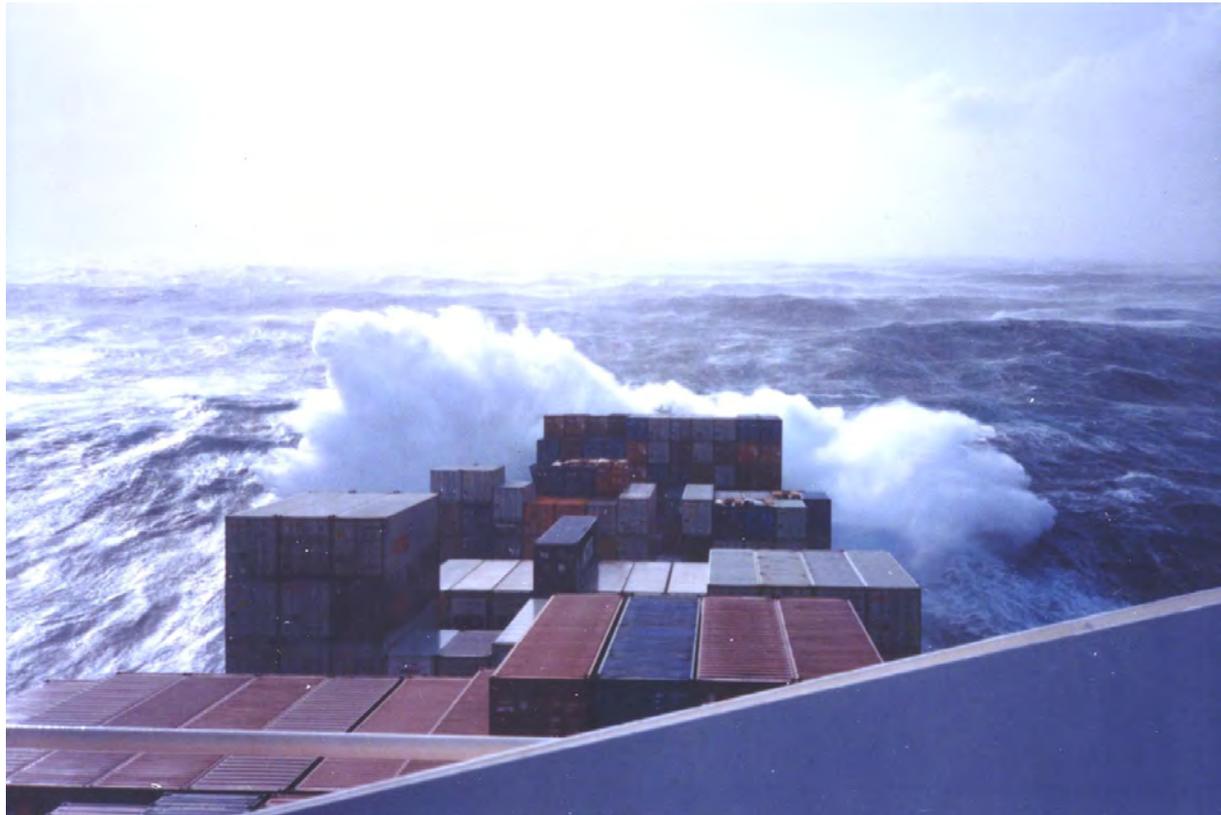
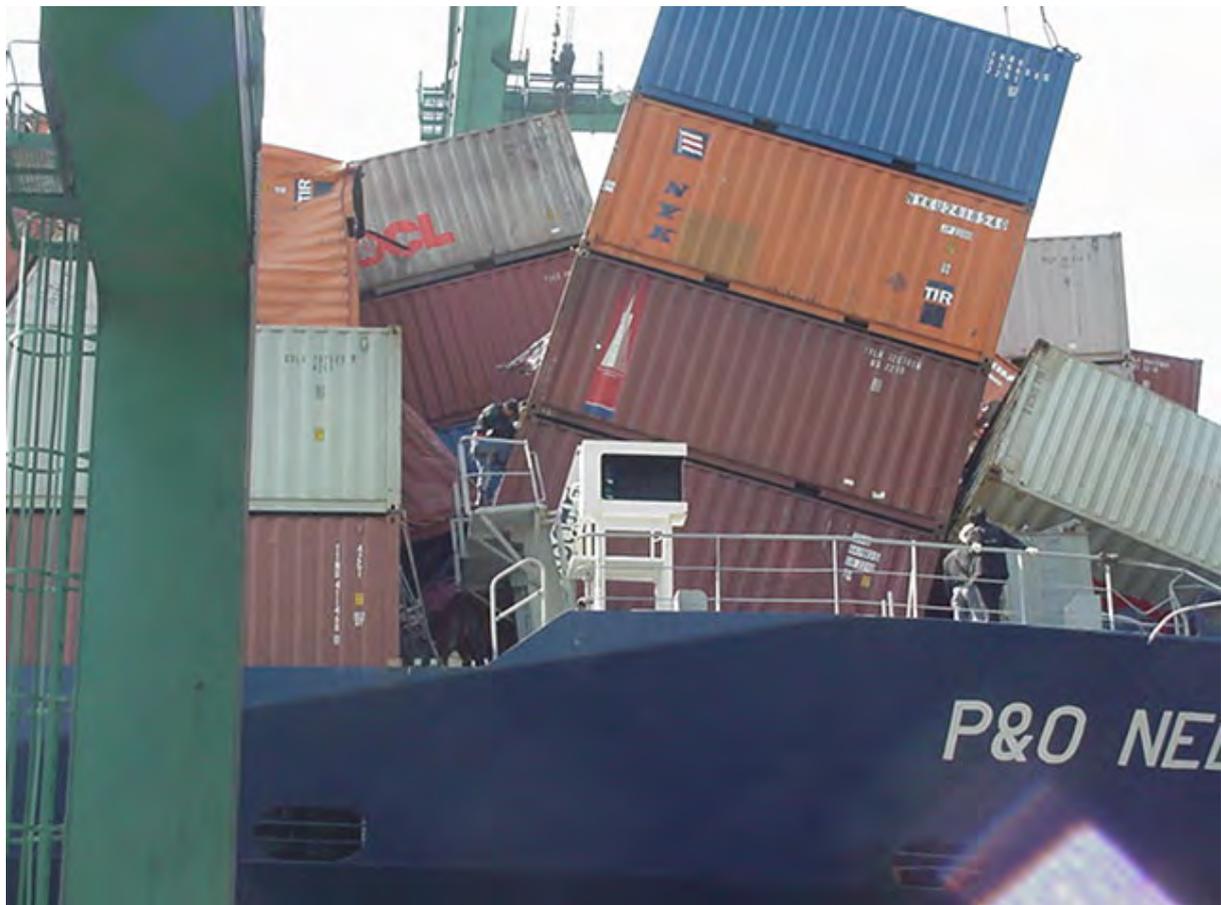
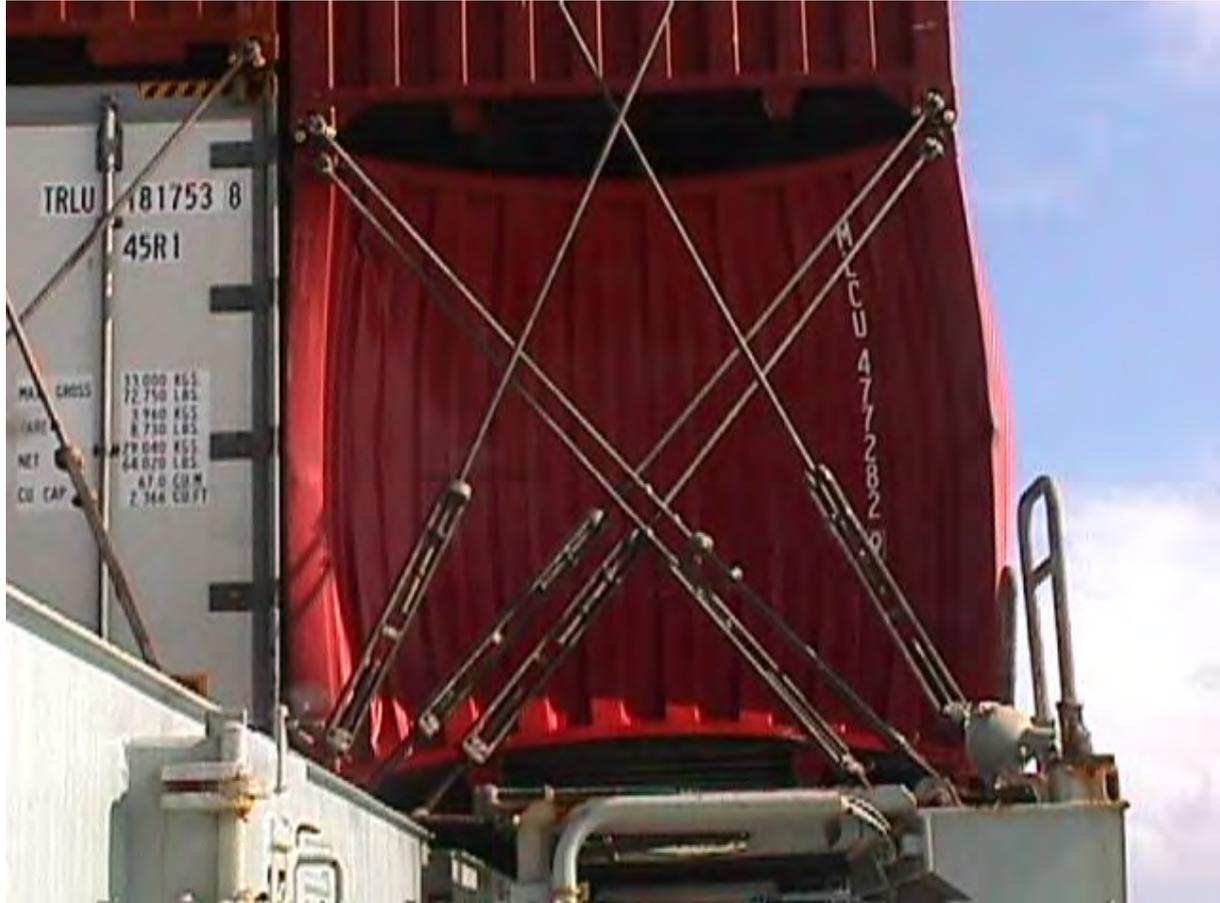
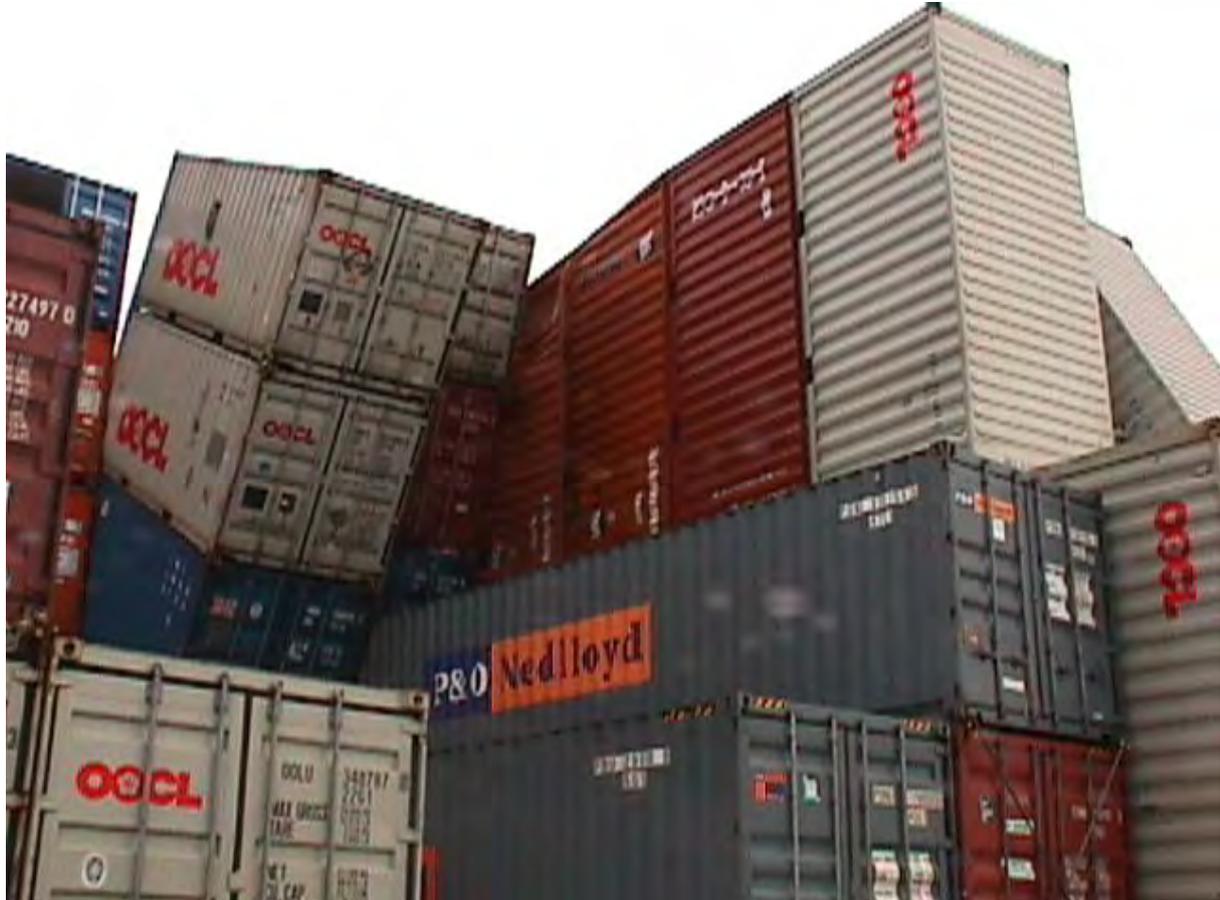
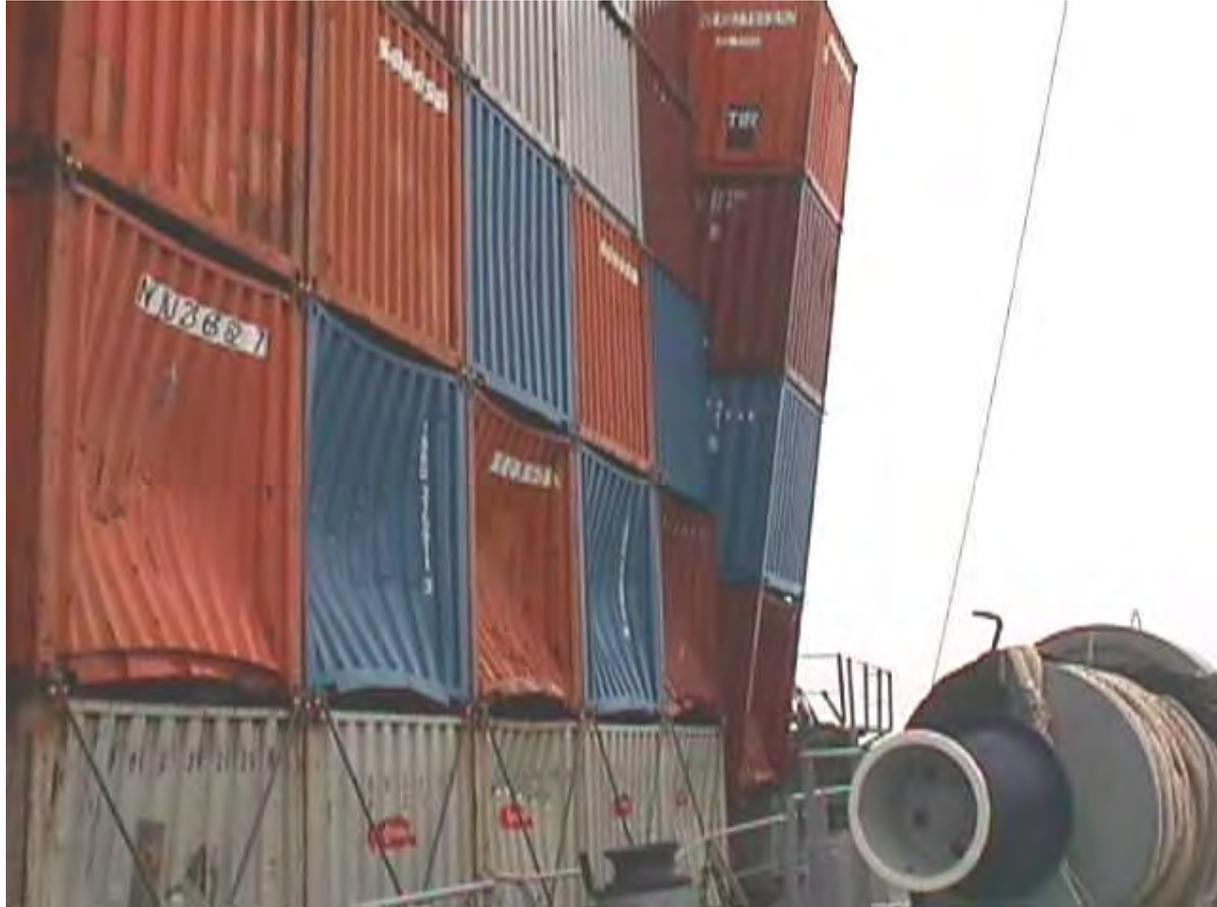
Figure 4-7: Selection of other incident photos

Most forward bay of containers is collapsed / damaged due to shipping of green water.

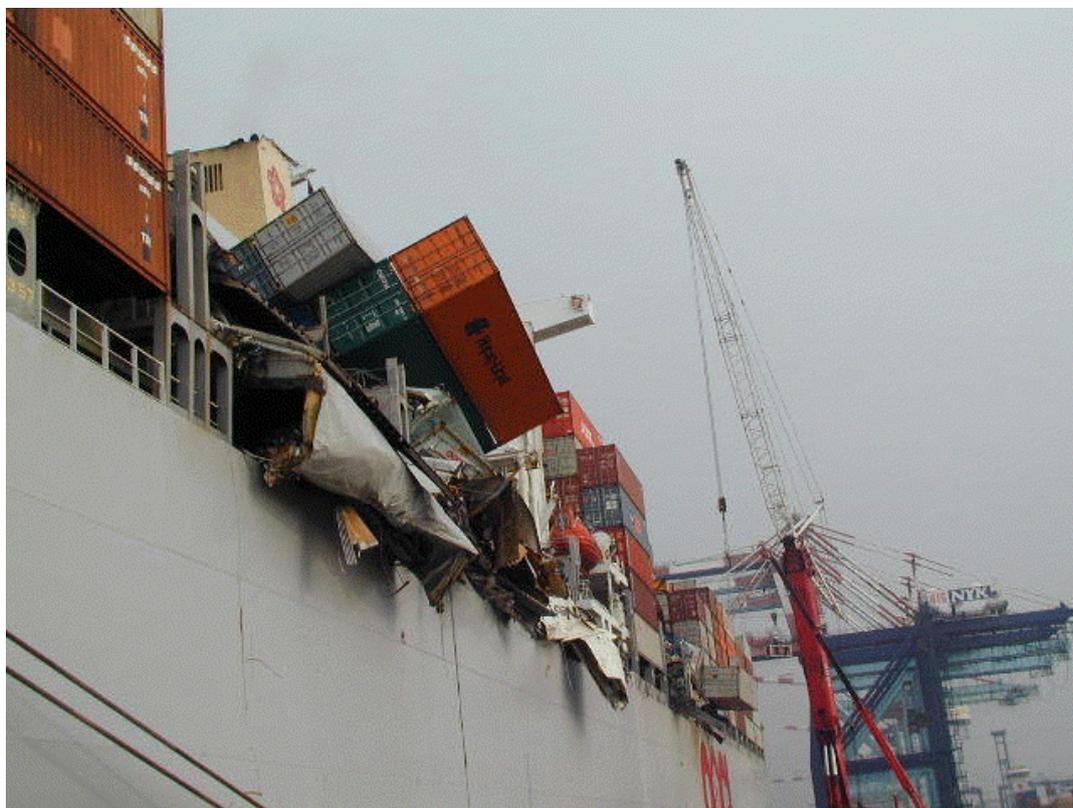
Figure 4-8: Damage overview photo

Collapse of 4 bays (3 bays at the stern and 1 bay forward of the bridge).

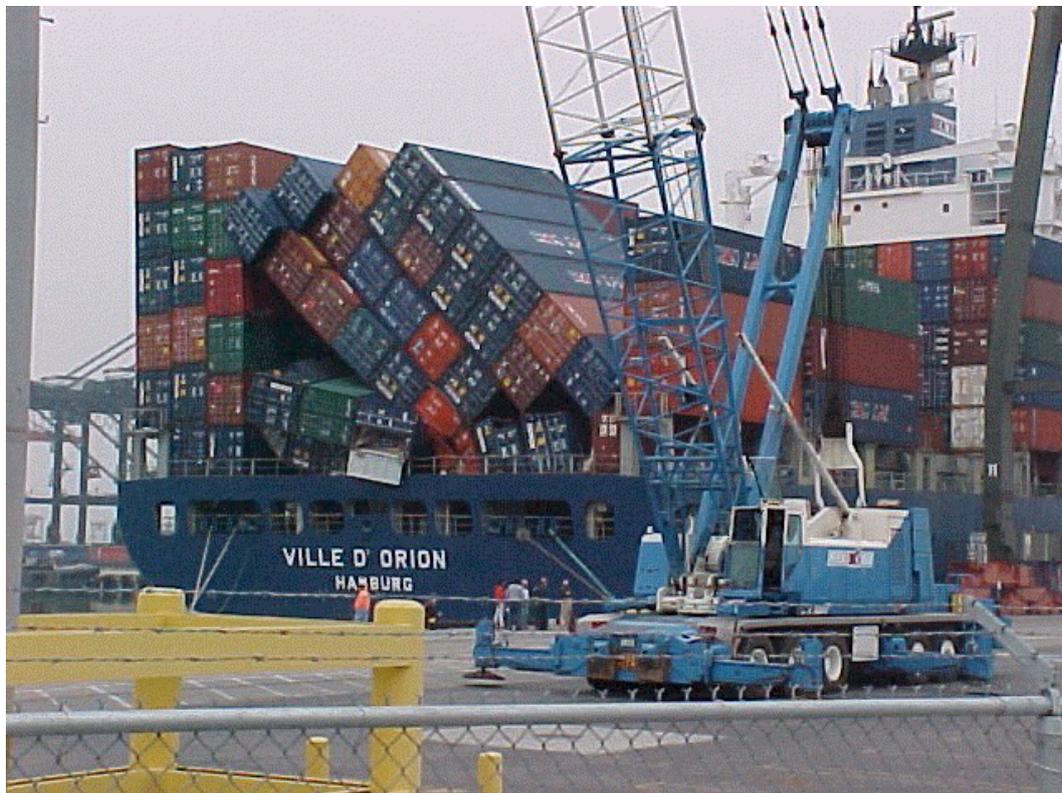
Figure 4-12: Damage overview photo

Collapse of 1 bay at the stern.

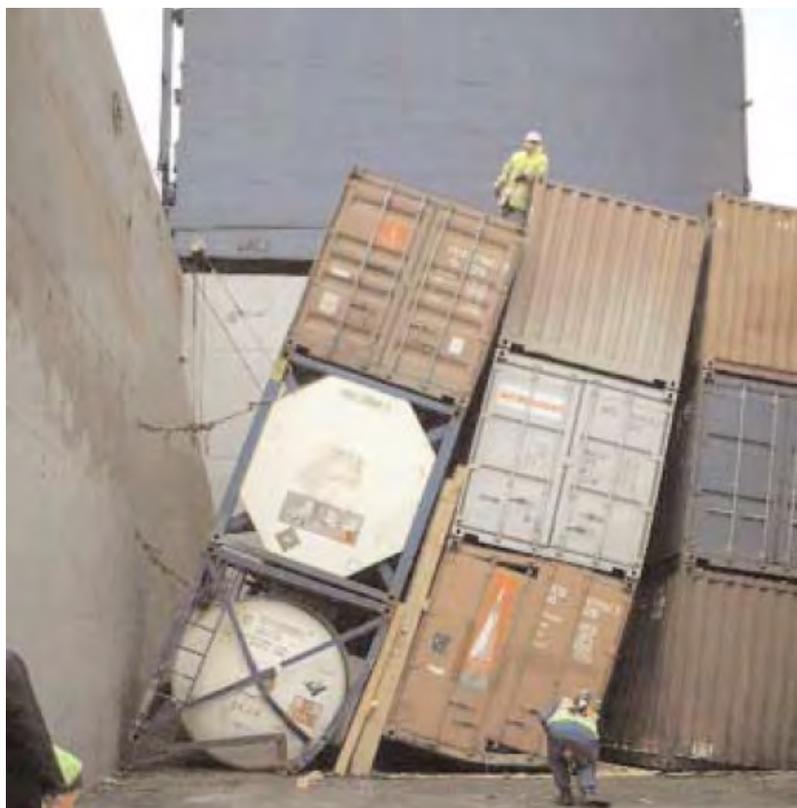
Figure 4-15: Damage overview photo

Single stack collapse in the cargo hold (at the bow). Together with the Annabella incident in 2017 (see section 4.13). These are the only cases in which it was reported that containers were damaged in the cargo hold.

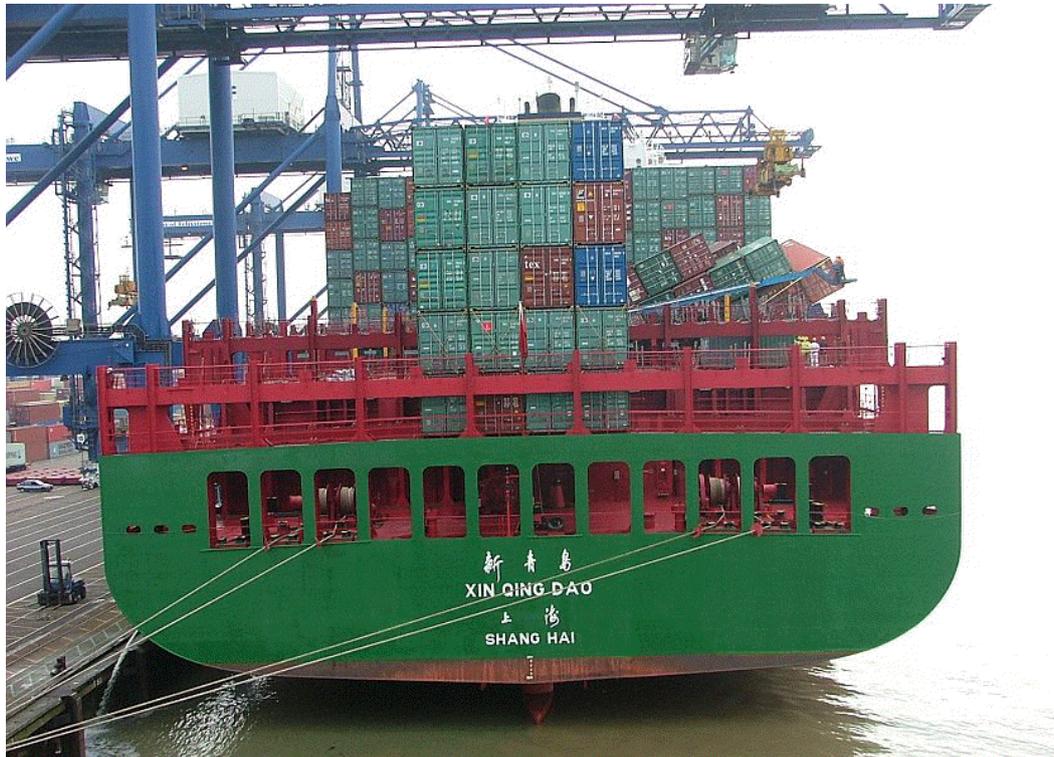
Figure 4-21: Damage overview photo

Collapse of 1 bay at the stern.

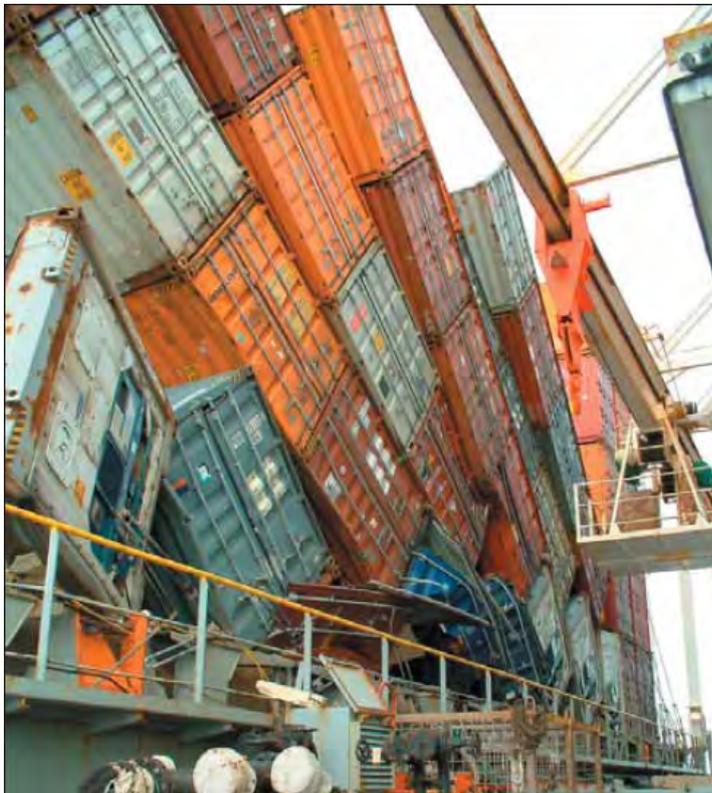
Figure 4-25: Damage overview photo

1 bay in front of the superstructure.

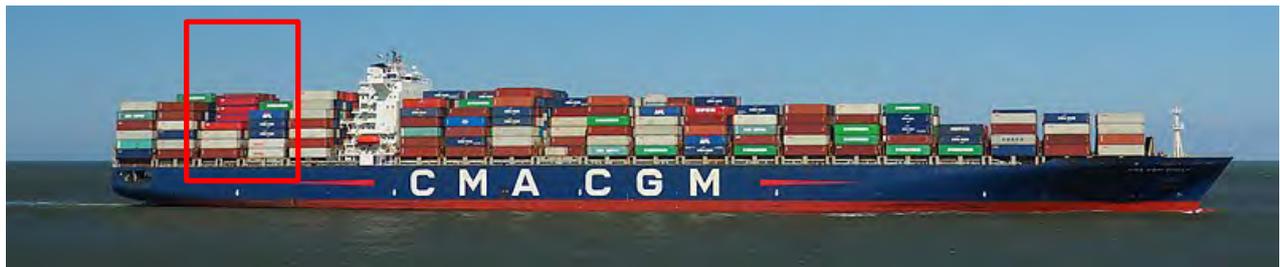
Figure 4-33: Location of damage

Collapse of 2 stacks at the stern

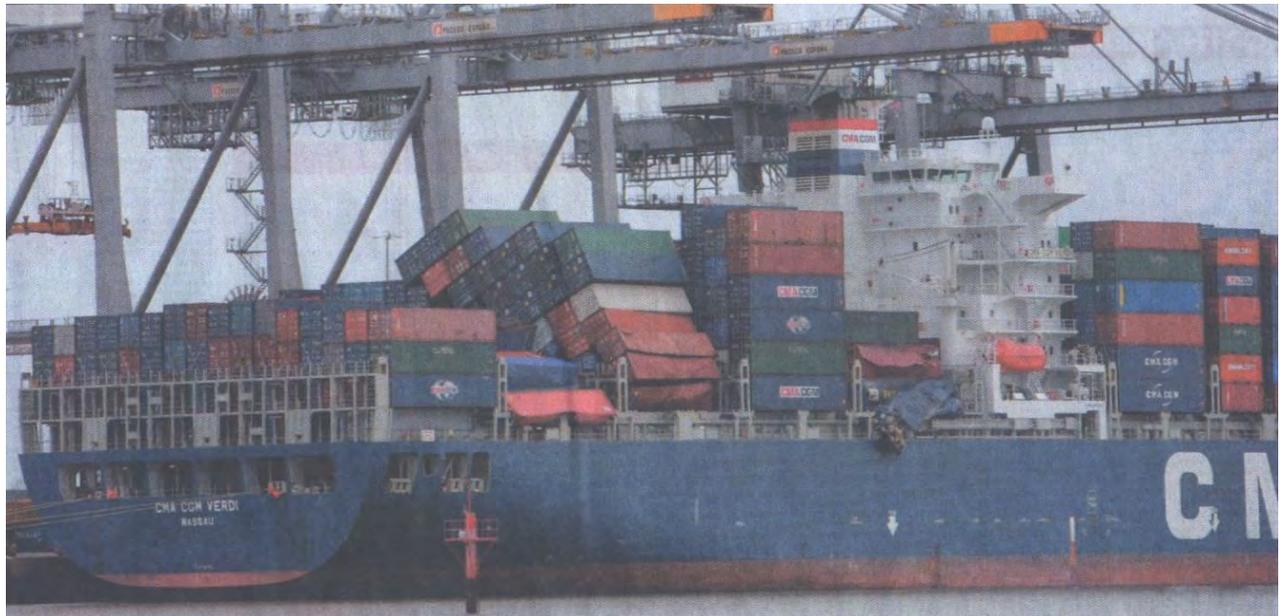
Figure 4-35: Damage overview photo

Multiple stack collapse at 3 bays aft of the wheelhouse.

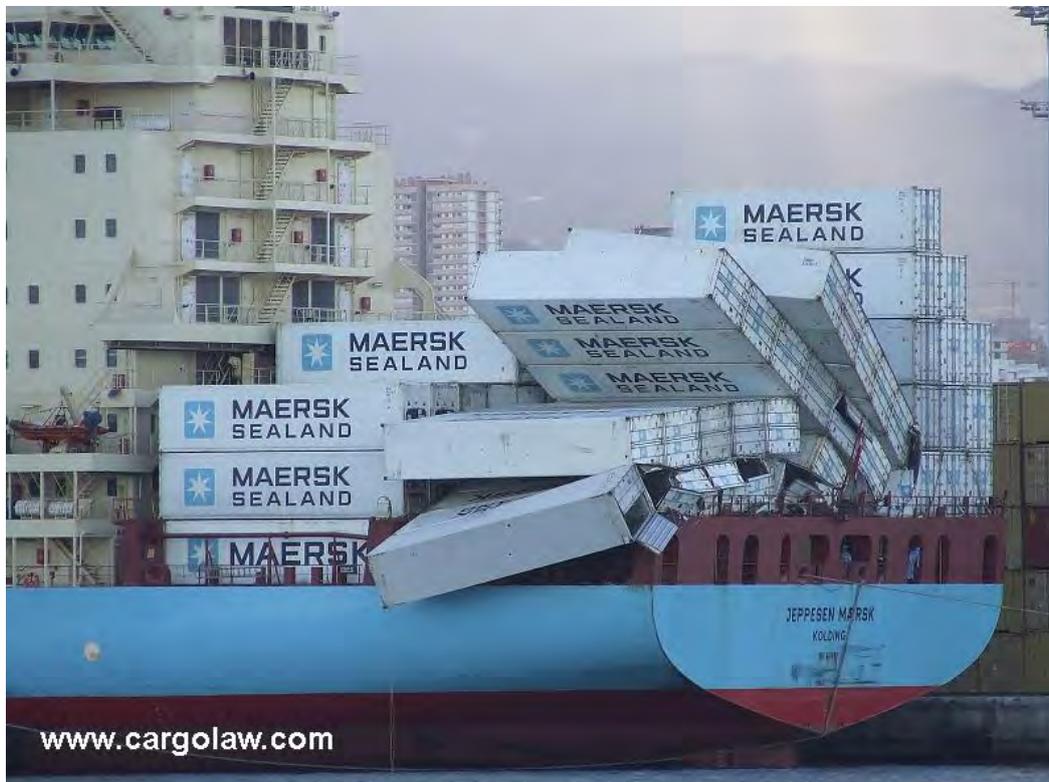
Figure 4-38: Damage overview photo

Collapse of 1 bay at the stern.

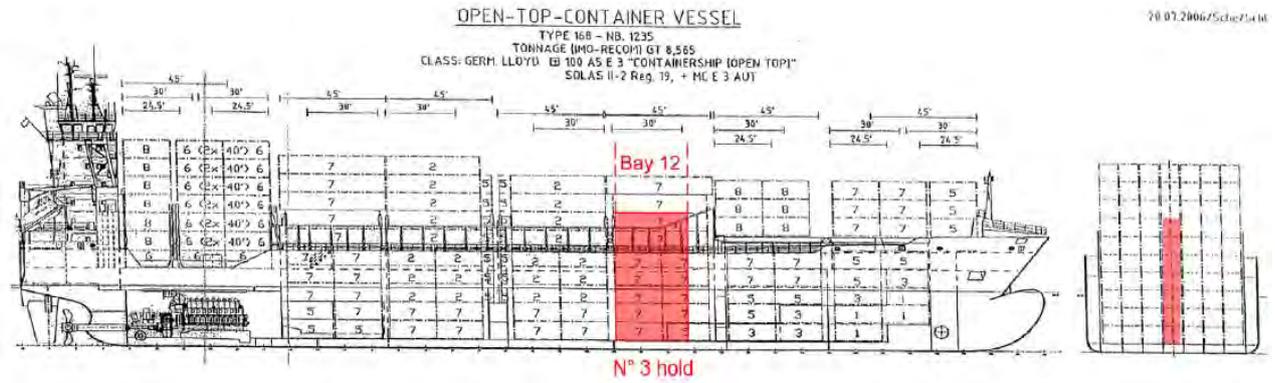
Figure 4-43: Location of damage

Based on the above wave conditions, resonant roll is less likely (although the vessel is sailing in close to beam seas). As one stack collapsed in the cargo hold, vertical motions due to heave in beam seas or pitch in bow quartering seas are the most likely contributors.

One stack collapsed around amidships at the centreline.

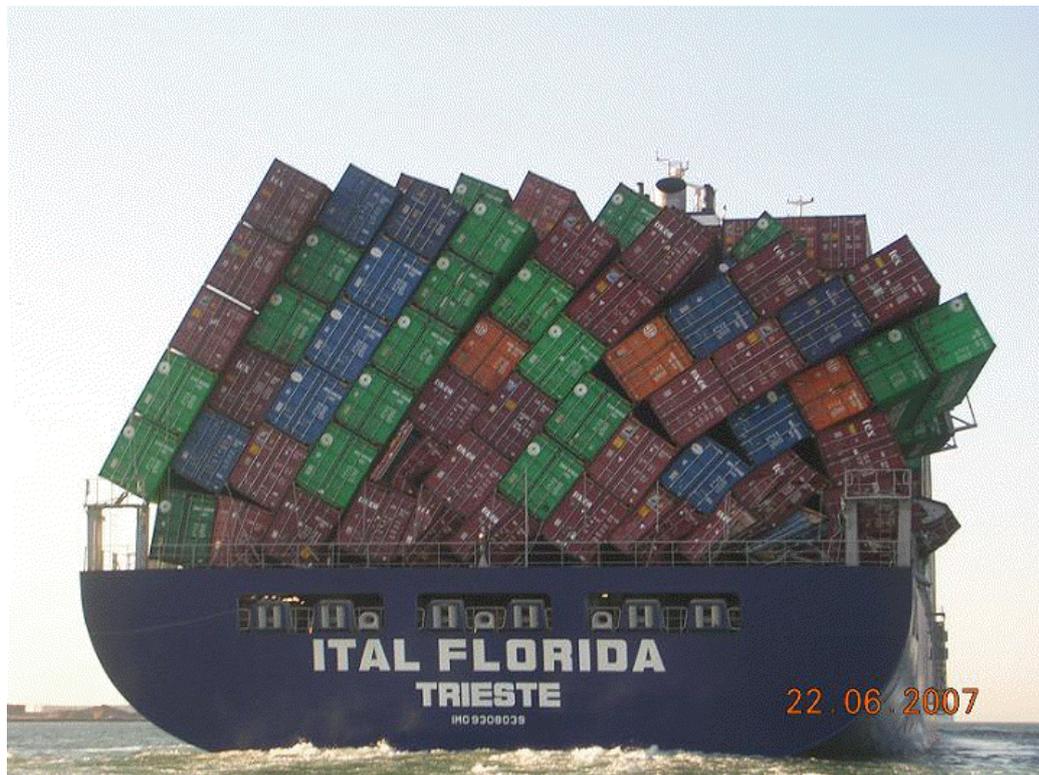
Figure 4-45: Damage overview photo

Stack collapse of 2 bays at the stern.

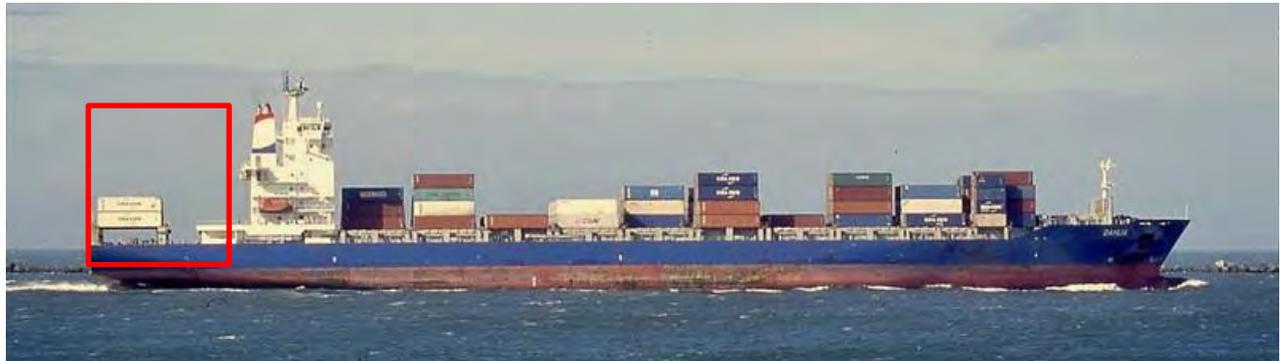
Figure 4-49: Location of damage

Partial collapse of 2 bays at the stern.

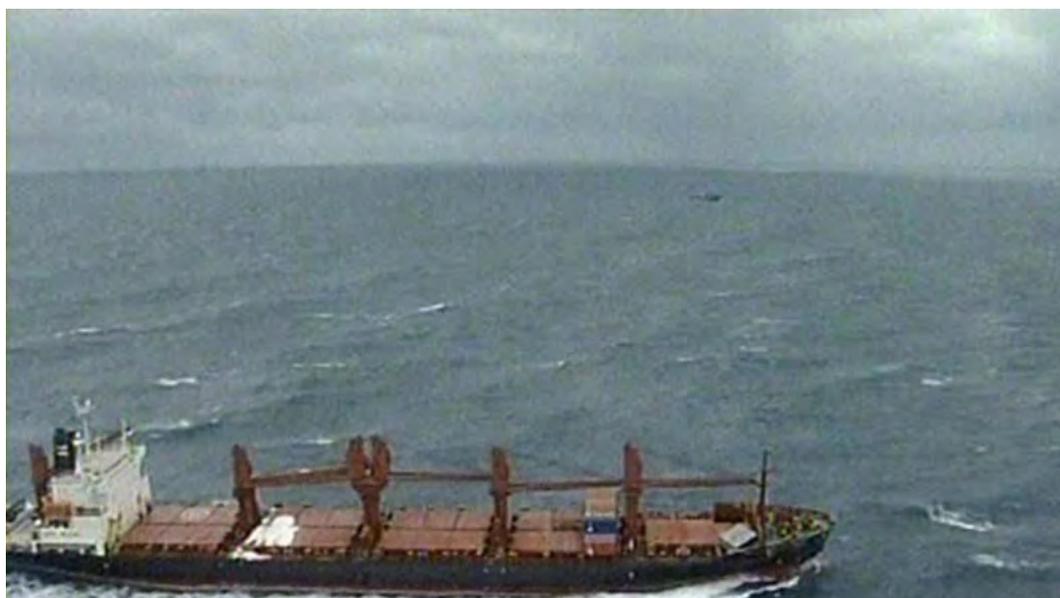
Figure 4-51: Damage overview photo

All 31 deck containers in bay 25 were lost and 2 containers were damaged (located at the most forward bay). The lost containers in bay 25 protruded the ship's hull and caused a significant oil spill.

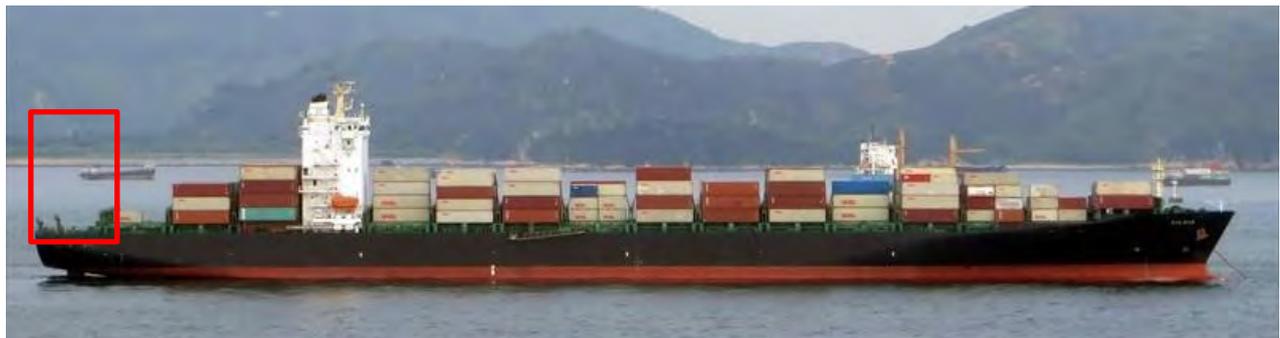
Figure 4-58: Location of damage

From the wave conditions and estimated rolling period, resonant roll in stern quartering seas seems most likely.

Partial stack collapse at the stern.

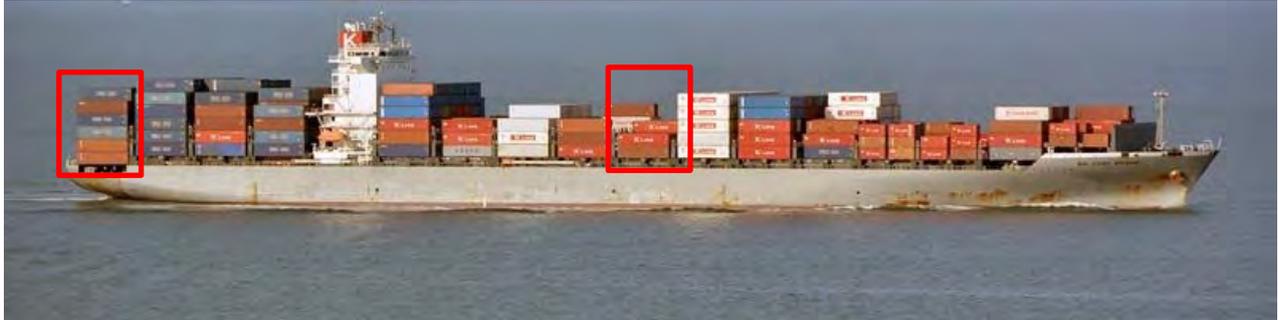
Figure 4-61: Location of damage

Stack collapse of 1 complete bay at the stern and one complete bay, 3 or 4 bays before the wheelhouse (this is not clearly visible on the incident photos).

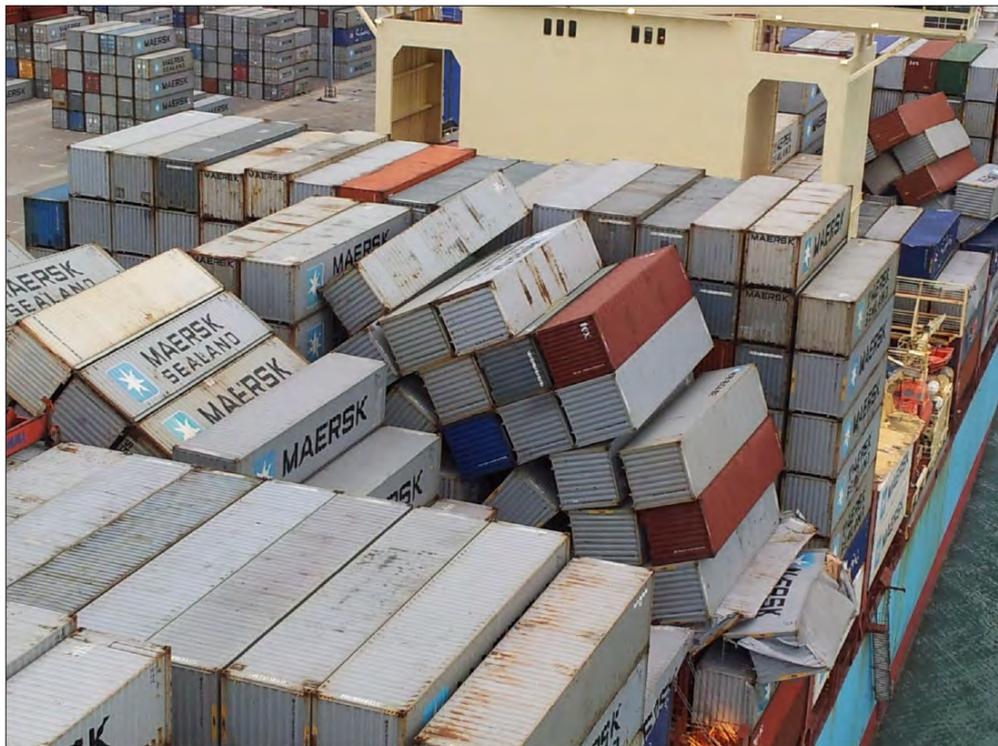
Figure 4-63: Damage overview photo

Based on the above wave conditions, the vessel was sailing in close to head seas conditions. With an estimated GM of around 4 m the T ϕ /Te is fairly close to 2, so parametric roll in head seas is likely. This was also the conclusion in the DMAIB report.

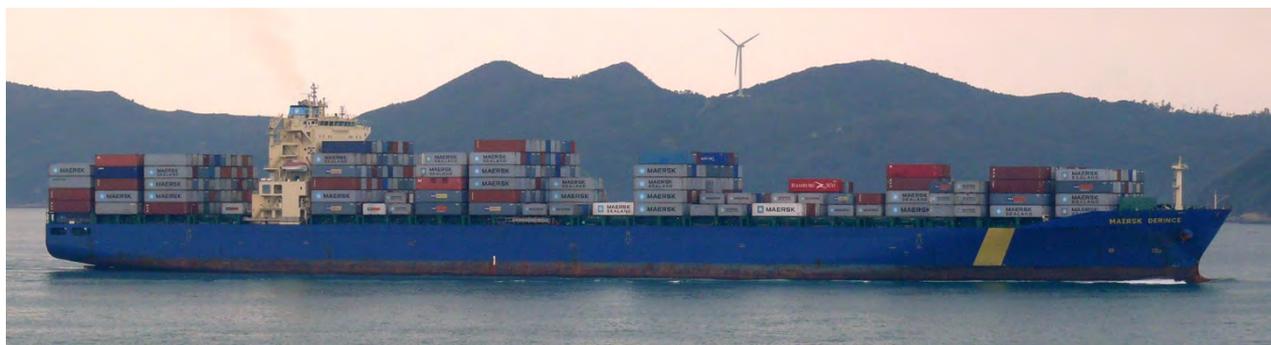
Figure 4-67: Overview photo (no damage photos available)

In these bow quartering seas conditions, resonant roll and parametric roll seems unlikely. Combined first order ship motions (heave, pitch, and roll) and/or slamming induced vibrations are the most likely contributors. However due to the rapidly changing weather conditions, the result is quite sensitive to position and time of the incident.

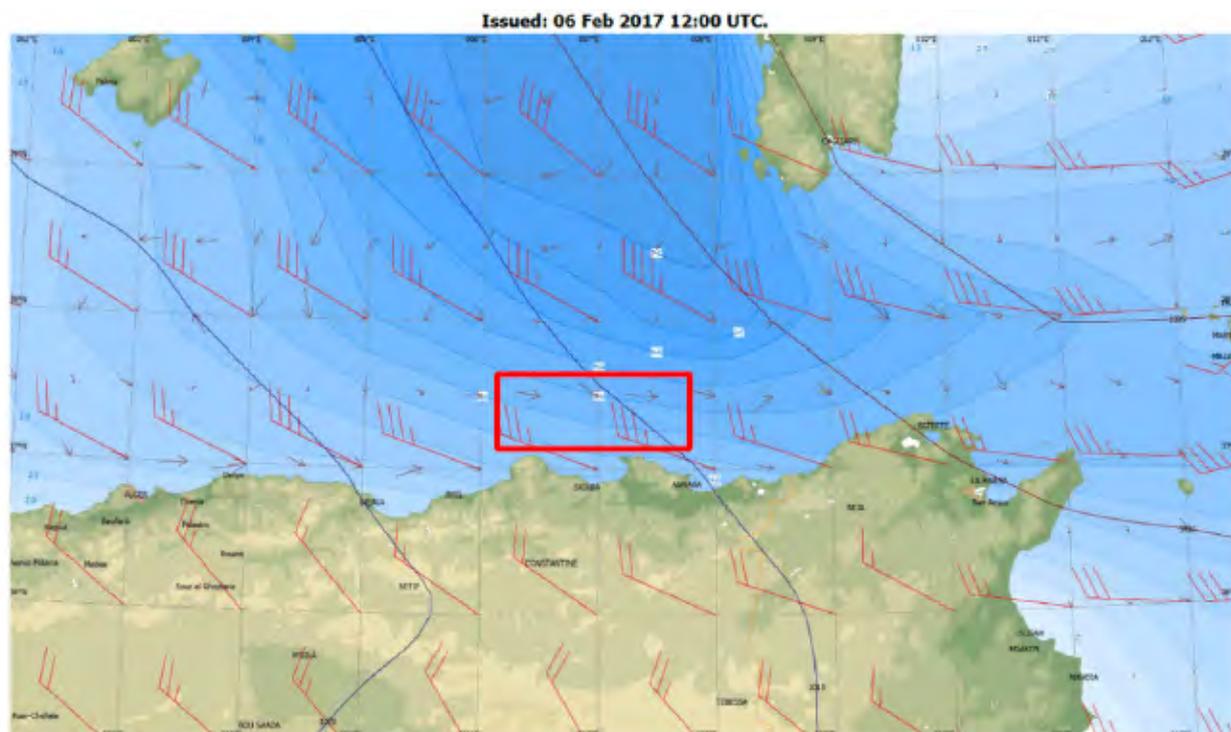
Weather forecast by SPOS. The area marked in red was where the vessel passed between 14:00 hrs and 20:00 hrs on 6 February 2017. In that area, the weather forecast remained 35 knots, equalling wind force 8 Bft.

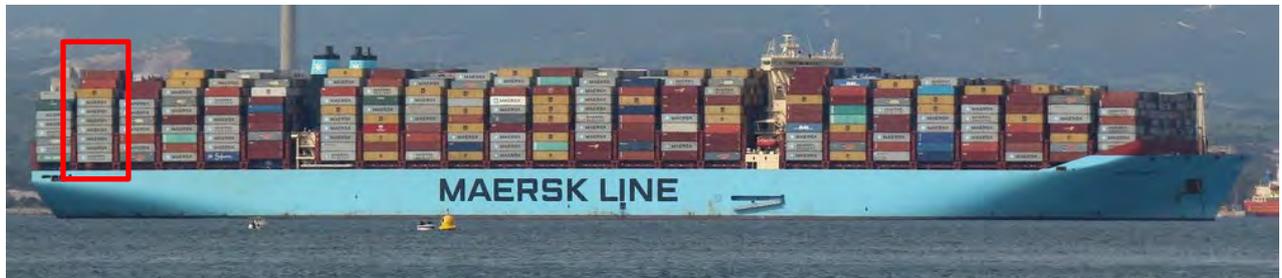
Figure 4-71: Location of damage

In these bow quartering seas conditions, resonant roll and parametric roll seems unlikely. Combined first order ship motions (heave, pitch, and roll) and/or slamming induced vibrations are the most likely contributors.

1 bay at the stern.

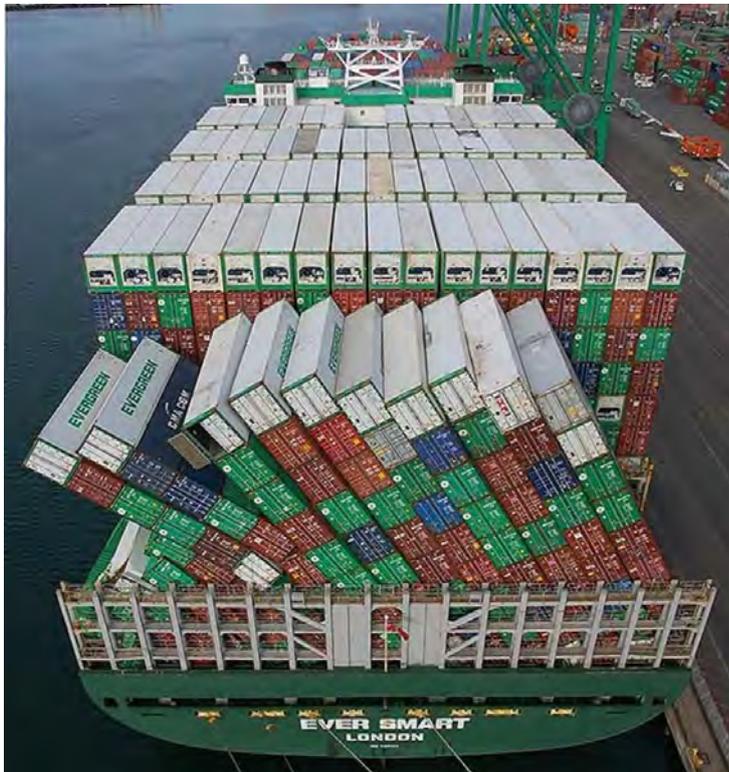
Figure 4-73: Damage overview photo

On 29 October 2017, the UK registered container ship Ever Smart suffered a container stow collapse while on passage between Taipei, Taiwan and Los Angeles, USA. The master had changed the ship's passage plan to avoid severe weather caused by a developing depression east of Japan. The ship continued in heavy seas; rolling 10° to 12° and pitching heavily with frequent bow flare slamming.

As wave directions conditions changed rapidly in this storm a more beam or stern quartering seas condition would also have been possible. But present heading (beam to bow quartering seas) seems to be more or less in line with the reported ship behaviour.

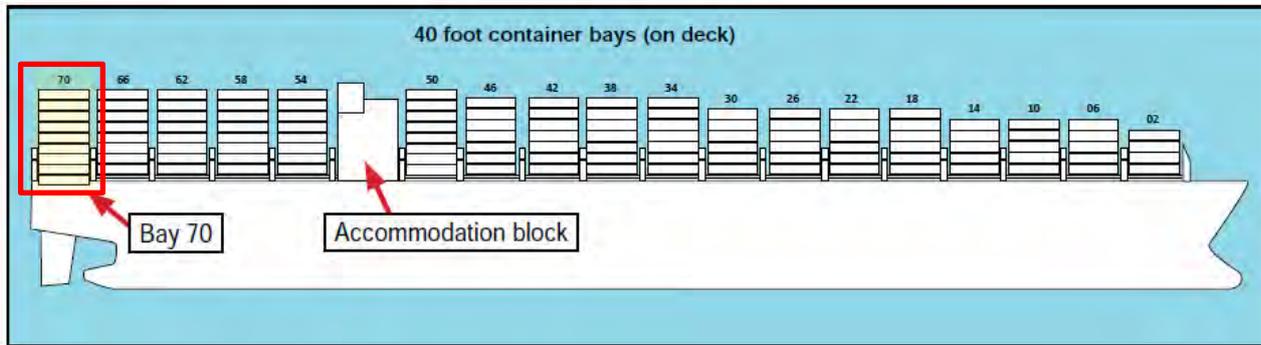
Figure 4-75: Location of damage

Stack collapse of 1 bay at the stern.

The MAIB investigation concluded that:

- The loss of the containers most likely occurred during a period of heavy pitching and hull vibration in the early morning of 30 October.
- A combination of factors resulted in a loss of integrity for the whole deck cargo bay; in particular, the containers were not stowed or secured in accordance with the cargo securing manual.
- The container lashings might not have been secured correctly.

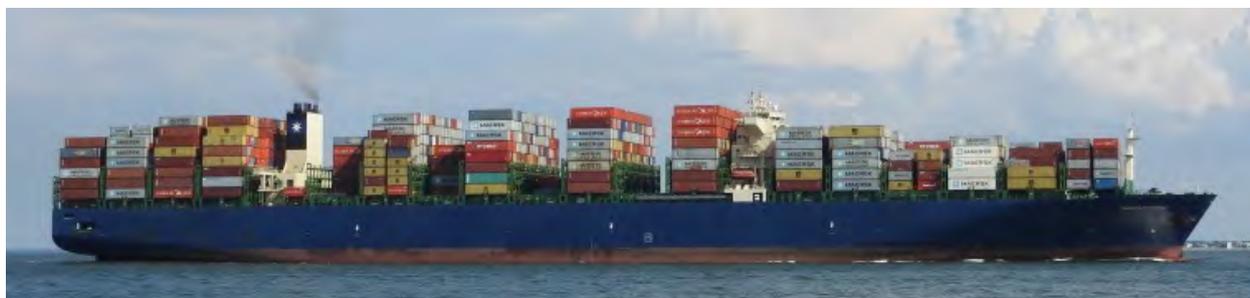
Figure 4-81: Side view (no damage photos available)

Based on the above conditions and an estimated speed of 15 kn, the wave encounter period is approximately 17 s. With the provided GM the rolling period would be around 48 s (varying between 36 to 58 s depending on kxx). Given the heading and T_ϕ/T_e ratio, both resonant roll as well as parametric roll seem unlikely.

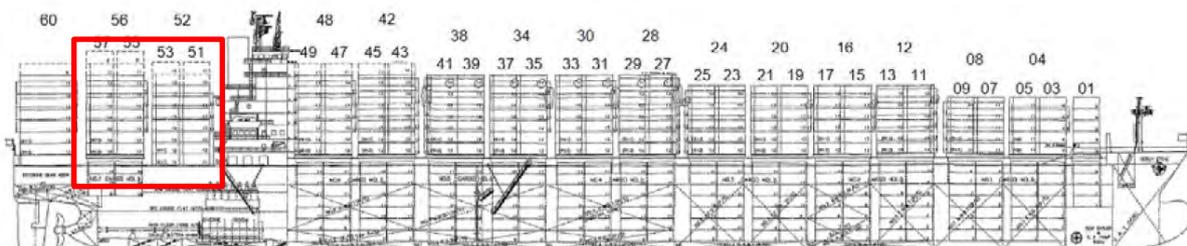
Figure 4-86: Location of damage

Given the close to head seas condition and the T_ϕ/T_e ratio of around 2, parametric roll in head seas is the most likely cause (and seems to match with the crew statement ...experienced a period of sudden rolling for between 60 and 90 seconds...).

Stack collapse of 2 bays at the stern (directly aft of the superstructure).

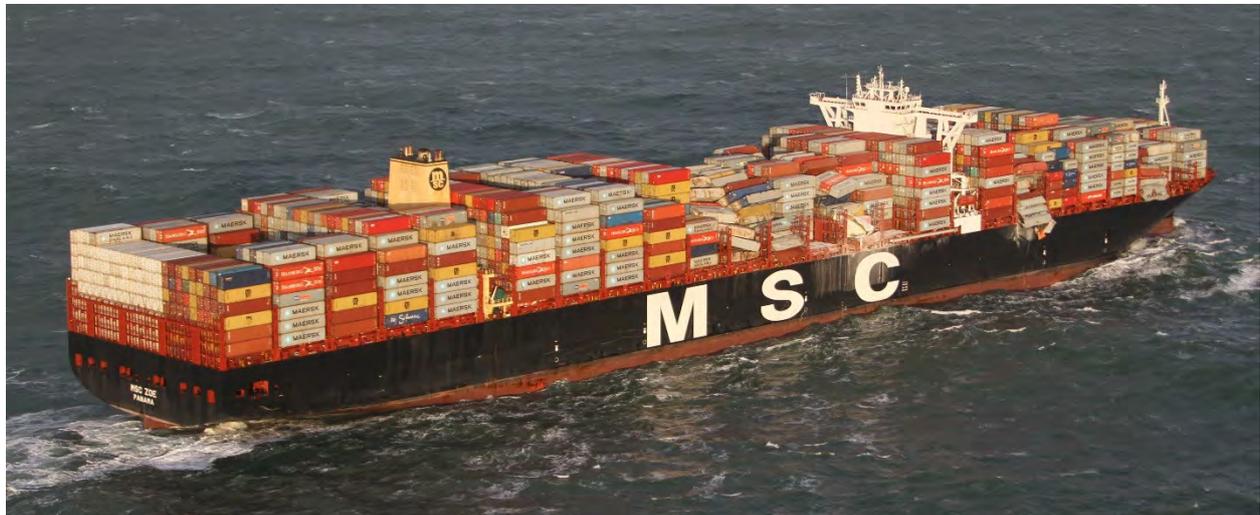
Figure 4-88: Damage overview photo

Given the wave conditions and rolling period, close to resonant roll in beam seas is most likely. This is also what the report mention, possibly in combination of green water and bottom contact.

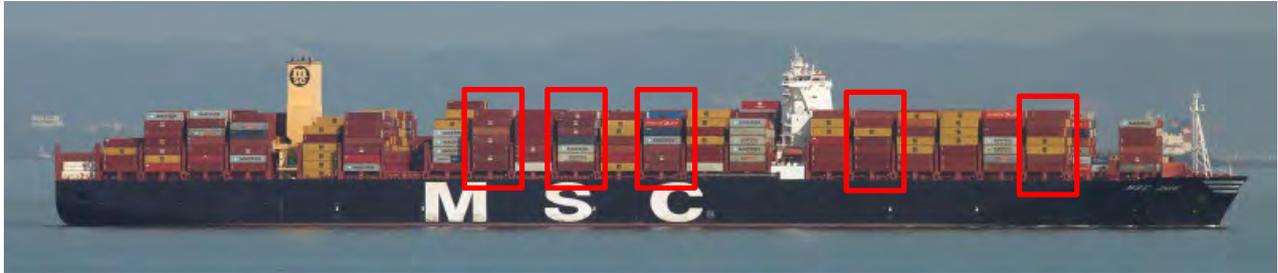
Figure 4-89: Location of damage

Major stack collapse of 5 out of the 24 bays.

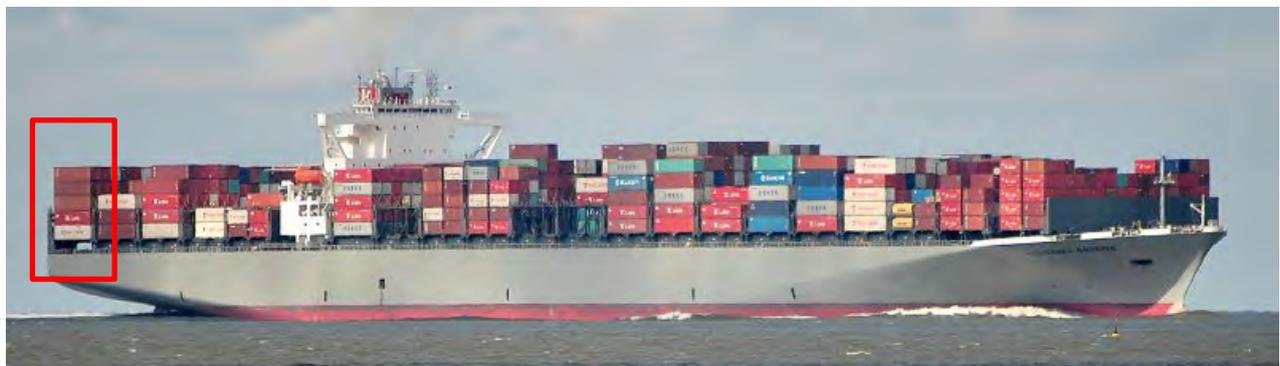
Figure 4-93: Location of damage

Based on these stern quartering seas conditions and given the estimated rolling period of 22 s (based on a GM of 3 m), resonant roll in stern quartering seas seems most likely.
