Review of incidents resulting in loss of containers

Report No. : 33039-1-SEA
Date : May 2022
Version : 1.2
Final Report

Ordered by : TopTier JIP

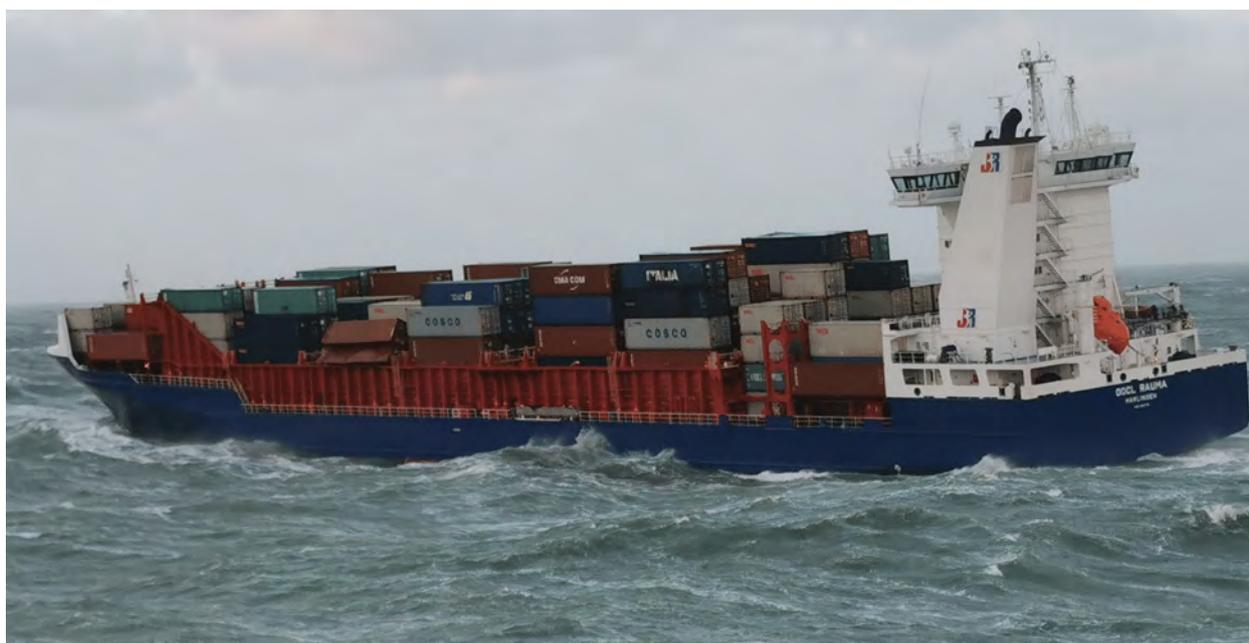
Figure 4-95: Damage overview photo

In these head seas conditions, large pitch/heave motions possibly in combination with shipping green water seem the most likely contributors.

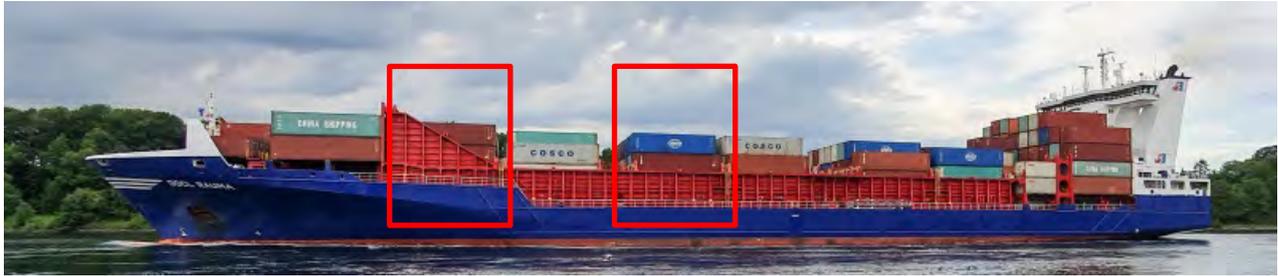
Figure 4-98: Location of damage

Partial stack collapse in 2 bays.

According to the lawsuit it was a combination of:

Heavy weather / maximum stack weight exceeded.

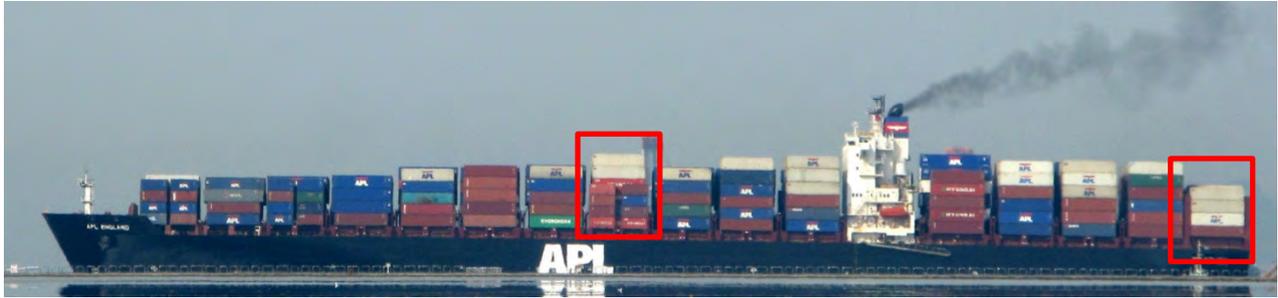
Figure 4-102: Location of damage

Based on the above conditions and a speed of 7 kn, the wave encounter period is approximately 8 s. As the transverse stability (GM) is not provided in the incident report, it is difficult to estimate the rolling period. A very rough guess would around 20 s (assuming a GM of 3 m and typical roll inertia) but it could vary between less than 10 s and above 38 s. Given the heading (head seas), low speed and T_{ϕ}/T_e ratio, parametric roll in head seas is likely.

Complete stack collapse of 3 top layers at the stern (lashing bridge up to the 5th layer). In addition partial stack collapse (3 or 4 rows at SB), 4 bays before the wheelhouse.

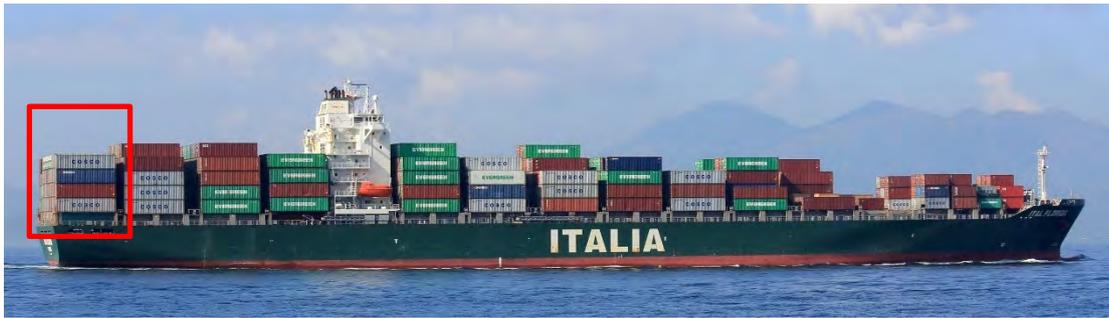
Figure 4-107: Location of damage

Stack collapse of 1 bay at the stern.

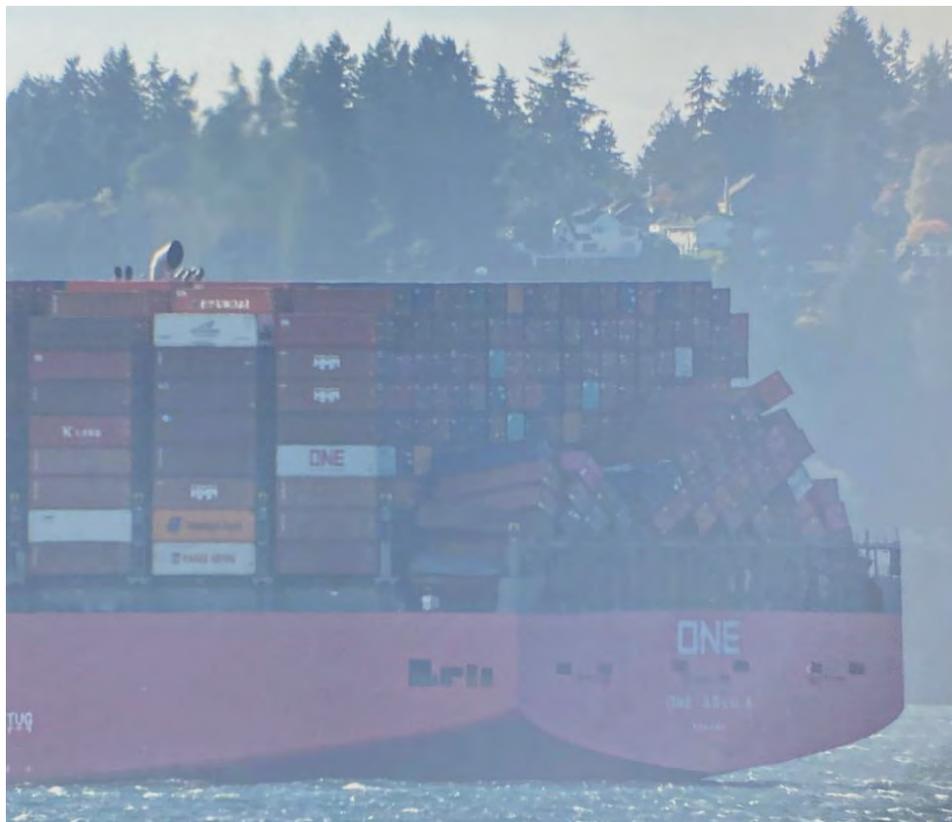
Figure 4-109: Damage overview photo

At a speed of 11.6 kn this results in a wave encounter period of approximately 16.7 s. As the loading condition is unknown it is difficult to estimate the rolling period. A very rough guess would around 31 s (assuming a GM of 2 m and typical roll inertia) but it could vary between less than 17 s and above 48 s. Therefore it is could be both parametric or resonant roll, but parametric roll seems slightly more likely.

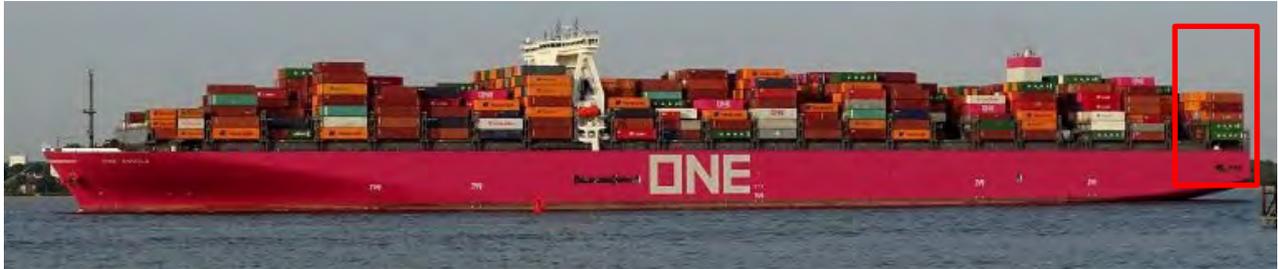
Figure 4-112: Location of damage

Stack collapse of 1 bay at the stern.

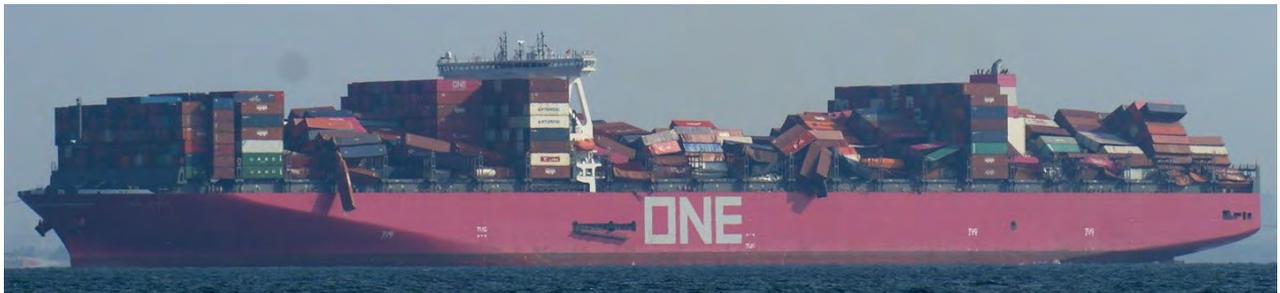
Figure 4-119: Location of damage

As the loading condition is unknown it is difficult to estimate the rolling period. A very rough guess would around 36 s (assuming a GM of 1.5 m and typical roll inertia) but it could vary between roughly 24 s and above 50 s. Based on the wave direction and T_ϕ/T_e ratio, parametric roll in following seas seems most likely.

18 Of the bays collapsed. From which 16 completely and 2 partially.

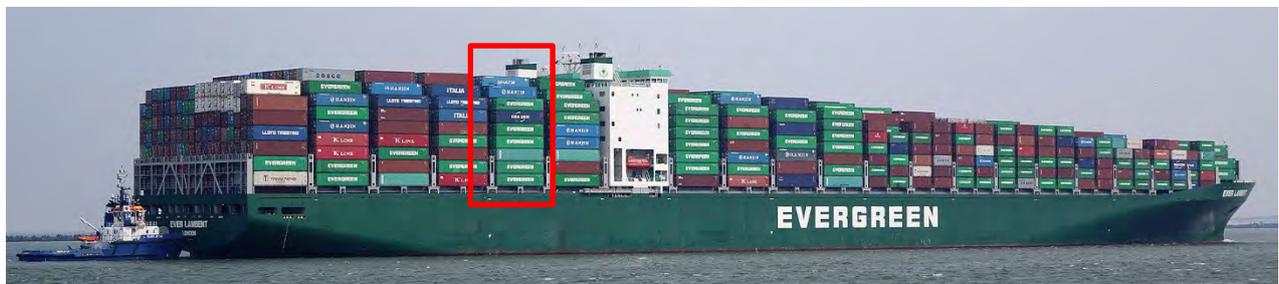
Figure 4-124: Location of damage

Stack collapse 2 bays behind the bridge

Lashing materials were inspected at bay no. 62 and found part of lashing bars were bent heavily, turnbuckles were parted, some twistlocks were broken and pin of shackles were missing. We noted most containers collapsed or fell into water from 6 tiers because the containers were secured by twistlocks only without lashing or bridge fitting applied on containers. Furthermore, we found a few different twistlocks applied on the containers. Deck officer revealed to us that such different twistlocks were possibly fitted by stevedores ashore during loading operation.

According to our above findings, we are of the view that the above noted collapse of containers stowed on board the vessel might have been attributed to insufficient strength of securing materials (twistlock) without lashing, resulted in the securing materials were parted due to sudden jerk during rolling at sea when encountered heavy weather and containers collapsed on deck or fell into water during the voyage. We further suspected that the different twistlocks applied on the containers might have also been one of the reasons resulting in containers collapsed.

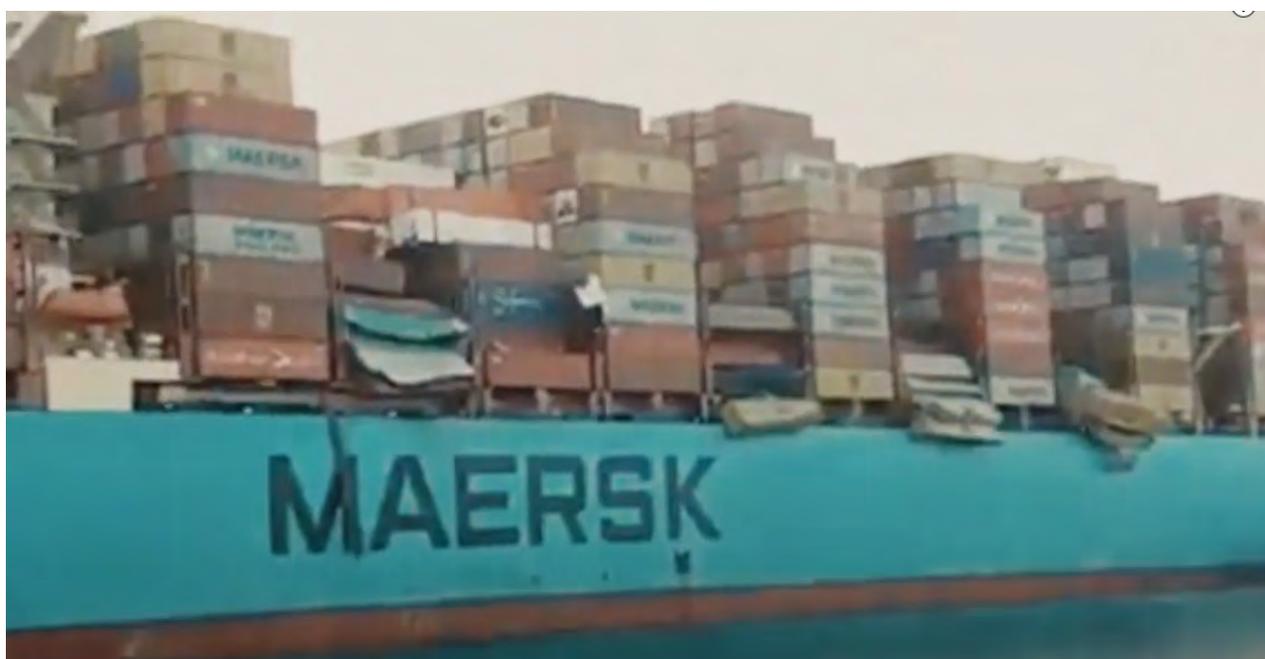
Figure 4-126: Damage overview photo

As the loading condition is unknown it is difficult to estimate the rolling period. A very rough guess would be around 34 s (assuming a GM of 1.5 m and typical roll inertia) but it could vary between less than 23 s and above 50 s. Based on the wave direction and T ϕ / T ϵ ratio, parametric roll and resonant roll are both possible. But given the following seas conditions, parametric roll in following seas is more likely.

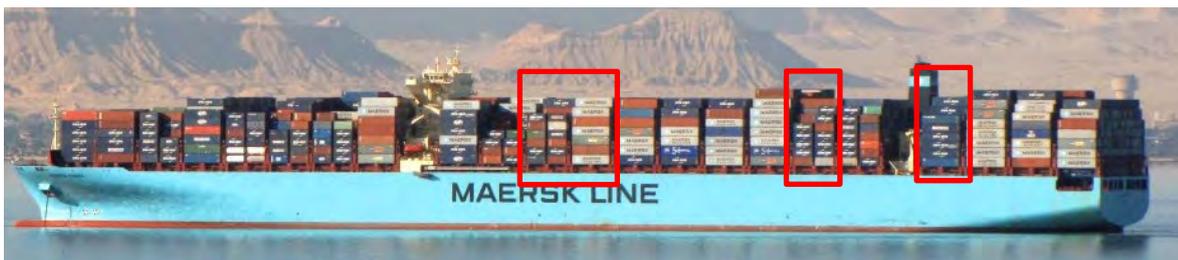
Figure 4-129: Location of damage

Multiple stack collapse bay 4, 9, 9 and 10.

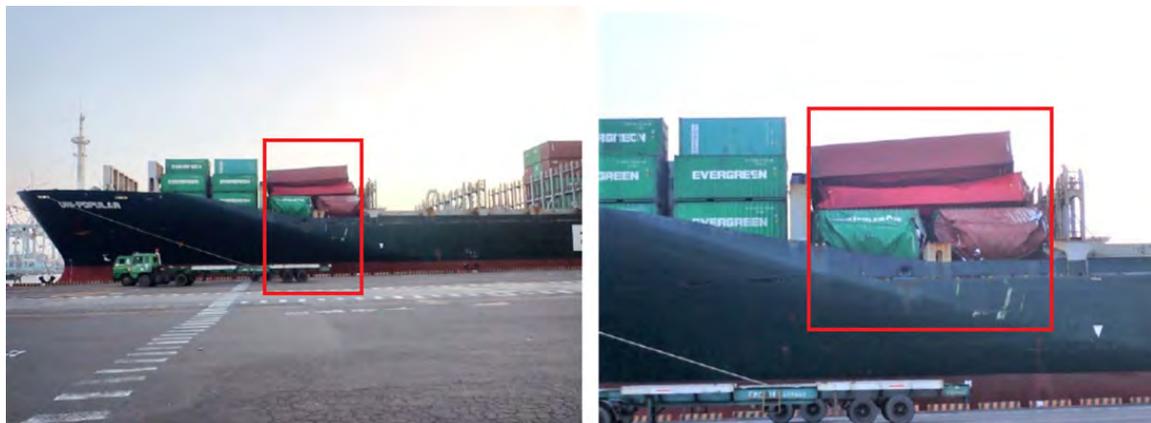
Figure 4-134: Damage overview photo

Based on the above conditions and a speed of 11 kn, the wave encounter period is approximately 8 s. The estimated rolling period is around 12.5 s (range approx. 10 s to 15 s depending on k_{xx}). Given the heading, combined motions in bow quartering seas are most likely.

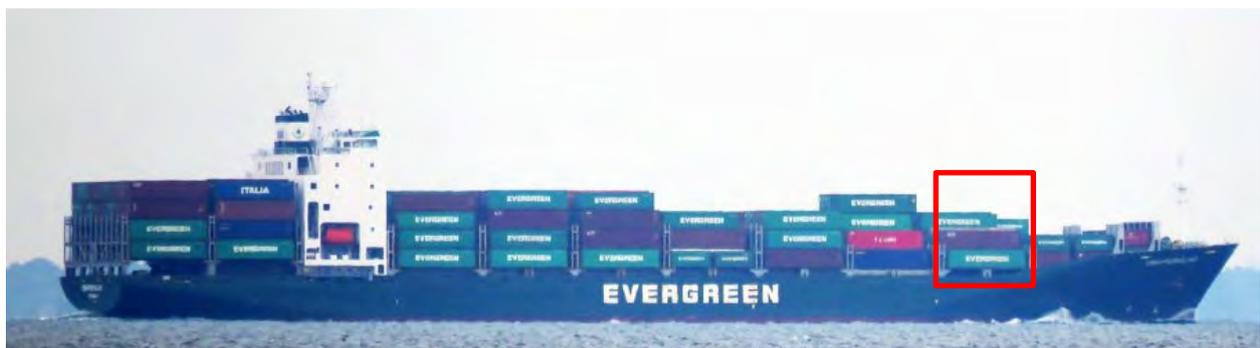
Figure 4-136: Location of damage

Partial collapse of 3 stacks in fairly empty bay.

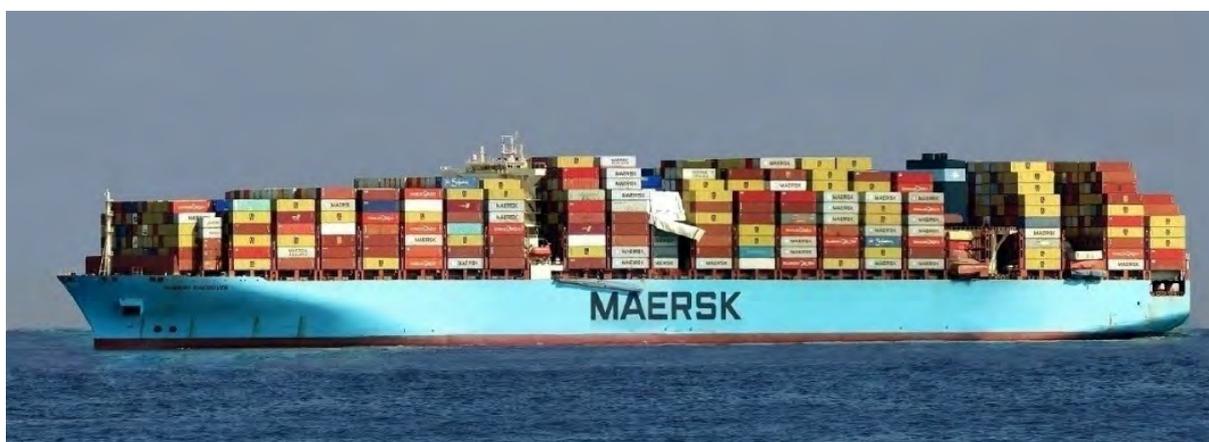
Figure 4-139: Damage overview photo

As the loading condition is unknown it is difficult to estimate the rolling period. A very rough guess would be around 34 s (assuming a GM of 1.5 m and typical roll inertia) but it could vary between less than 23 s and above 50 s. Based on the wave direction, speed and T_{ϕ}/T_e ratio, it is could be both parametric roll or resonant roll, but parametric roll in (close to) following seas seems slightly more likely.

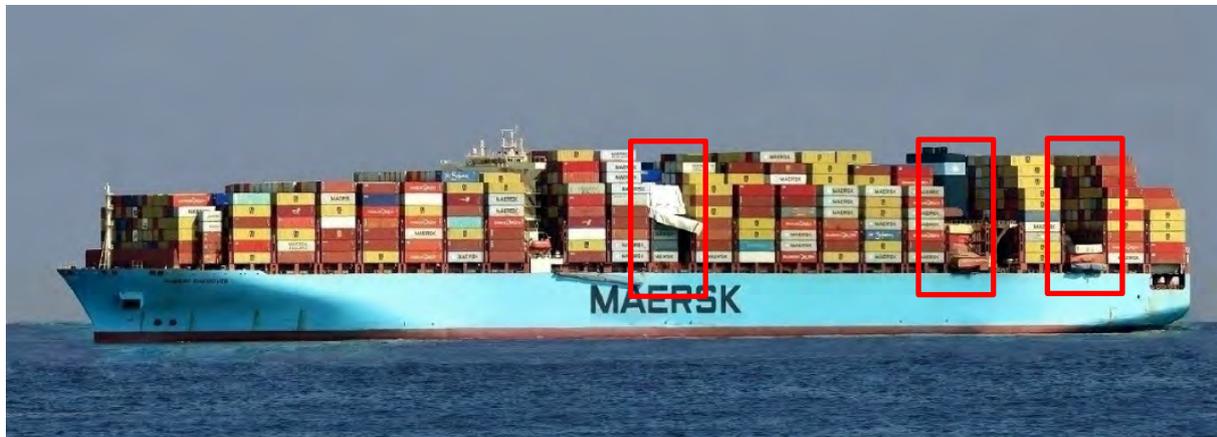
Figure 4-142: Location of damage

Collapse of 3 bays along the length of the ship.

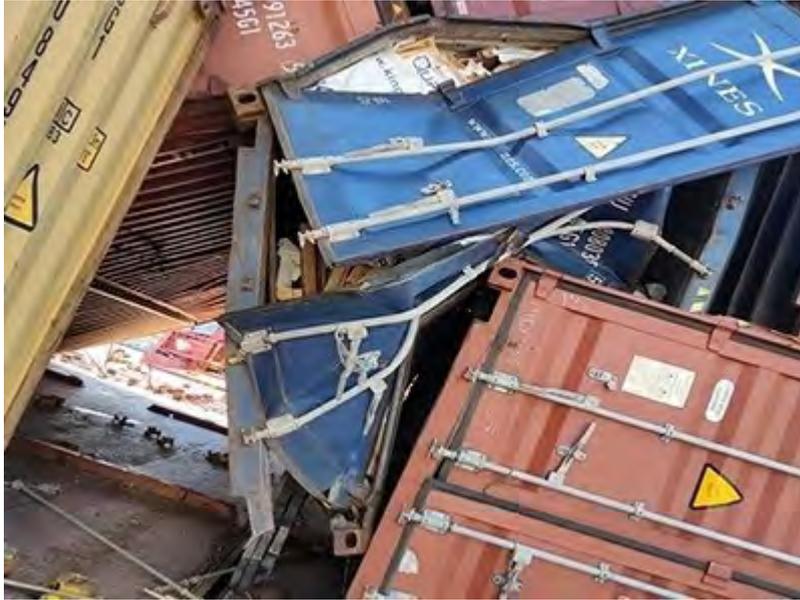
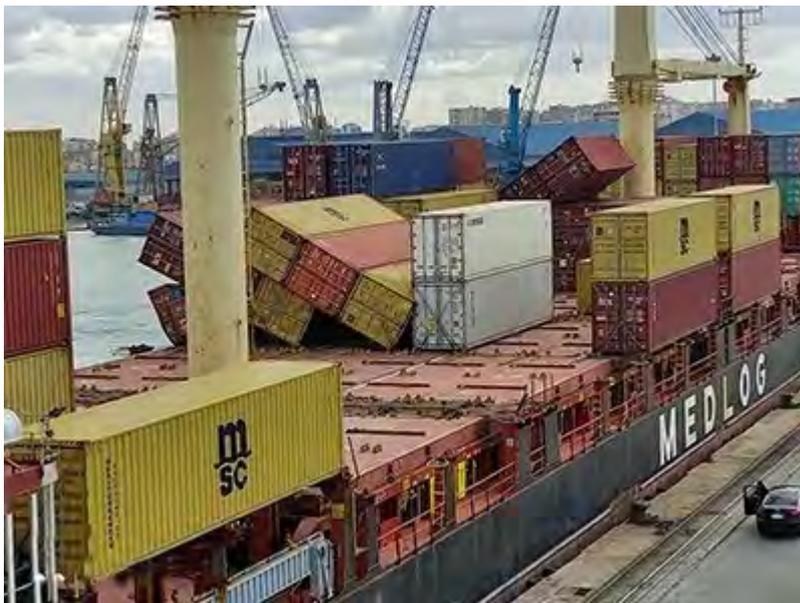
Figure 4-144: Selection of other incident photos

Multiple containers collapsed (possible lost) on fairly empty deck.

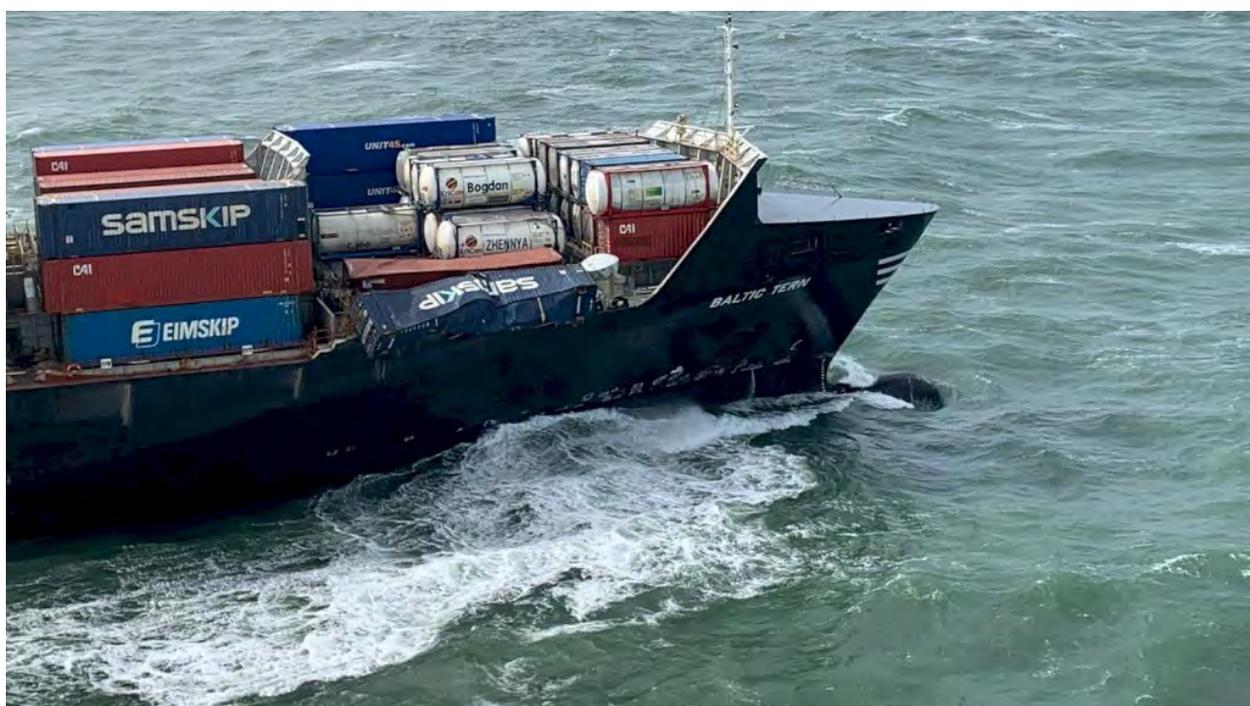
Figure 4-145: Damage overview photo

Resonant roll in close to beam seas conditions seems most likely.

Partial stack collapse in 1 bay at the bow.

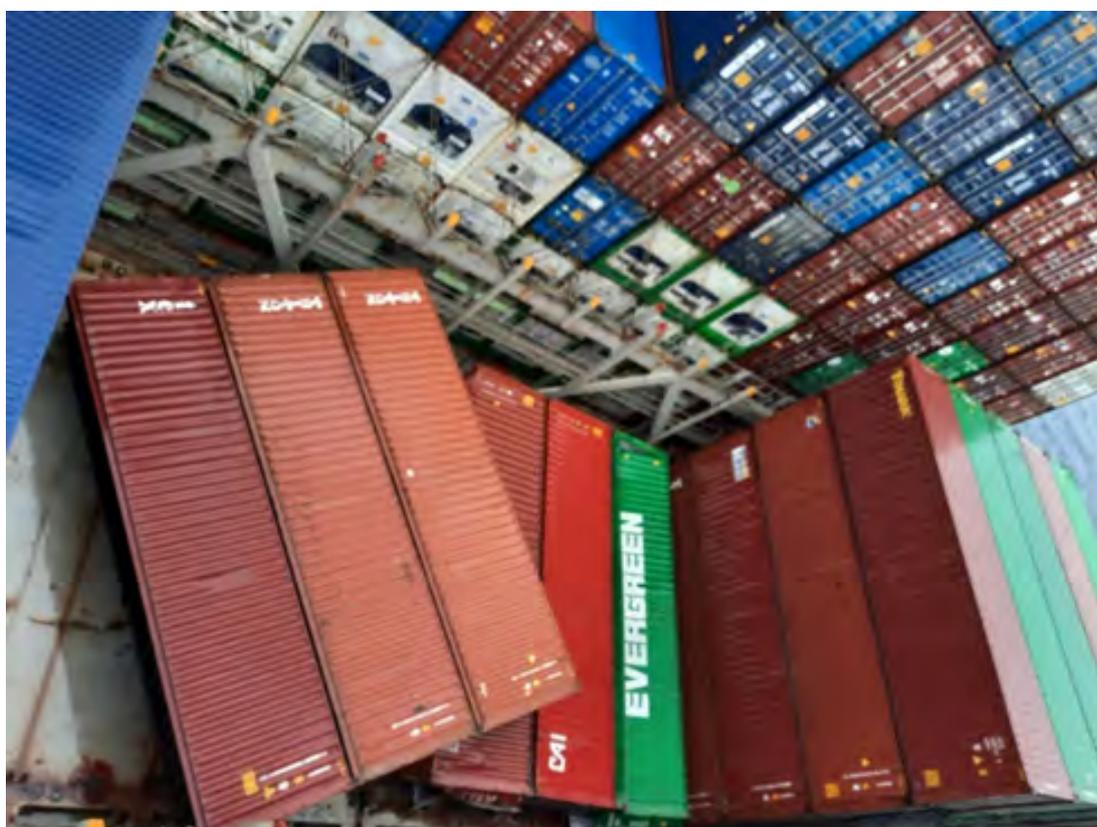
Figure 4-149: Damage overview photo

0200LT to 0700LT Wind force 4 grades from North and SW swell 2 meters height
 0700LT to 0900LT Swell direction was from the ship's port beam and ship started rolling moderately. Maximum list is 9 degree.
 0905LT Suddenly a heavy swell occurred and ship rolled seriously to 19 degree. There was found 6 containers collapsed on the center of the hatch cover and saw some containers fell overboard at starboard side.
 0906LT Master changed course to 270 degree immediately to avoid more rolling on the ship.
 0907LT Master broadcasted the situation to all crew and asked Chief Officer to go to the scene for checking.
 0910LT Chief Officer found six containers collapsed on the center of hatch cover and lost nine containers at BAY54.

Partial collapse of a few stacks within 1 bay.

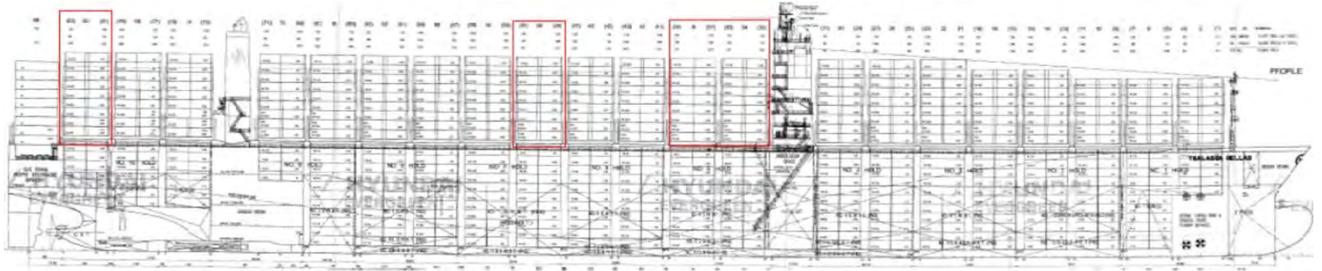
Figure 4-155: Location of damage

Partial collapse of containers in multiple bays. Most severe damage and lost containers at the stern.

- *The damages/loss have occurred only to the bays situated aft of the accommodation block. Overwhelming majority of the damaged containers was stowed on the starboard side of the midship (rows 01 to 19). Except Bay No.82, all the containers have damages to the forward side. Most of the damaged containers have suffered damages to their permanent member like posts (mostly forward right posts).*

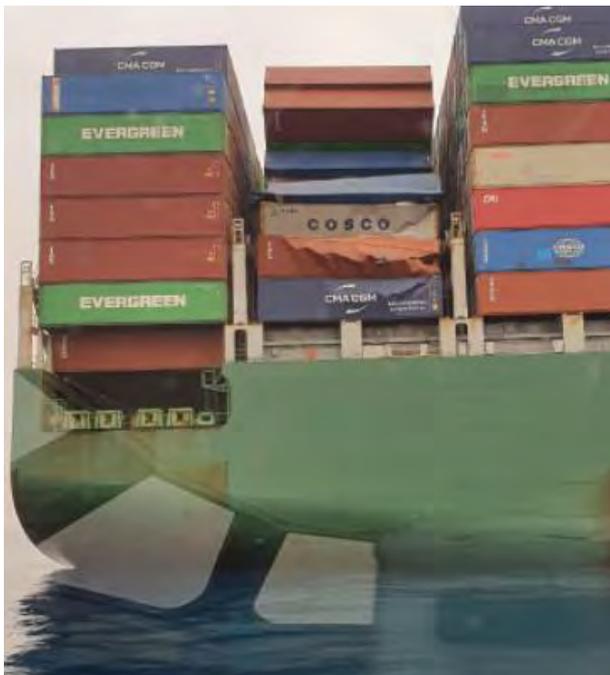
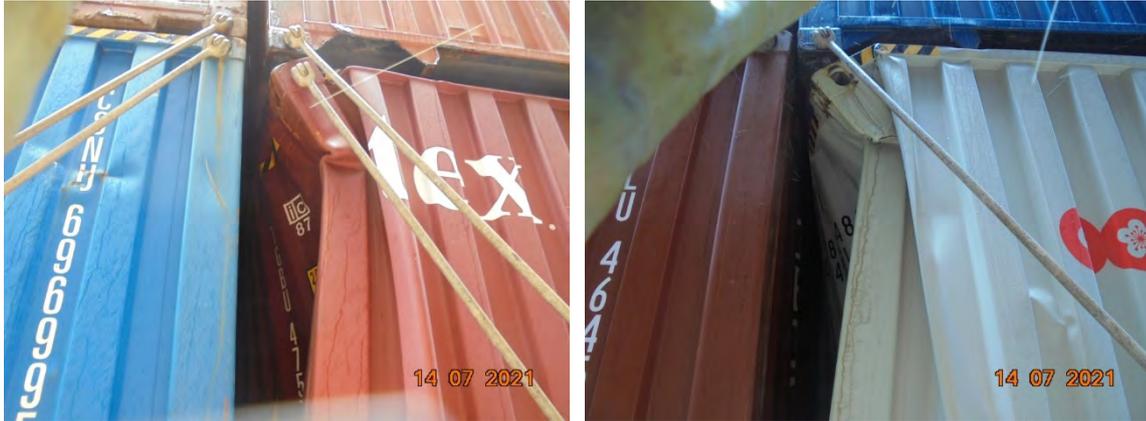
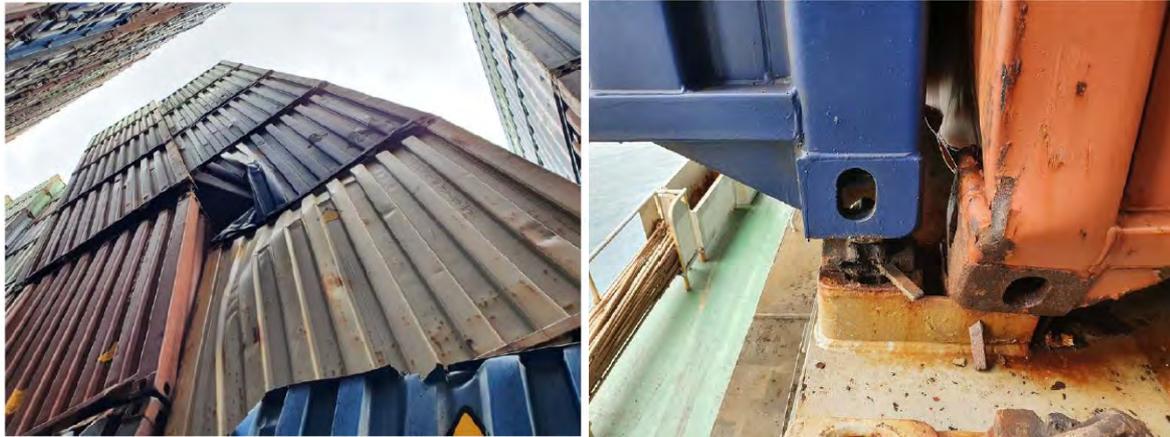
Figure 4-157: Selection of other incident photos

The container's forward inboard bottom twist lock was in open position and the container base was not resting completely on the lock. Surveyor unable to comment if the container was completely landed during loading with lock left in open position or it moved upward due to heavy weather. The fact that lock did not break may be an indication that it was not locked properly. The aft inboard twist lock was found almost at half position i.e. not fully closed. This row (No.19) had lost five containers overboard and wonder if this was the start of problem. The apparent condition of the lashing gear onboard was good.

- *From the pattern of damages/losses, the focus should be on the possibility of vessel encountering "Parametric Rolling" that might have exposed her to heavy stress at starboard quarter. If such situation was allowed to continue for some time, this could have resulted in failure of lashing/securing material and resultant damages.*

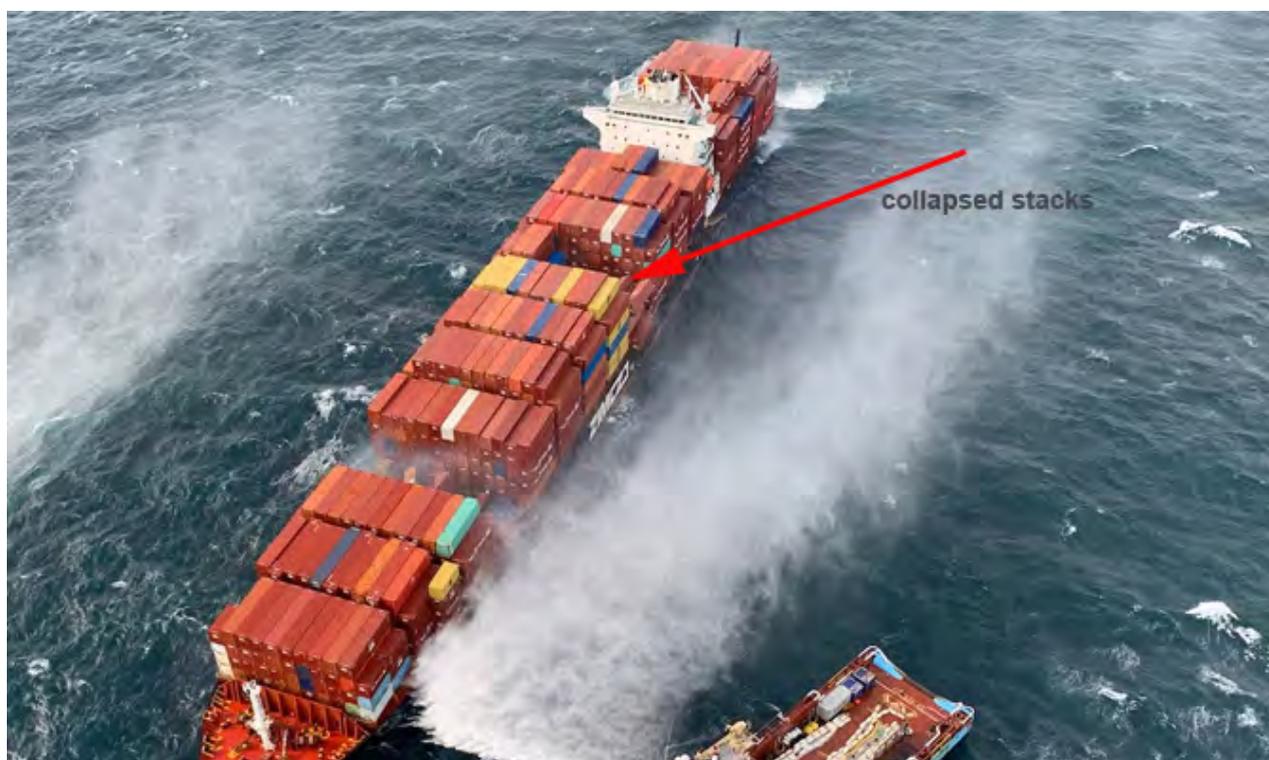
Figure 4-158: Damage overview photo

Given above wave conditions resonant roll in stern quartering seas seems likely.

Collapse of 3 bays (complete collapse at most forward bay, partial collapse of bays at around the amidships and stern).
