The Marco Polo Tension Leg Platform (TLP) has been subjected to an extensive monitoring campaign since June, 2004. Report tracks its progress.

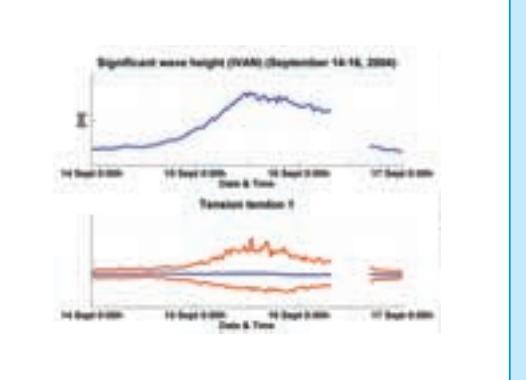
Instrumentation comprises strains in the columntendon supports, loads and vibrations of the tensioned risers, as well as high frequency and low frequency motions of the platform. Both to check the design input data and to gather sufficient data for analysing the platform behaviour, much attention was paid to wind, wave and current conditions. In total, 173 signals are continuously recorded with a high sample rate and stored for post-processing.
