Tombua Landana transports undergo fatigue assessment

Heerema Marine Contractors (HMC) contracted MARIN to monitor the barge motions during two Tombua Landana transports with Compliant Tower sections from its yards in the US to the installation site in Angola.

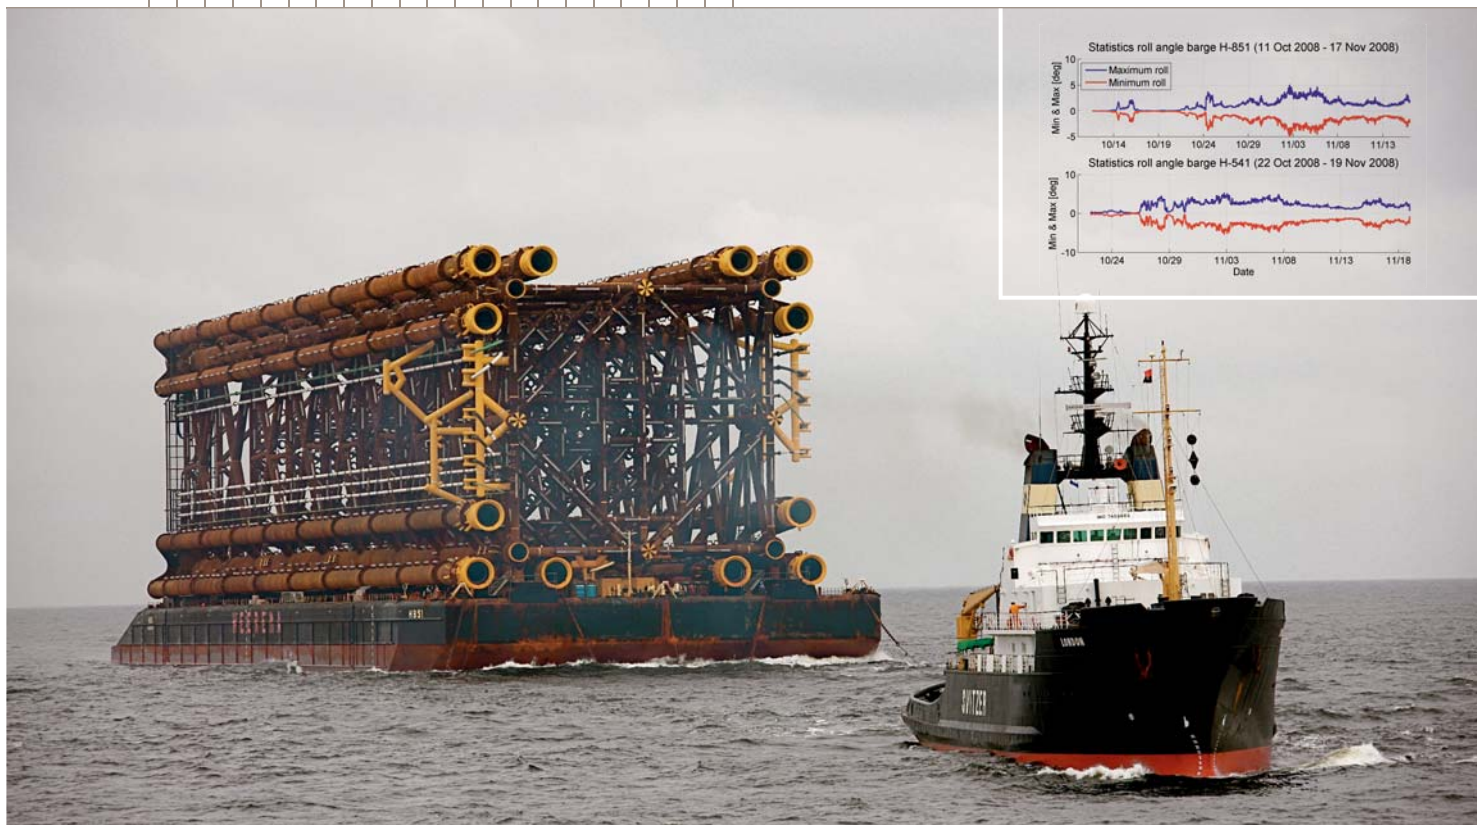
After successful monitoring of both transports, all the measurements were analysed at MARIN in more detail. Statistics and the cumulative rain flow distribution of the motions were determined and reported. In the figure above, the roll motions of the barge/cargo during both voyages are shown. ▢
